## status report

#### Volkswagen T-Roc Style

Vehicle identification number	<b>WVGZZA1ZKV020133</b>	mileage read:	<b>52462 km</b>
..			
First Registration / construction year:	<b>08.11.2018 / 2018</b>	Visit Date / place of birth:	<b>21.11.2024 Riedstadt-Goddelau</b>
Bodywork:	<b>SUV</b>	Re - import:	<b>unknown</b>
Body type:	<b>Road /</b>	KBA no. :	<b>0603//CFO</b>
Fuel / emission class:	<b>diesel / -</b>	transmission type:	<b>manual transmission</b>
Displacement / power:	<b>1598 ccm / 85 kW (116 PS)</b>	Engine:	<b>front-wheel drive</b>
paint:	<b>Pure White</b>	Number of previous owners:	<b>3</b>
Doors / seats:	<b>5 / 5</b>	number keys:	<b>2</b>
Next HU / AU:	<b>- / -</b>	cushion type:	<b>substance</b>
Service book available:	<b>no</b>	Interior Color:	<b>black</b>
smoking vehicle:	<b>no</b>	Last service km / on the:	<b>- / -</b>
Vehicle roadworthy:	<b>yes</b>	Vehicle roadworthy:	<b>yes</b>
Submitted vehicle	<b>-</b>	state outside:	<b>3 - Average</b>

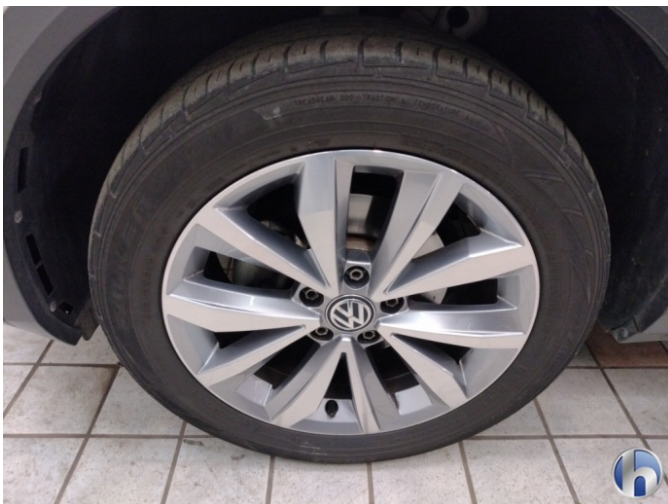
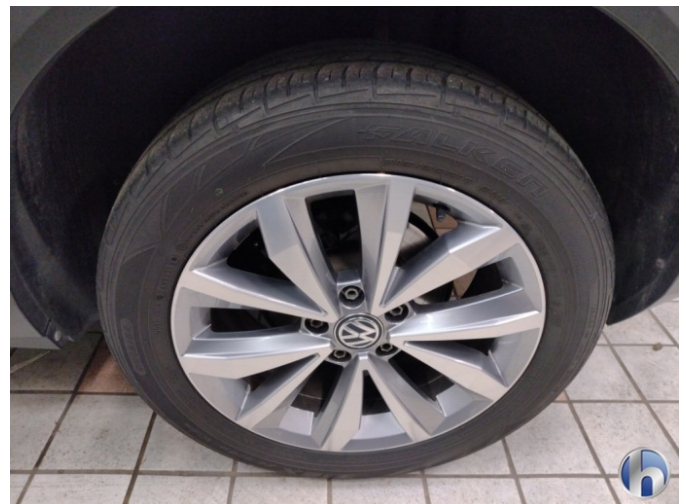
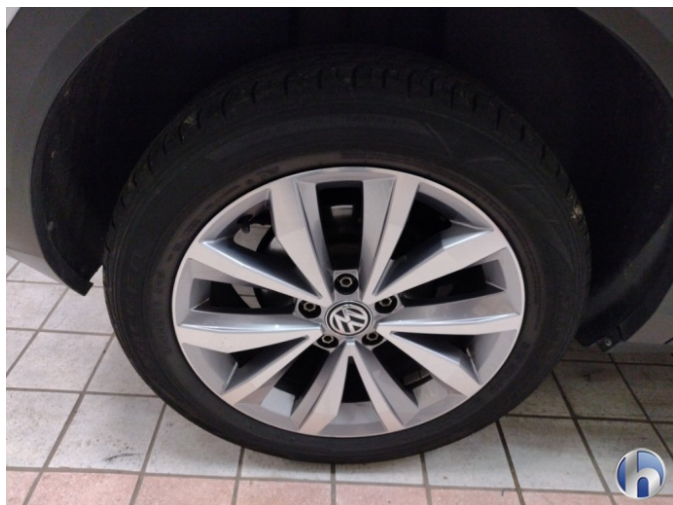
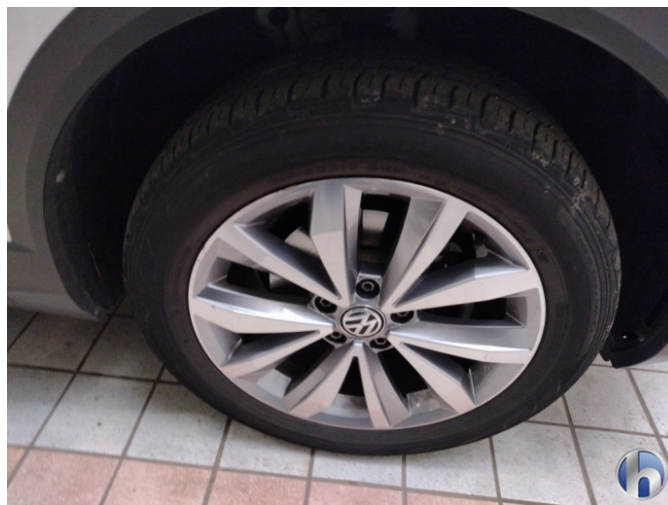
rims

component	Damage	Rep kind
1.	Sitz Vorne Links	Wear and tear	acceptable
2.	proof of maintenance	Missing	Replace
3.	Tire-fit compressor	Missing	Replace
4.	Rim front - right	Damaged	Replace
5.	Rim rear - right	Damaged	Replace
6.	spoiler	Scratch(es)	Replace
7.	Rear door - left		Refurbish and paint
8.	tailgate		Smart repair
9.	Heckklappenverkleidung Halter Hutablage Rechts	Damaged	Replace
10.	maintenance	Due	Replace
