## status report

#### Volkswagen Golf V Lim. United

| Vehicle identification number | <b>VWVZZZ1KZ9W009150</b> | mileage read: | <b>146654 km</b> |

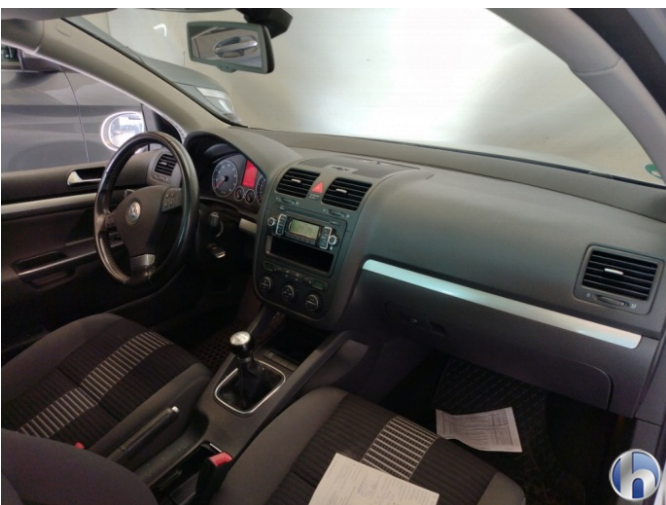
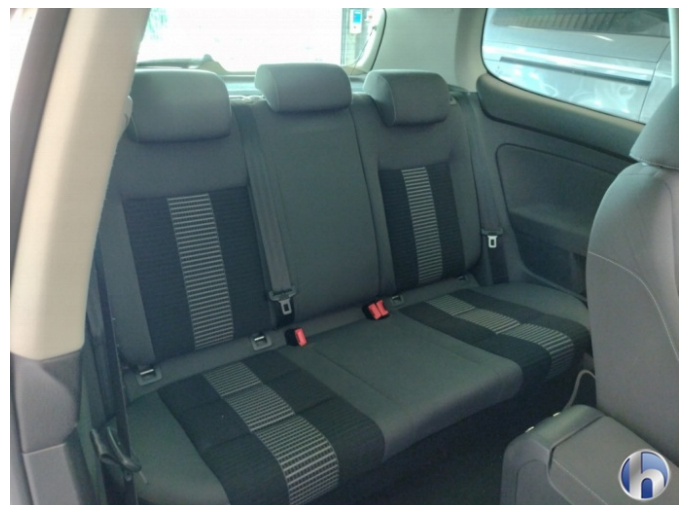
| component | Damage | Rep kind |
|---|---|---|
| 1. Sitz Vorne Links | Wear and tear | acceptable |
| 2. steering wheel | Damaged | Smart repair |
| 3. headlining | Damaged | Replace |

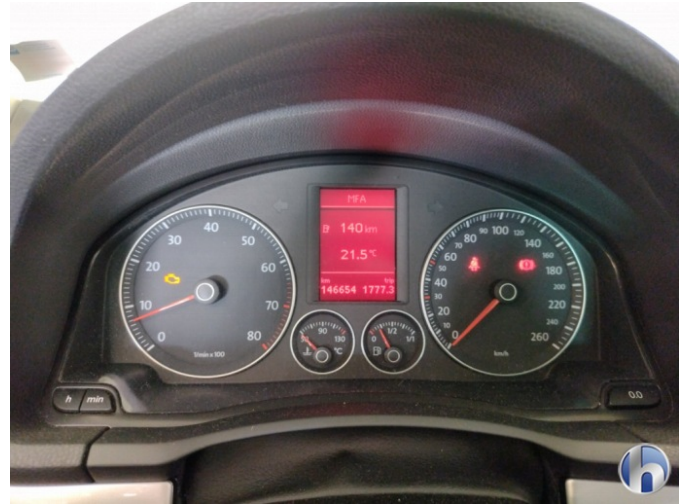
instrument cluster

| Performed testing technology | |
|---|---|
| <b>engine running:</b> | A field test of the engine had to acoustic or visual defects for visiting time .<br>**Engine warning light. |

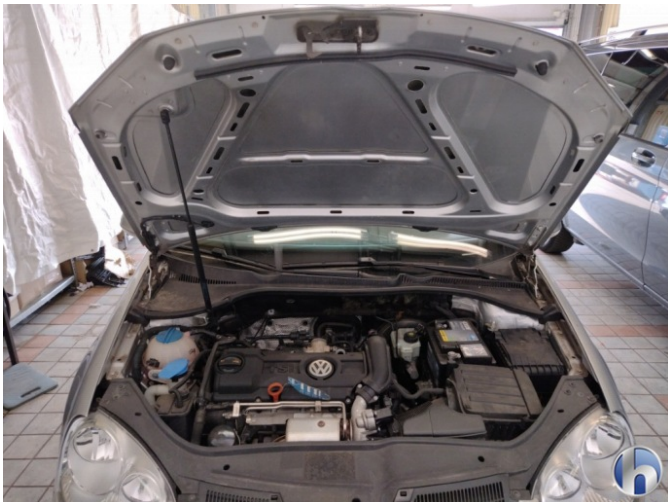
engine compartment

| Performed testing technology | |
|---|---|
| <b>oil loss:</b> | The vehicle could be checked only limited to oil leaks . |
