VOLKSWAGEN Passat Passat Variant 2.0 TDI DPF

Inspection Report Summary

| Customer | BCA Online | Report Number | P20250523093014 |
| Inspection Date / Place | 2025-05-23 / BCA Heidenheim | Cosmetic Grade | 4 |

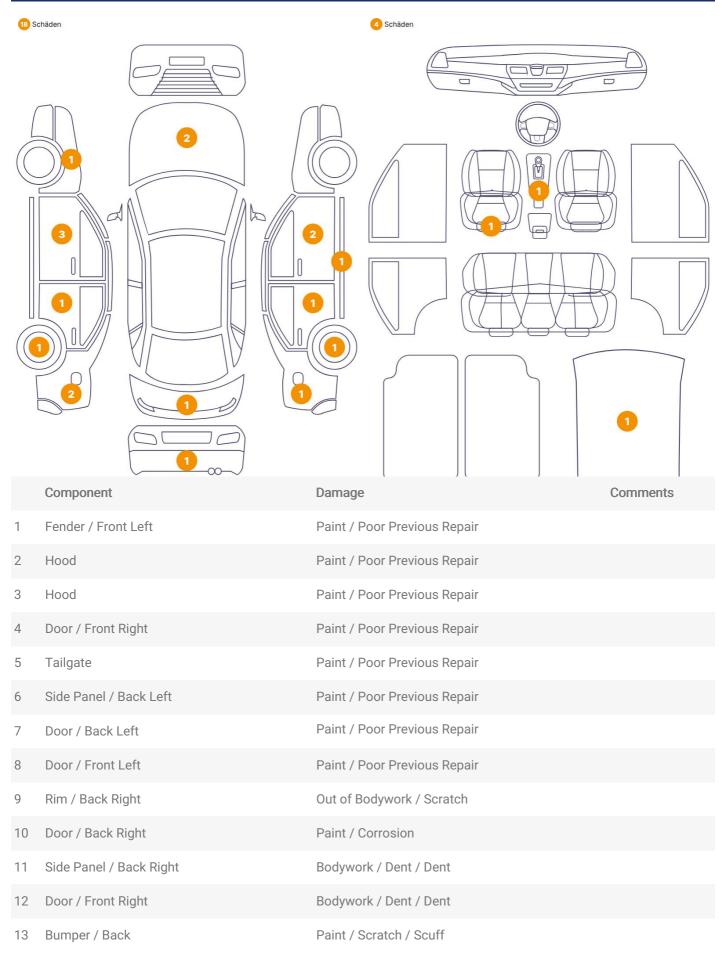
Cosmetic Damage

| 14 | Side Panel / Back Left | Paint / Corrosion |
| 15 | Rim / Back Left | Out of Bodywork / Scratch |
| 17 | Door Side Molding / Front Left | Bodywork / Poor Previous Repair |
| 21 | Luggage Space Cover / Back | Interior / Missing |
| 22 | Rocker Panel / Center Right | Paint / Corrosion |
