# VOLKSWAGEN Polo 2009 Diesel

## polo 1.2 tdi Trendline 5p

VIN NO WVWZZZ6RZEY038741

### Inspection Report Summary

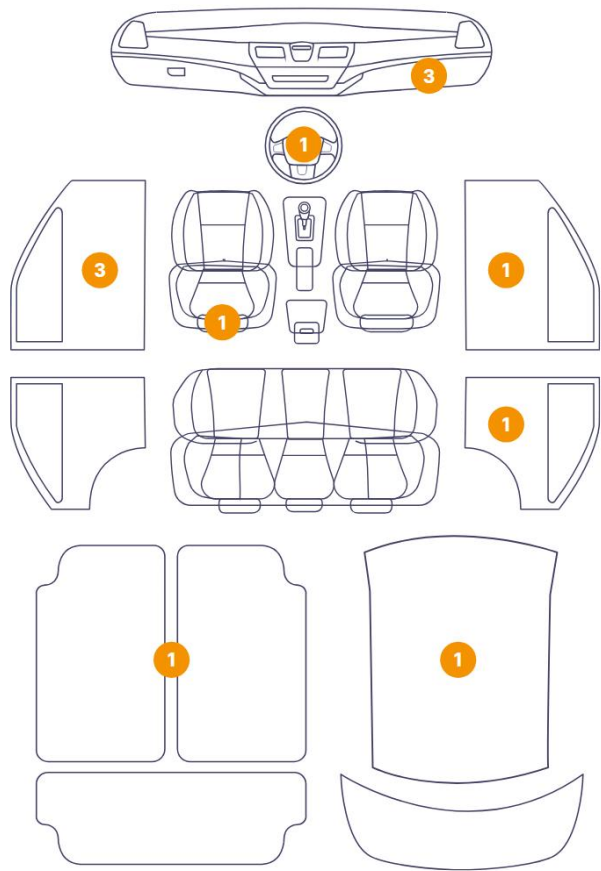
13 Danni

| Component | | Damage | Comments |
|---|---|---|---|
| 1 | Panel Filling / Front Left | Interior / Broken | |
| 2 | Floor Carpet | Interior / Broken | |
| 3 | Seat / Front Left | Interior / Broken | |
| 4 | Steering Wheel / Front | Interior / Worn - out | |
| 7 | Center Console | Interior / Worn - out | |
| 8 | Panel Filling / Front Right | Interior / Broken | |
| 9 | Ignition Key | Interior / Broken | |
| 10 | Window Switch / Front Left | Interior / Broken | |
| 11 | Window Switch / Front Left | Interior / Broken | |
| 12 | Roof Upholstery | Interior / Broken | |

| 13 | Panel Filling / Back Right | Interior / Broken |
