IVECO DAILY
DAILY BP FGN 35 C 14S EMP 3520L V12
H2 Q-TOR BVM6

VIN NO ZCFCL35A305558010
Registration Number GP376RD

Inspection Report Summary

Customer	BCAuto Encheres	Report Number	P20250513164336
Inspection Date / Place	2025-05-13 / BCA ROPPE	Cosmetic Grade	4

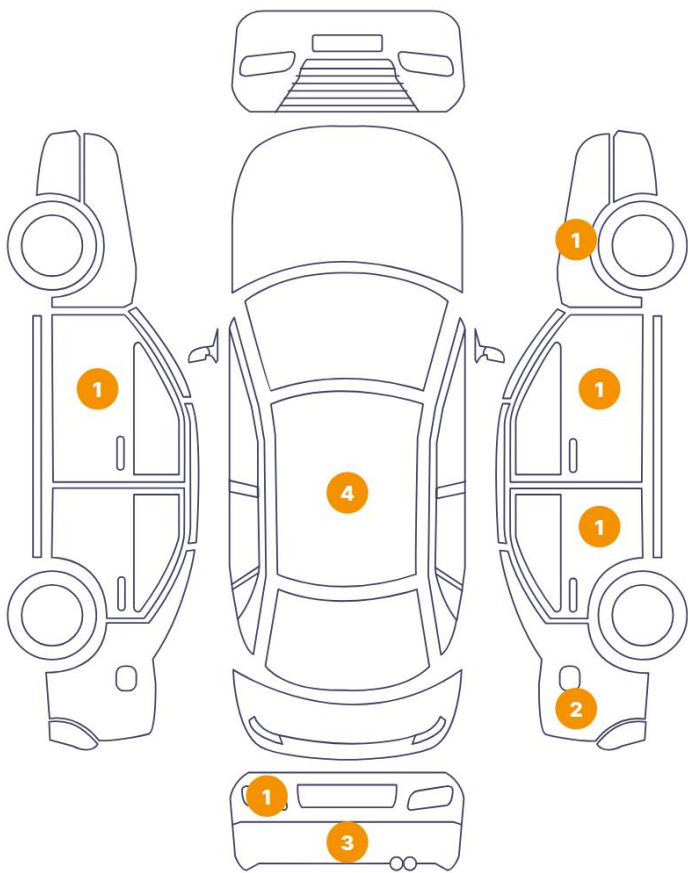
14 Dommages

Component		Damage	Comments
1	Panel Filling / Front Left	Interior / Scraped	
2	Panel Filling / Front Left	Interior / Dirty	
3	Floor Carpet	Interior / Dirty	
4	Seat Cushion / Front Left	Interior / Dirty	
5	Roof Upholstery	Interior / Distorted	
6	Trunk Carpet	Interior / Dirty	
7	Panel Filling / Front Right	Interior / Scraped	
8	Panel Filling / Front Right	Interior / Dirty	
9	Seat / Front Right	Interior / Dirty	
10	Dashboard / Front	Interior / Scraped	
11	Cant Rail / Right	Bodywork / Breakage	
12	Mirror / Front Left	Paint / Scratch / Line	
13	Cant Rail / Right	Bodywork / Dent / Deformation
