FIAT 500 Benzina 500 1.2 S 69cv E6

VIN NO ZFA3120000J111656 Registration Number ET212HL

Inspection Report Summary

Customer	BCA Lodi	Report Number	P20250925171018
Inspection Date / Place	2025-09-25 / BCA Lodi	Cosmetic Grade	4

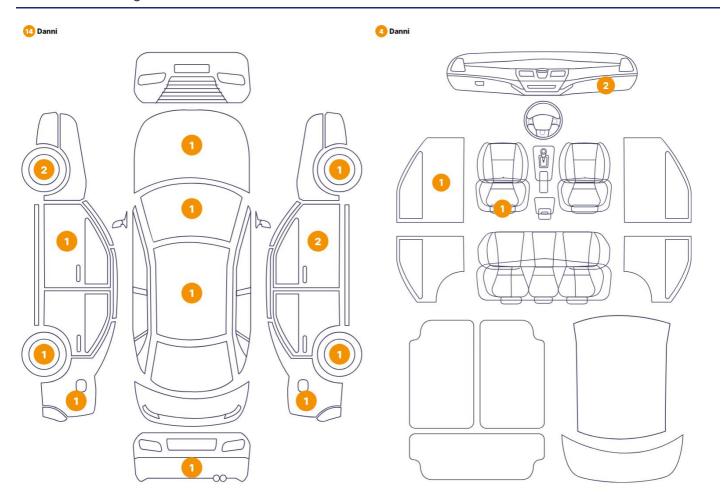
Cosmetic Damage

Component	Damage	Comments
1	Aeration Grid / Front Center	Interior / Broken	
2	Dashboard / Front	Interior / Scratched	
3	Panel Filling / Front Left	Interior / Scratched	
4	Seat / Front Left	Interior / Worn - out	
5	Rim / Front Left	Out of Bodywork / Scratch	
6	Tire / Front Left	Tire	
7	Door / Front Left	Bodywork / Dent	
8	Rim / Back Left	Out of Bodywork / Scratch	
9	Fender / Back Left	Paint / Scratch / Line	
10	Bumper / Back	Paint / Scratch / Line	
11	Fender / Back Right	Bodywork / Dent	
12	Rim Brake pads	Out of Bodywork / Scratch

13	Door / Front Right	Paint / Scratch / Line
14	Door / Front Right	Bodywork / Dent
15	Rim / Front Right	Out of Bodywork / Scratch
16	Hood	Paint / Chipping
17	Windshield / Front	Glass Break / Impact
18	Roof	Bodywork / Dent
