# ₩ VEHICLE DESCRIPTION - Škoda Superb Style 1.5 TSI ACT

## SUMMARY OF THE VEHICLE'S CONDITION

### **OVERVIEW OF DAMAGES AND SHORTAGES**

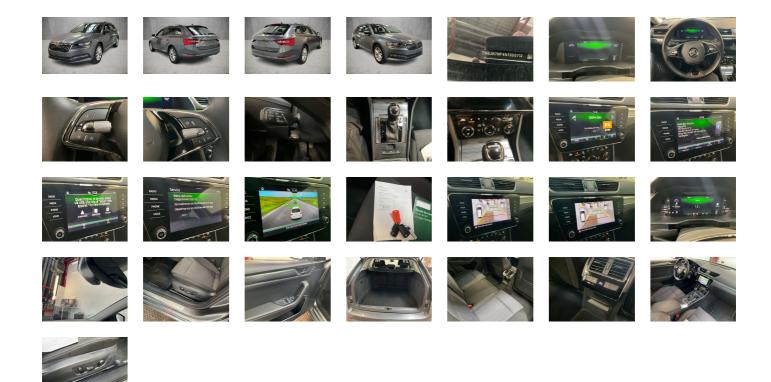
### **PICTURES**

LOCATION	TYPE	SEVERITY	INSURANCE	NOTES	DAMAGE GROUP
L. Rocker Panel	Scratch	C4	Reporting needed		
[ [ [ ] ] [ ] [ ] [ ] [ ] [ ] [ ] [ ] [					
L. Rear Quarter Pa	anelScratch	C4	Reporting needed		Group 1
		*			
Rear Bumper	Scratch	C4	Reporting needed		Group 1
R. Rear Door	Scratch	C3			
	10				
R. Front Quarter Panel	Scratch	C3			
SA	mun				
L. Rear Door	Scratch	C3			
	3
