Expertise

Protocol number: 41494768
Order No. / Reference: 25078733
Inspection date: 11 Sept 2025

Manufacturer: Mercedes-Benz	Model: E 220 d 9G-TRONIC Avantgarde
VIN: W1K2130041B092992

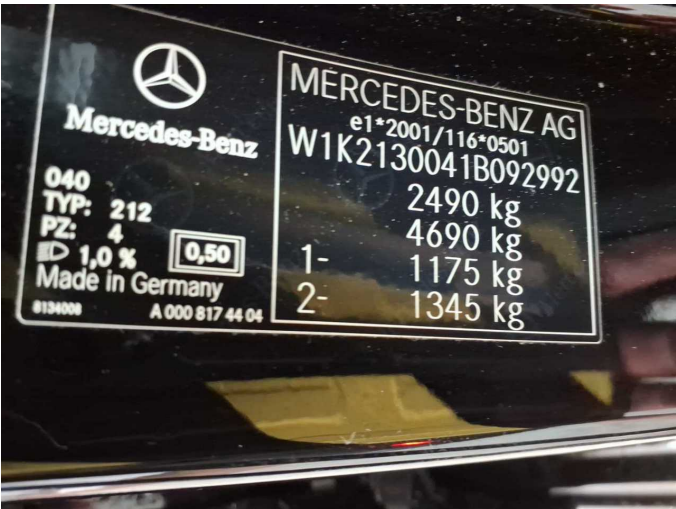
Figure 11: VIN

Documents submitted	At the time of the inspection, the registration certificate Part 2 (letter) was available, but the registration certificate Part 1 (certificate) was not. (Copy)
VIN comparison	The vehicle identification number (VIN) was read from the vehicle and its conformity with the submitted documents was verified during the inspection by the undersigned.
Inspection	The inspection conditions were sufficient for the assessment of the vehicle. Lifting equipment and a pit were available for examining the vehicle.
Test drive	No test drive/maneuvering was carried out during the inspection of the vehicle.
Engine function test	An engine test run was performed.

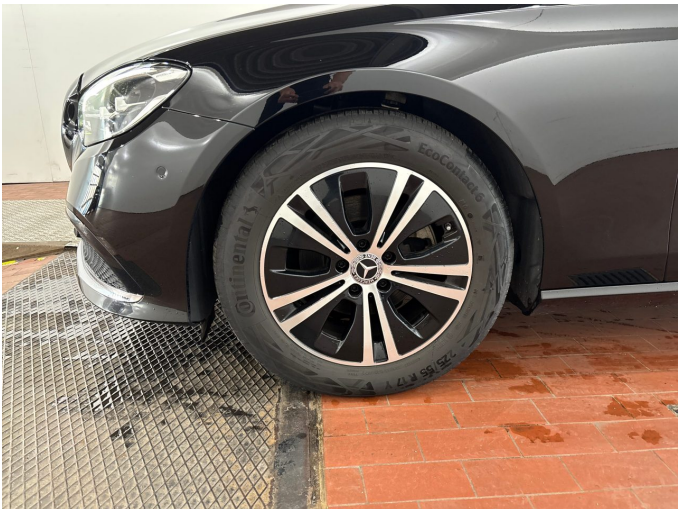
Figure 12: Mounted tyres

#	Tyre size	Type of tyre	Manufacturer	Tread depth
1)	225/55 R17 97Y	Summer tyres on Light alloy	Continental	5mm / 5mm
2)	225/55 R17 97Y	Summer tyres on Light alloy	Continental	6mm / 6mm

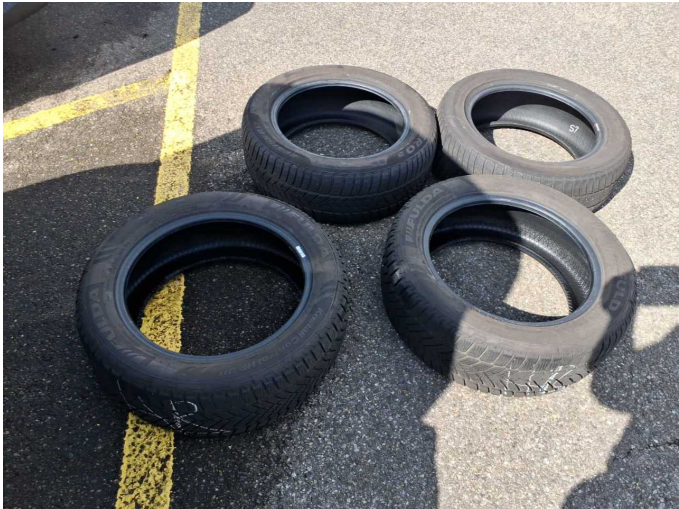
Figure 16: Additional tyres

#	Tyre size	Type of tyre	Manufacturer	Tread depth
1)	225/55 R17 97H	Winter tyres (Without wheel rim)	Pirelli	5mm / 5mm
2)	225/55 R17 101V	Winter tyres (Without wheel rim)	Fulda	7mm / 7mm

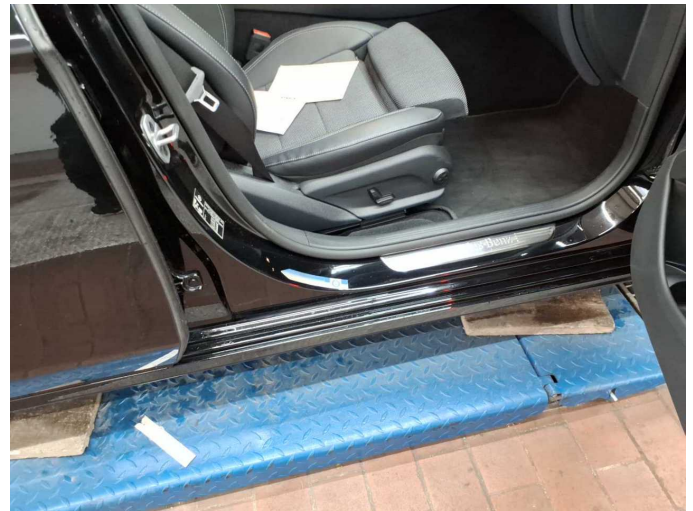
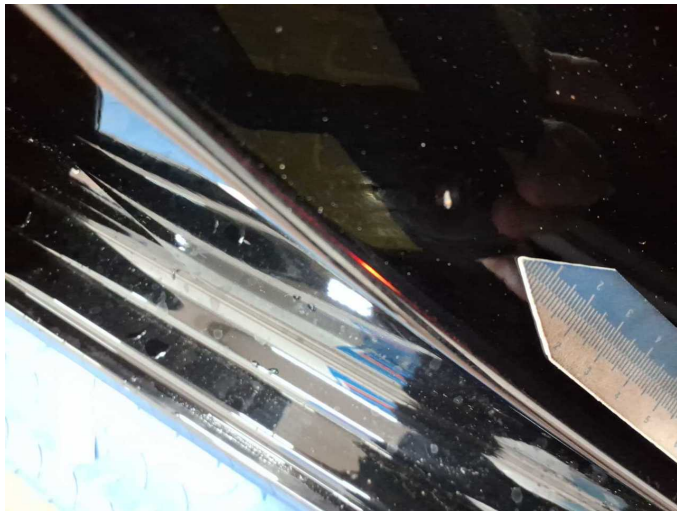
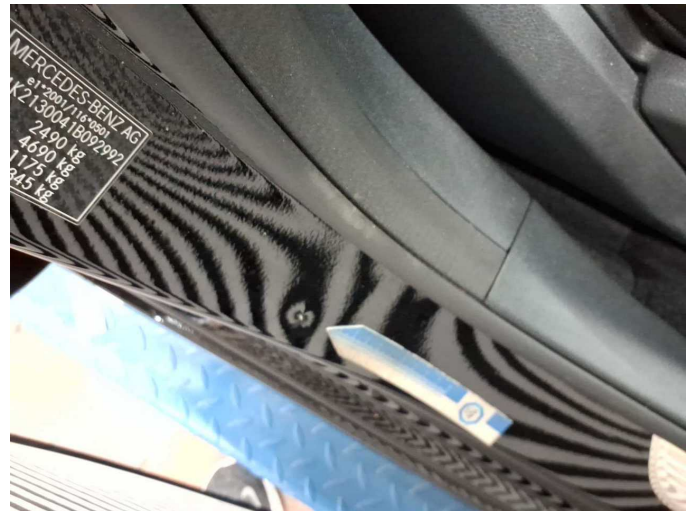
Damage 1: Sill - right side: Sill - Dent / paintcoat damage - Smart repair

No.	Component group	Description
1	Sill - right side	Sill - Dent / paintcoat damage - Smart repair
2	Rear bumper	Rear bumper - Scratch(es) - Loss in value

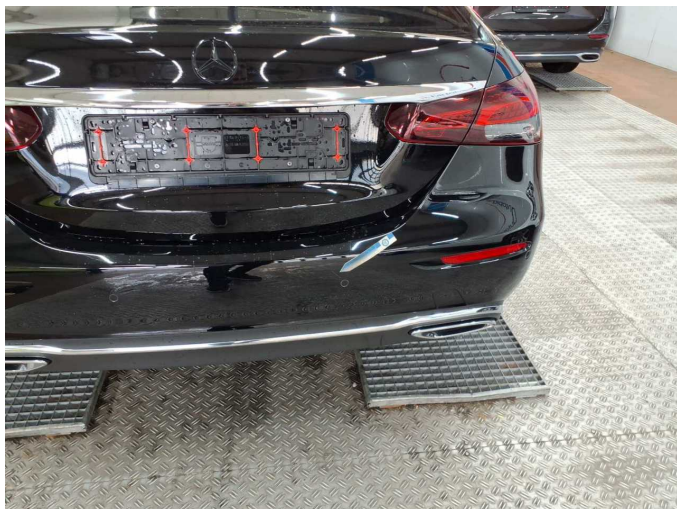
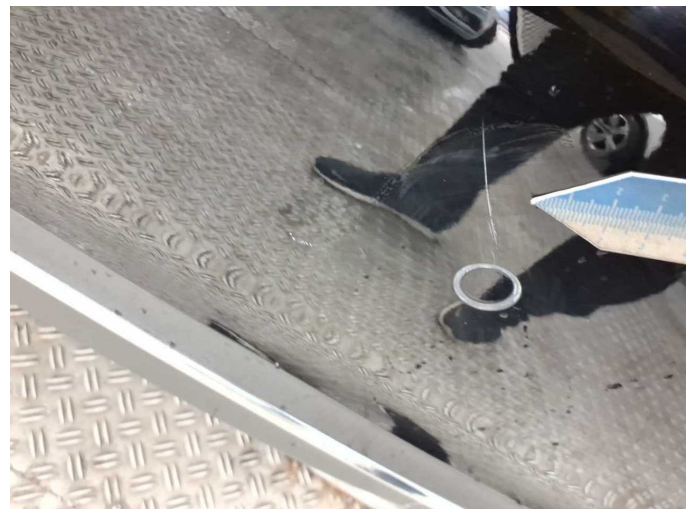
Damage 2: Rear bumper: Rear bumper - Scratch(es) - Loss in value
