Expertise

Protocol number: 41388219
Order No. / Reference: 25046983
Inspection date: 3 Sept 2025

Manufacturer: Mercedes-Benz
VIN: W1N1671171A494835

Model: GLE 350 de 4Matic 9G-TRONIC AMG Line

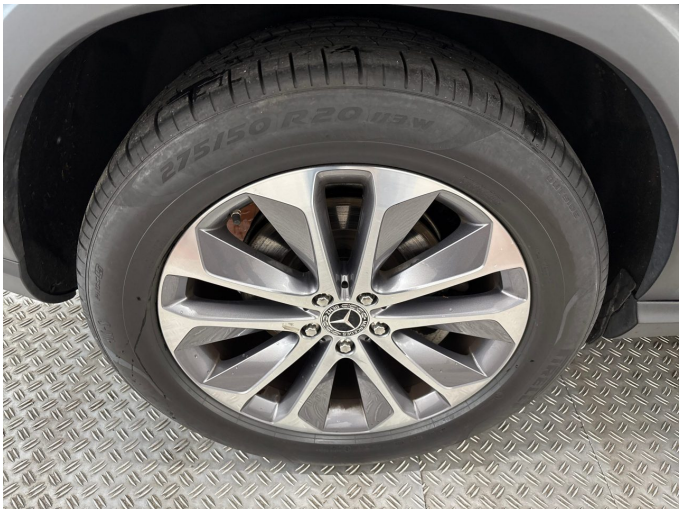
Figure 12: Mounted tyres

#	Tyre size	Type of tyre	Manufacturer	Tread depth
1)	275/50 R20 113W	Summer tyres on Light alloy	Pirelli	7mm / 7mm
2)	275/50 R20 113W	Summer tyres on Light alloy	Pirelli	7mm / 7mm

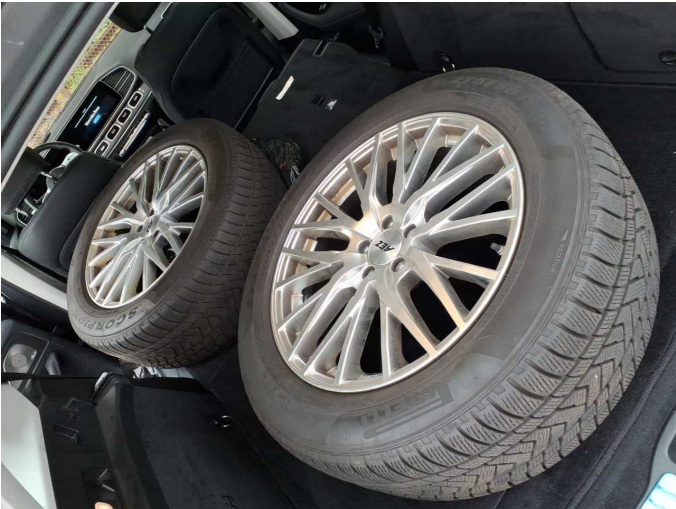
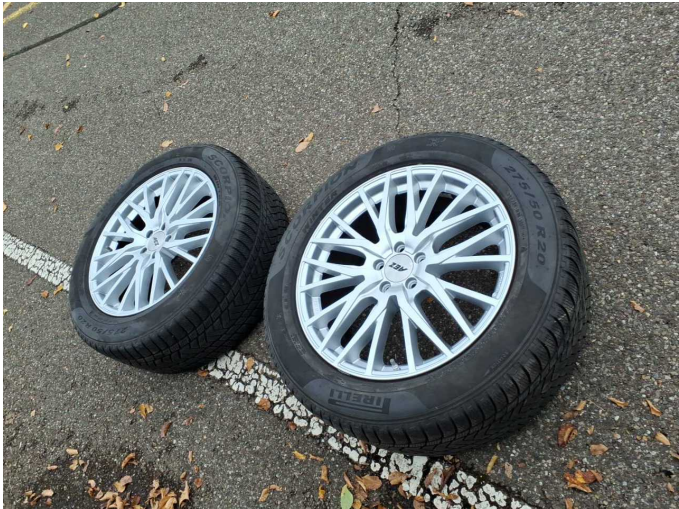
Figure 15: Additional tyres

#	Tyre size	Type of tyre	Manufacturer	Tread depth
1)	275/50 R20 113V	Winter tyres on Light alloy	Pirelli	6mm / 6mm
2)	275/50 R20 113V	Winter tyres on Light alloy	Pirelli	6mm / 6mm

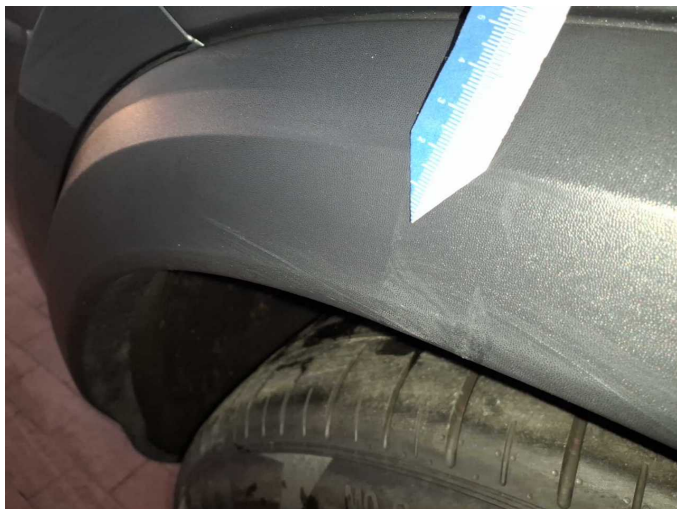
No.	Component group	Description
1	Side panel - rear right side	Wheel arch - Scratched - Smart repair

Damage 1: Side panel - rear right side: Wheel arch - Scratched - Smart repair

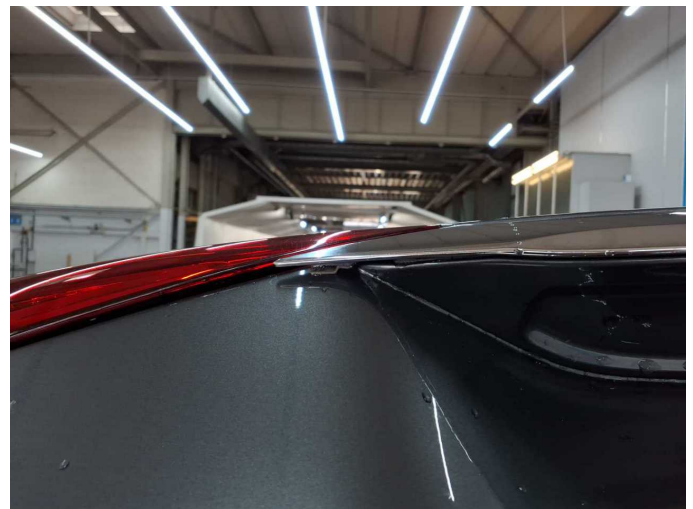
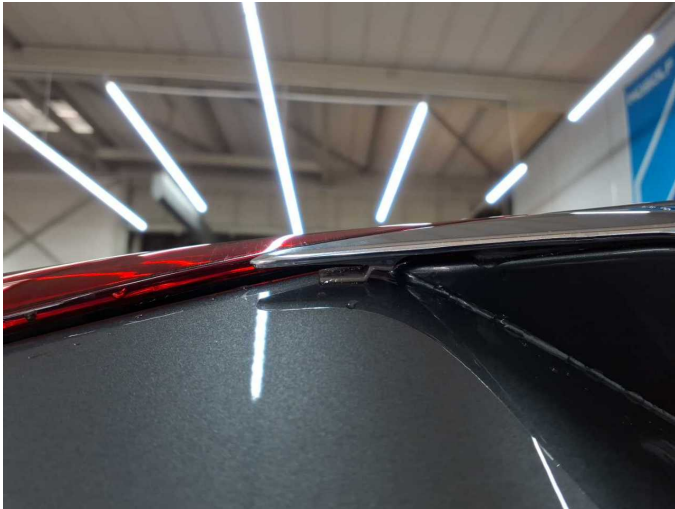
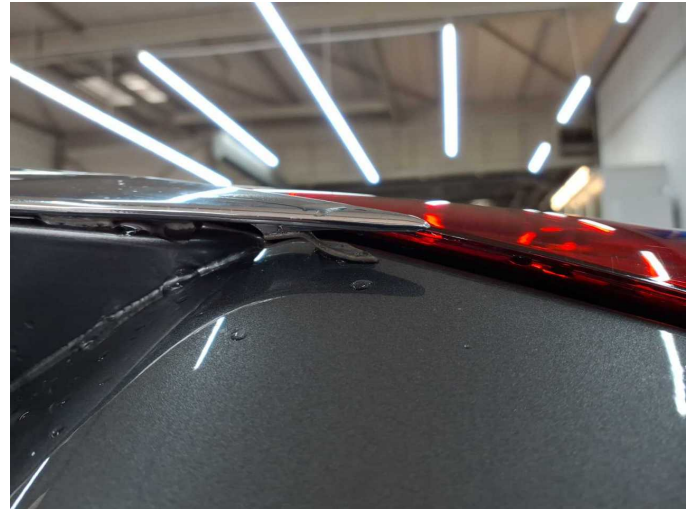
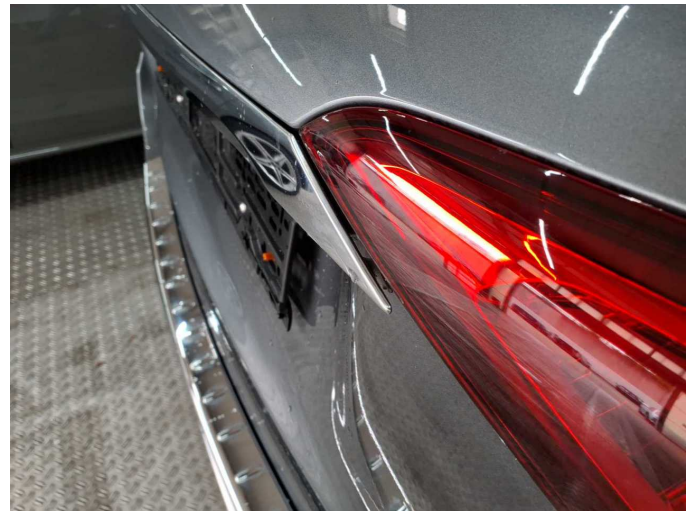
No.	Component group	Description
2	Boot lid / rear door	Boot lid (Zierleiste, Klebefestigung lose) - Unprofessionally repaired - Replace

Damage 2: Boot lid / rear door: Boot lid (Zierleiste, Klebefestigung lose) - Unprofessionally repaired - Replace

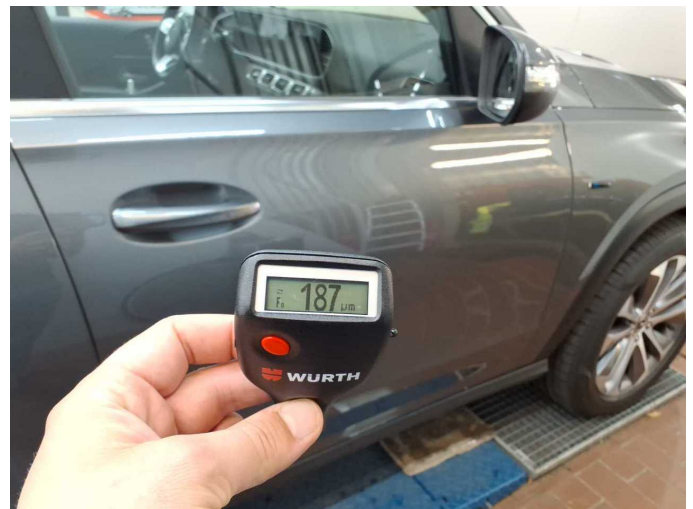
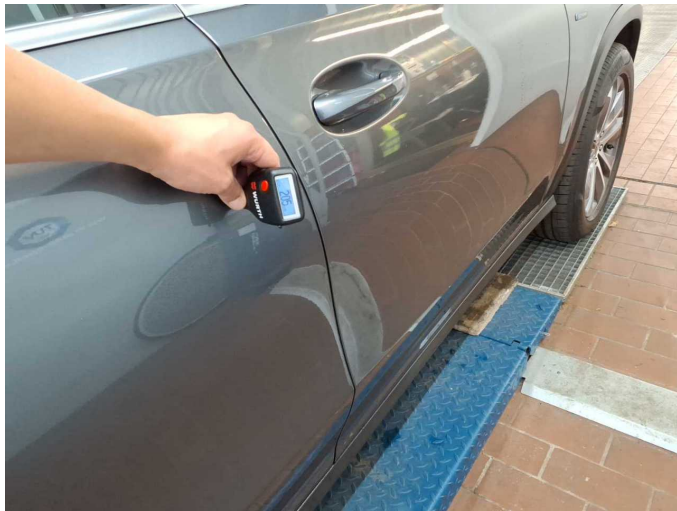
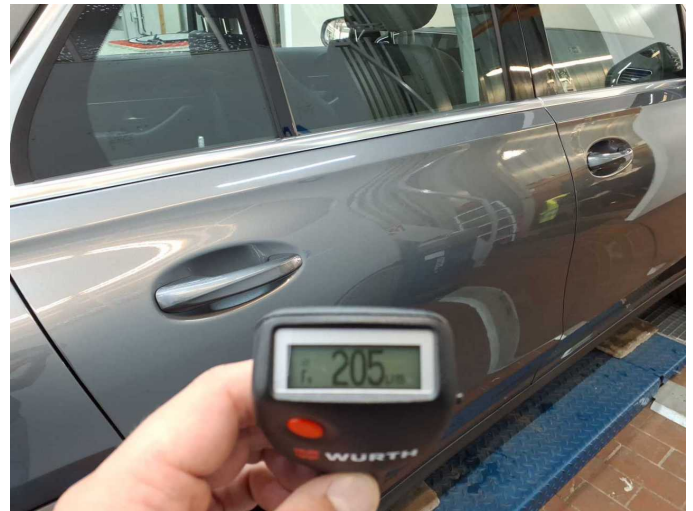
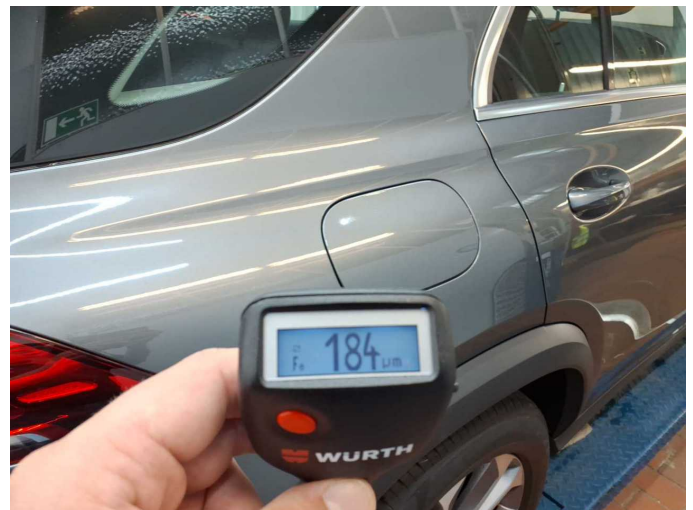
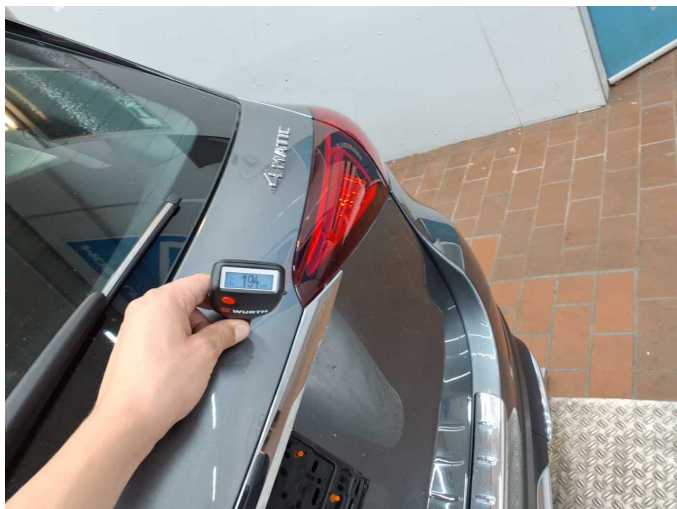
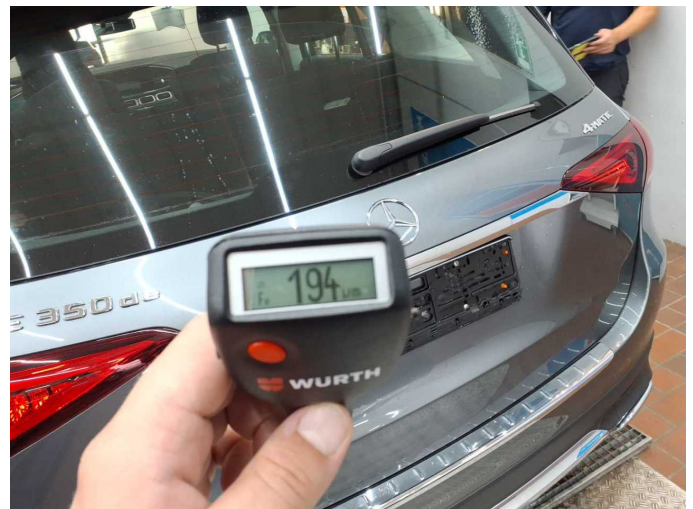
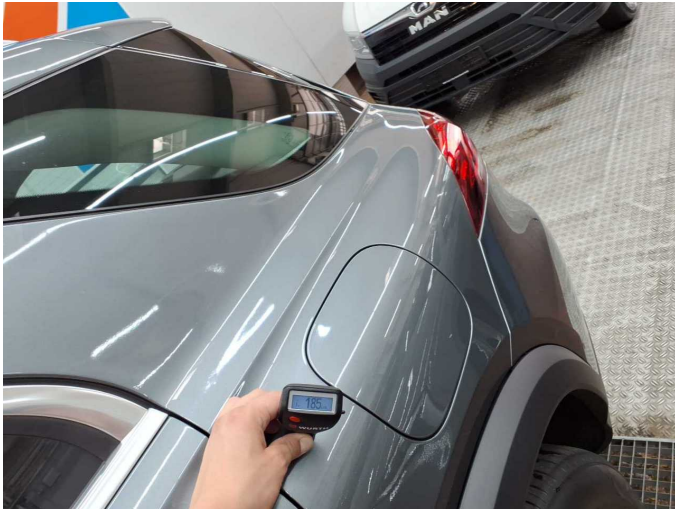
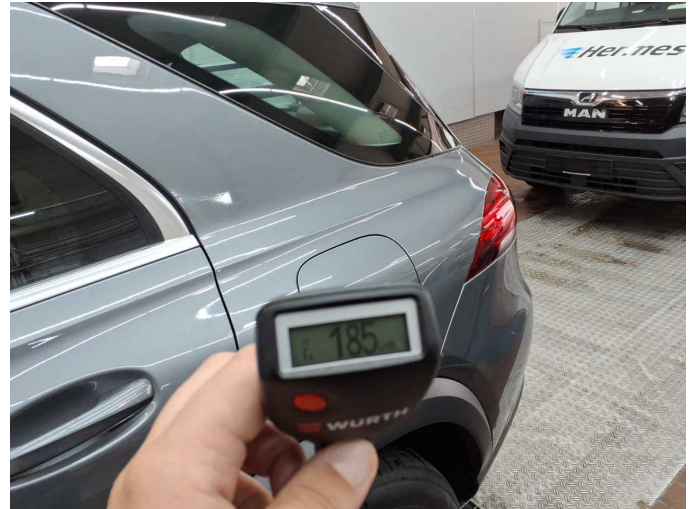
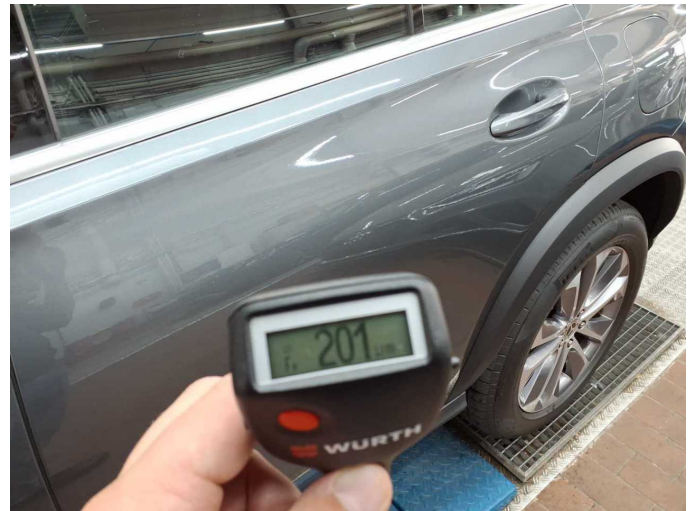
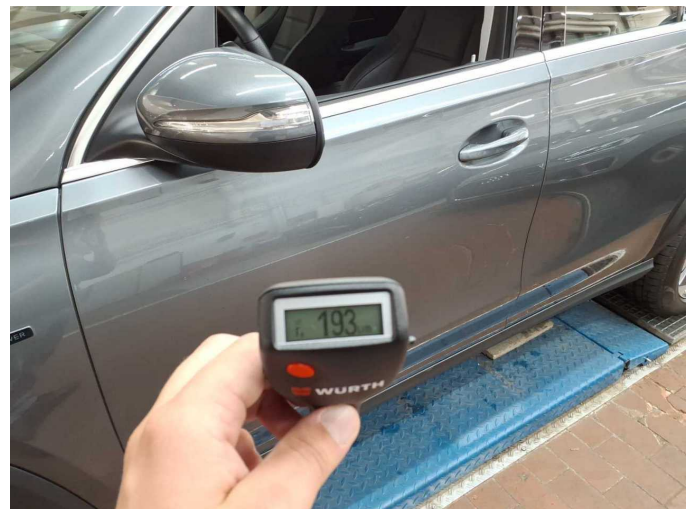
No.	Repainting
1	Boot lid / rear door, Side panel - rear left side, Side panel - rear right side, Door - rear left side, Door - rear right side, Door - front left side, Door - front right side

Boot lid / rear door	194 µm	Side panel - rear left side	185 µm
Side panel - rear right side	184 µm	Door - rear left side	201 µm
Door - rear right side	205 µm	Door - front left side	193 µm
Door - front right side	187 µm

Repainting 1: Boot lid / rear door, Side panel - rear left side, Side panel - rear right side, Door - rear left side, Door - rear right side, Door - front left side, Door - front right side
