# INSPECTION REPORT

**End Of Contract**

| License plate | 2APD303 |
| Make | Audi A4 Av.35 TDi Advan.Bus.Ed |

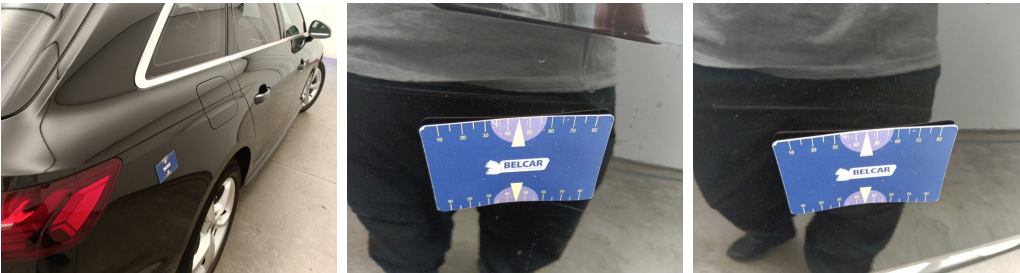
| Damages | Type | Acceptable |
|---|---|---|
| 186 | Wing Rear Right // Polish | Y |

Wing Rear Right // Polish-scratch

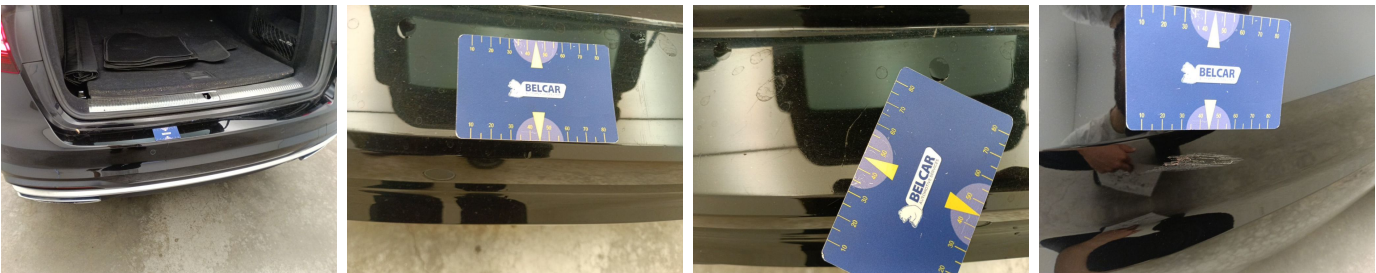
| Damages | Type | Acceptable |
|---|---|---|
| 133 | Bumper Rear // Painting | Y |

Bumper Rear // Painting-scratch

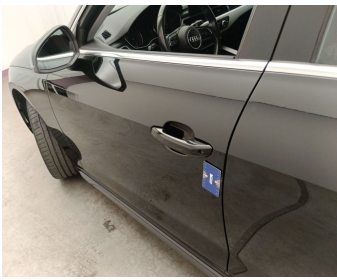
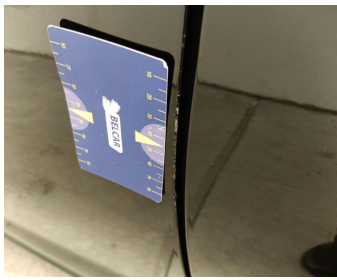
| Damages | Type | Acceptable |
|---|---|---|
| 83 | Door Front Left // Painting | Y |

Door Front Left // Painting-scratch

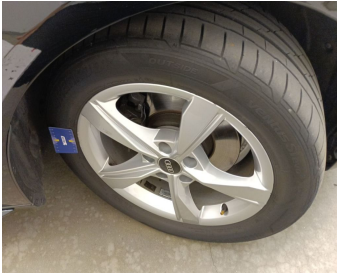
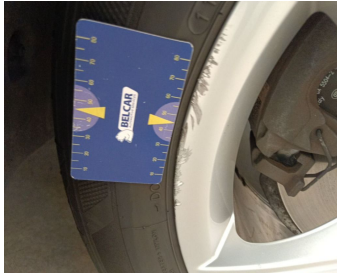
| Damages | Type | Acceptable |
|---|---|---|
| 341 | Wheel Alloy Front Right // Repair | N |

Wheel Alloy Front Right // Repair-scratch

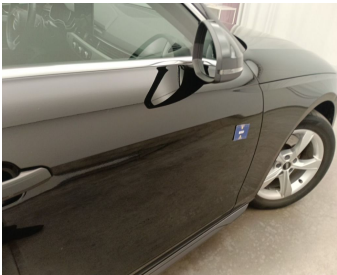
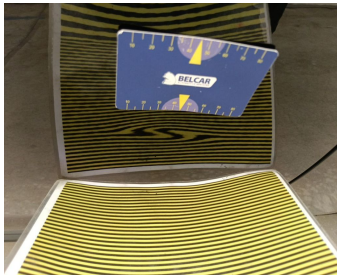
| Damages | Type | Acceptable |
|---|---|---|
| 210 | Door Front Right // Smart Repair Small | N |

Door Front Right // Smart Repair Small-dent

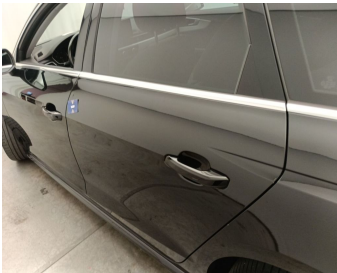
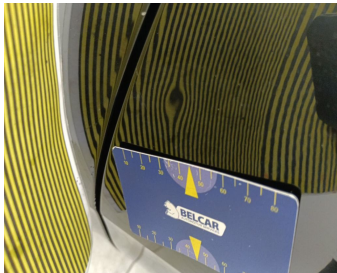
| Damages | Type | Acceptable |
|---|---|---|
| 100 | Door Rear Left // Smart Repair Small | N |

Door Rear Left // Smart Repair Small-dent

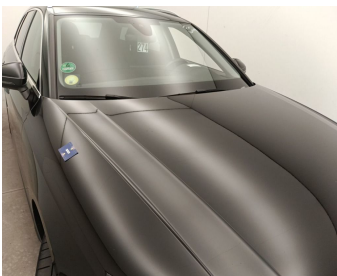
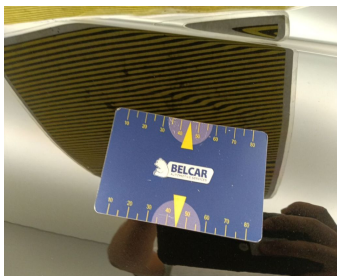
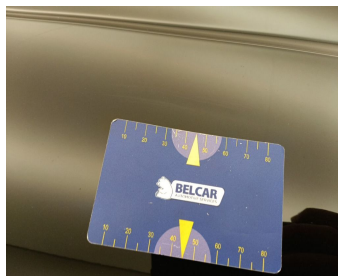
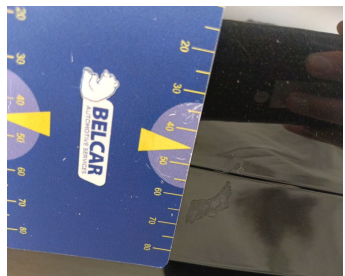
| Damages | Type | Acceptable |
|---|---|---|
| 31 | Front Bonnet // Smart Repair Small | N |

Front Bonnet // Smart Repair Small-scratch + dent

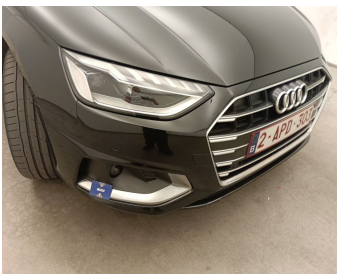
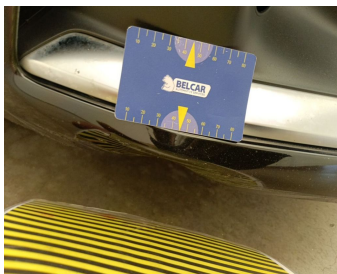
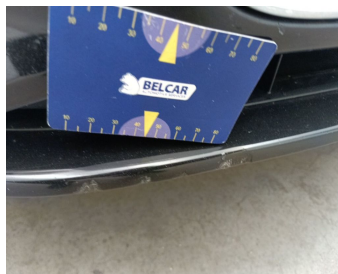
| Damages | Type | Acceptable |
|---|---|---|
| 15 | Bumper Front // Replace & Painting | N |

Bumper Front // Replace & Painting-scratch + dent

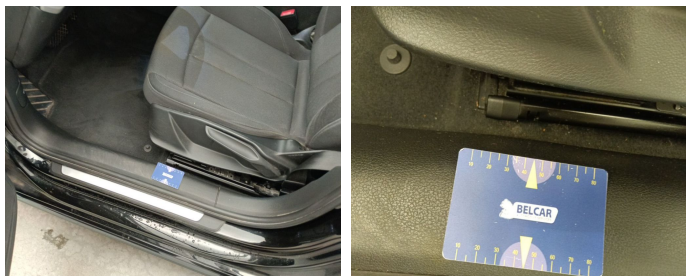
| Damages | Type | Acceptable |
|---|---|---|
| 540 | Interior // Repair 1 | N |

Interior // Repair 1-Incinerated

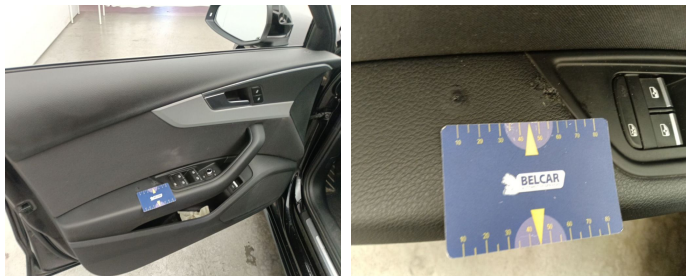
| Damages | Type | Acceptable |
|---|---|---|
| 614 | Front Left Door Interior Coating // Replace Completely | N |

Front Left Door Interior Coating // Replace Completely-Incinerated

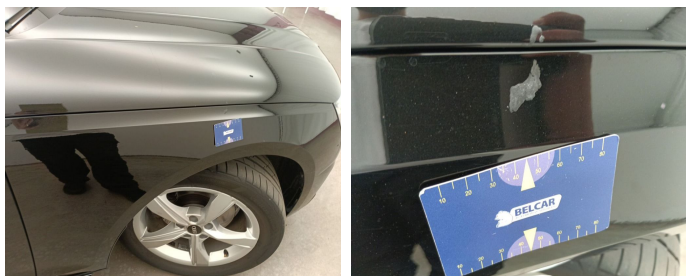
| Damages | Type | Acceptable |
|---|---|---|
| 233 | Wing Front right // Painting | N |

Wing Front right // Painting-Chemical reaction
