Inspection data

Vehicle data

License plate **N396TS**
 Make / Type **BMW 3 SERIE TOURING**
 VIN **WBA6N91030FM26676**
 First registration date **14/01/2022**
 Mileage **109,952 km**

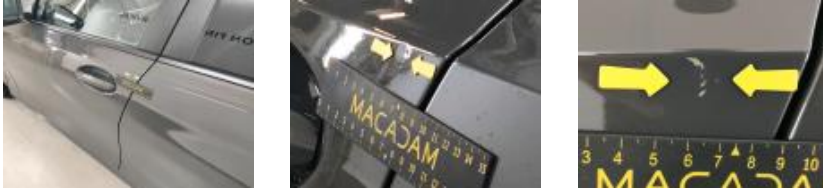
Door FL	Dent(s) and scratch(es)	Repair and paint (complete)	367.79	0.00
---------	-------------------------	-----------------------------	--------	------

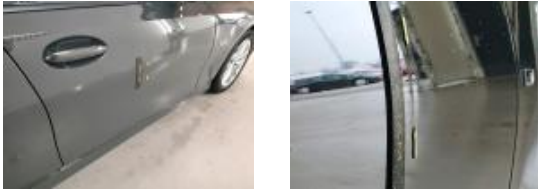
Door FR	Dent(s)	Repair and paint (complete)	367.79	0.00
---------	---------	-----------------------------	--------	------

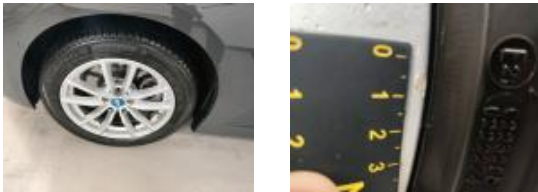
Alloy rim FL	Scratch(es)	Repair and paint (complete)	50.00	0.00
--------------	-------------	-----------------------------	-------	------
