# Inspection Protocol

## VW TRANSPORTER T32 2.0 TDI BMT

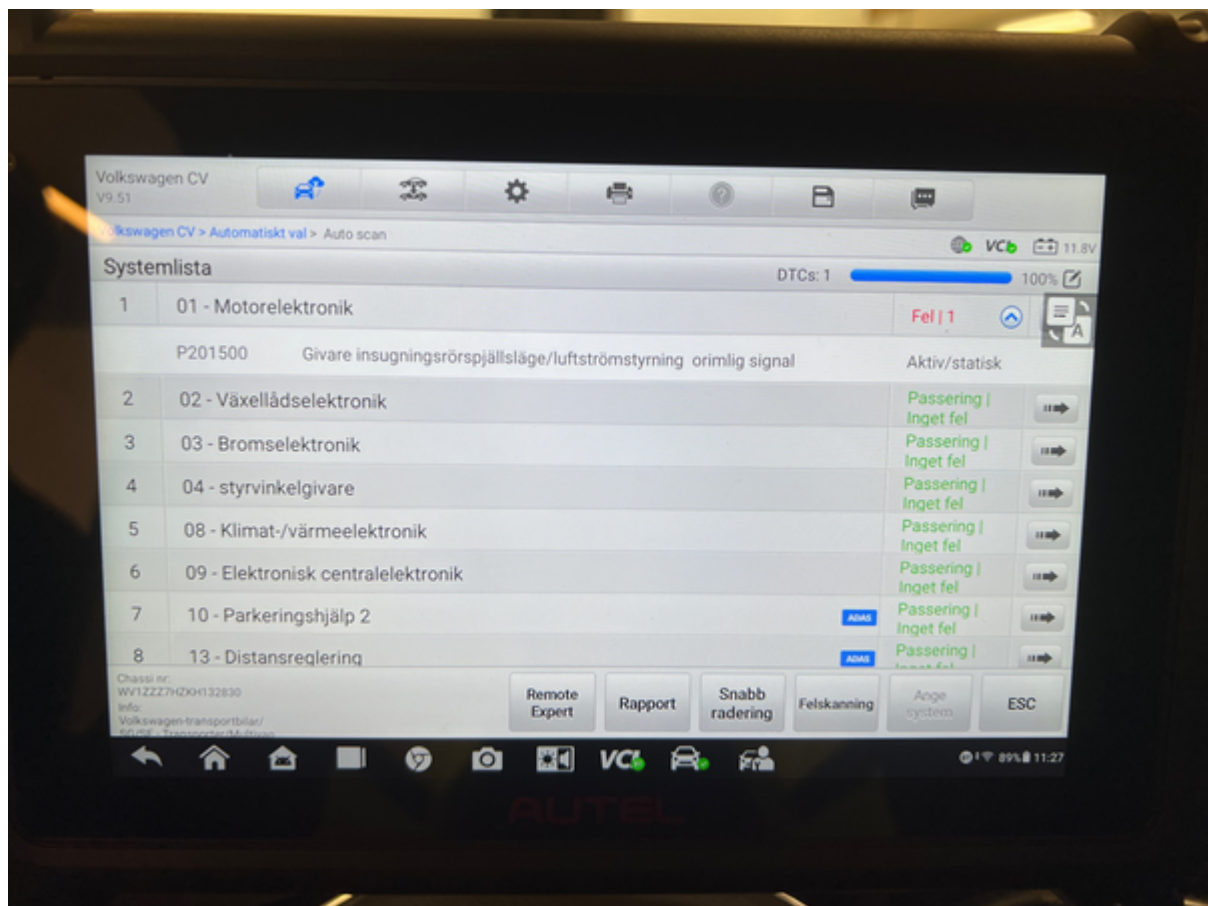
Motor och Växellåda Motor Övrigt Motorlampa lyser. Felkod: p201500 Om motorkontrolllampan lyser på din Volkswagen Transporter och felkoden som visas är P201500 (eller liknande P2015) så handlar det troligen om ett problem med insugsrörets flapp/ställmotor och/eller sensor. Här är vad koden betyder och vad man bör göra:

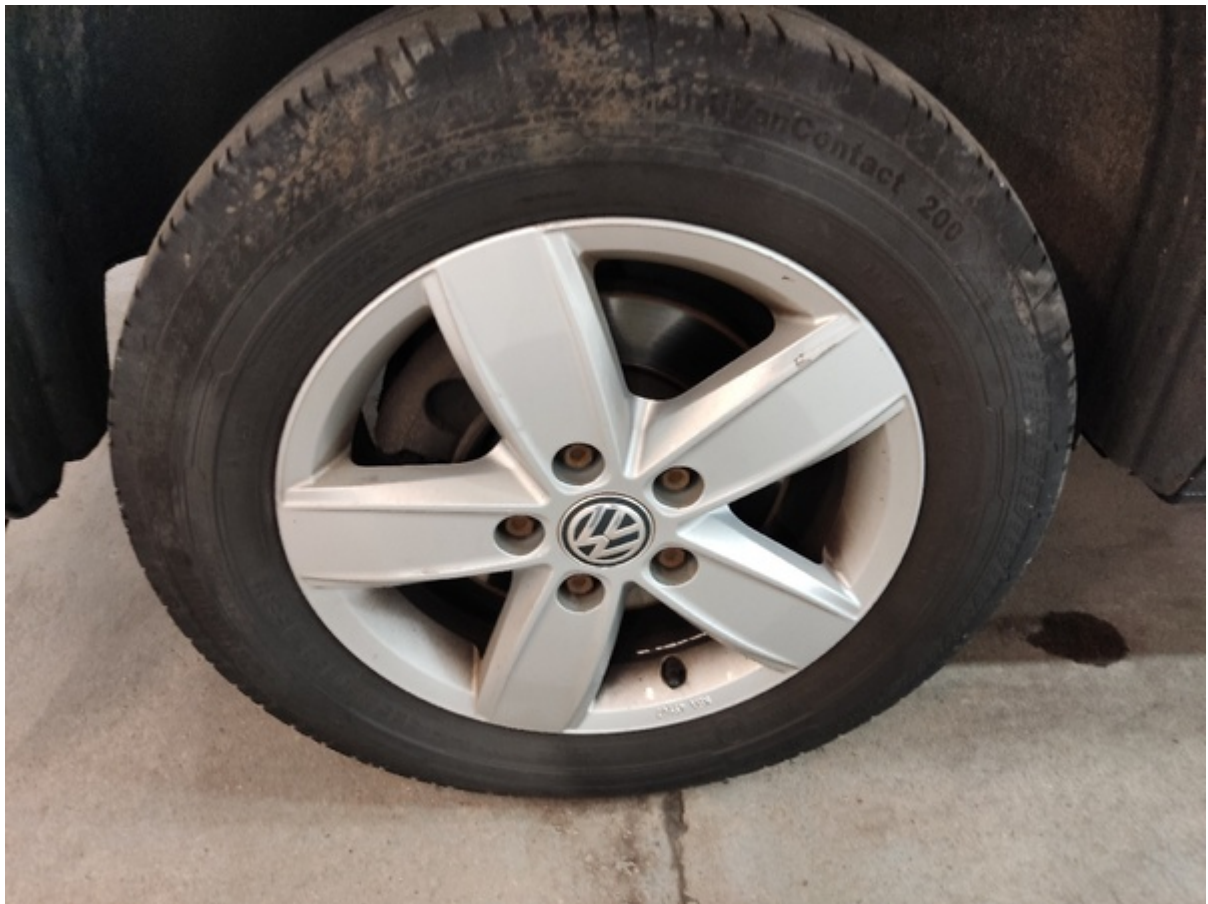
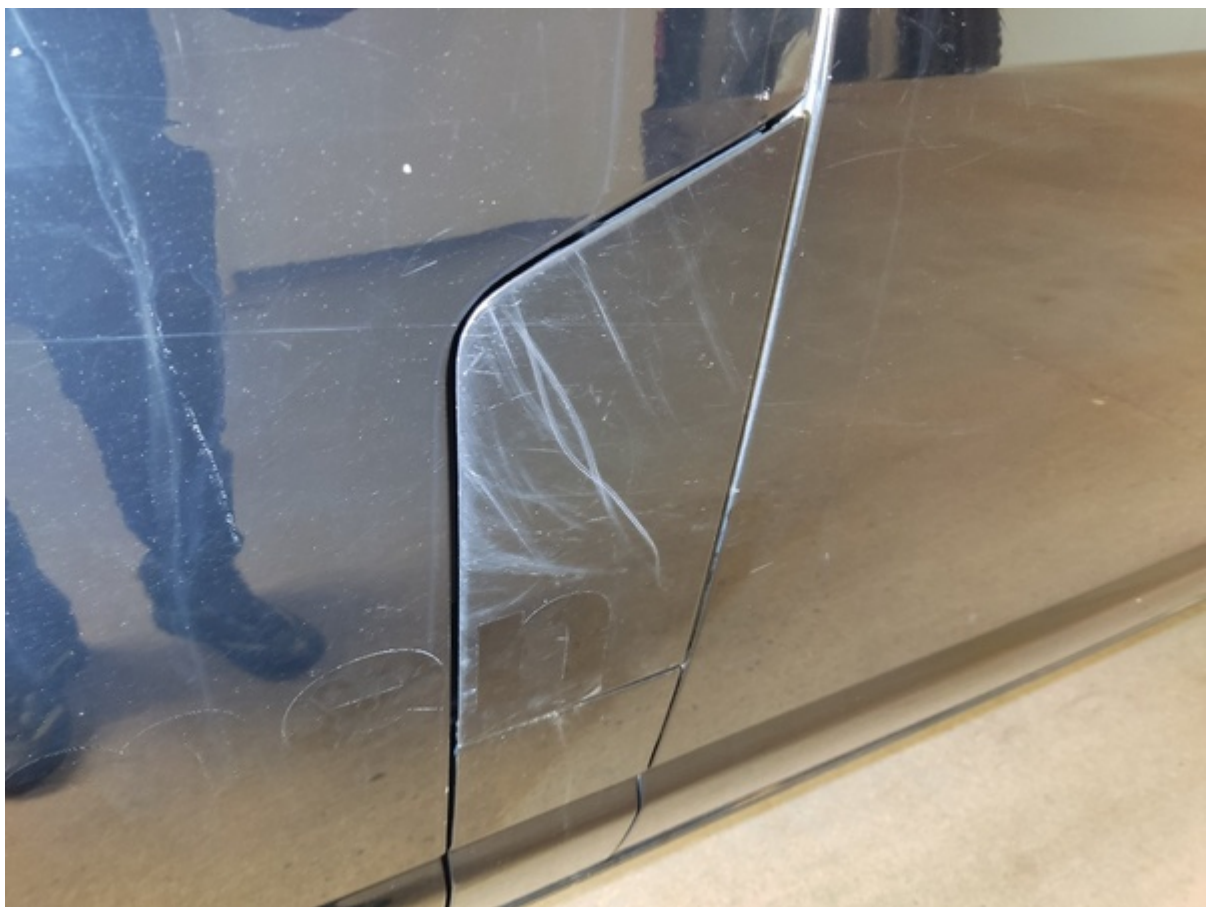
| Location | Damage | Comments | Costs excluding VAT |
|---|---|---|---|
| Wing, Filler cap | Scratches above 100 mm | | 150 € |

Skärm Tanklock Repor över 10 cm 2 000 kr

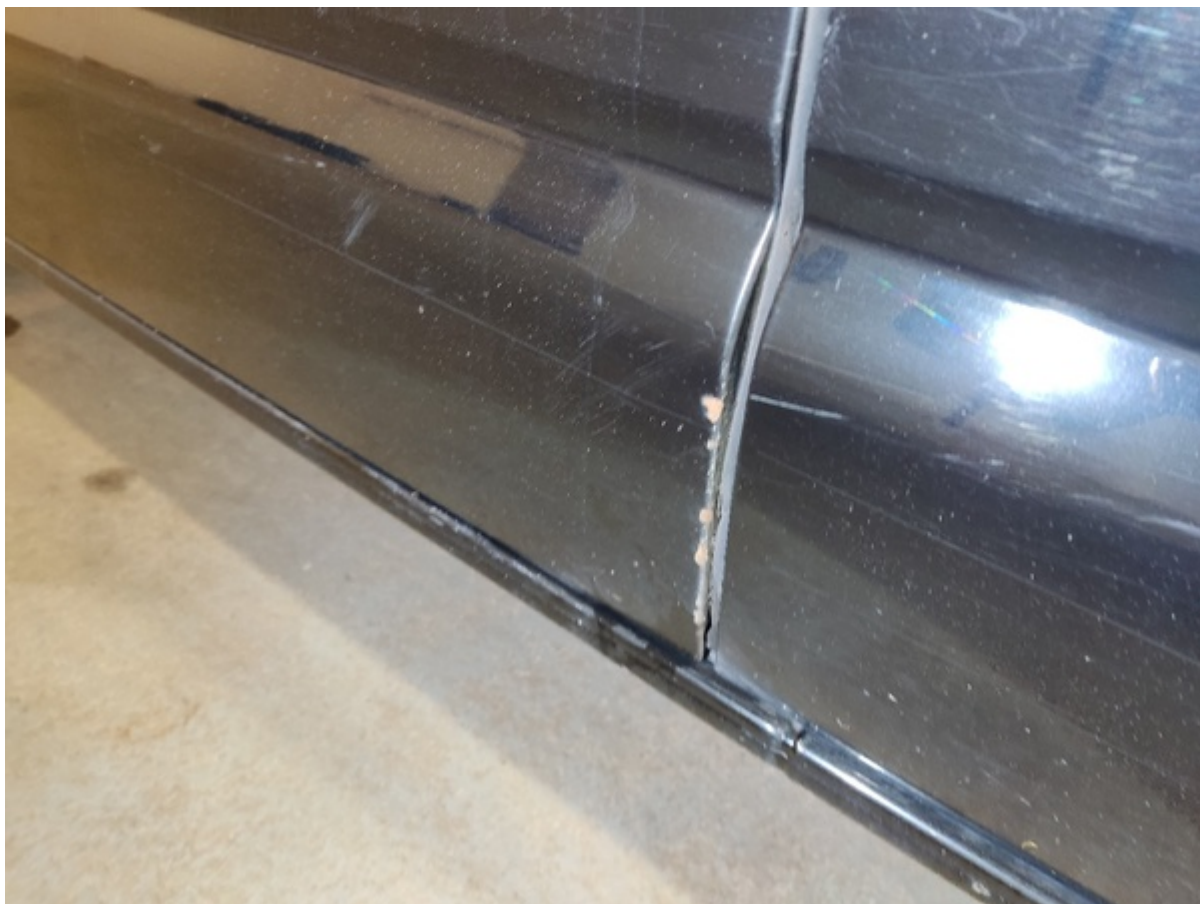
Dörr Höger fram Repor 3-10 cm 1 100 kr

| Location | Damage | Comments | Costs excluding VAT |
|---|---|---|---|
| Door, Front right | Scratches 30-100 mm | | 80 € |

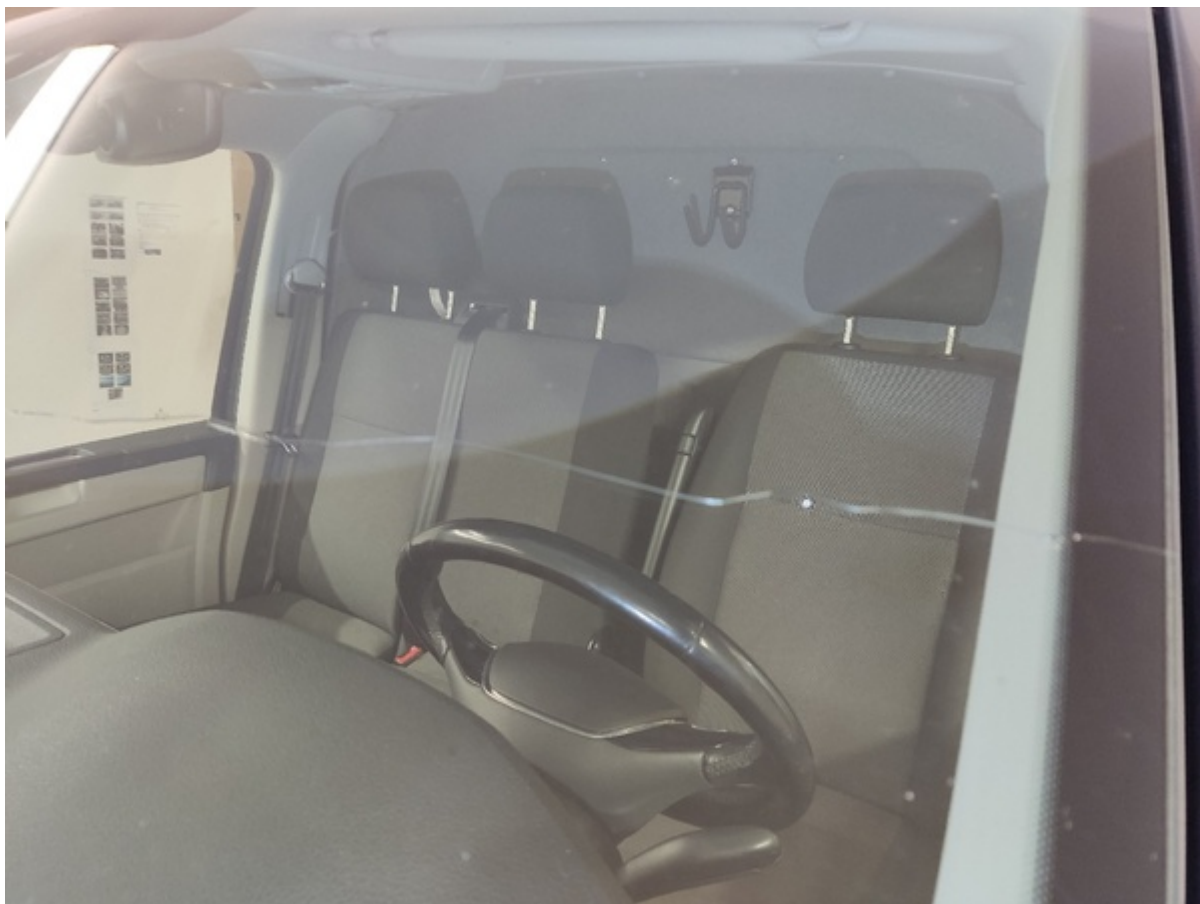
Motorhuv Stenskott flertal 2 200 kr

Glas Vindruta Sprickor långa (Över 15 cm) 7 000 kr

| Location | Damage | Comments | Costs excluding VAT |
|---|---|---|---|
| Bonnet | Chips, several | | 160 € |
| Glass, Windshield | Cracks long (Above 150 mm) | | 510 € |
