## status report

**customer:** Bank 11, Neuss  
**contract number:** 903930931  
**reference:**

#### Dodge Ram 1500

| Vehicle identification number | <b>1C6RR7LG3MS589304</b> | mileage read: | <b>50389 km</b> |

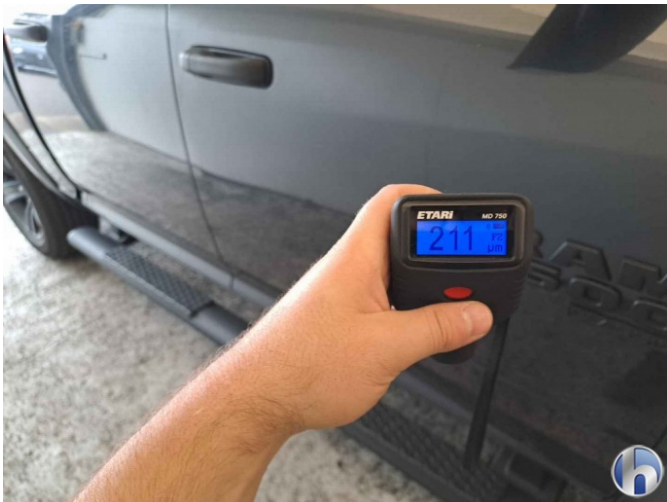
3. Front door - right

| 53. | Front door - right | Execution defect | Refurbish and paint |

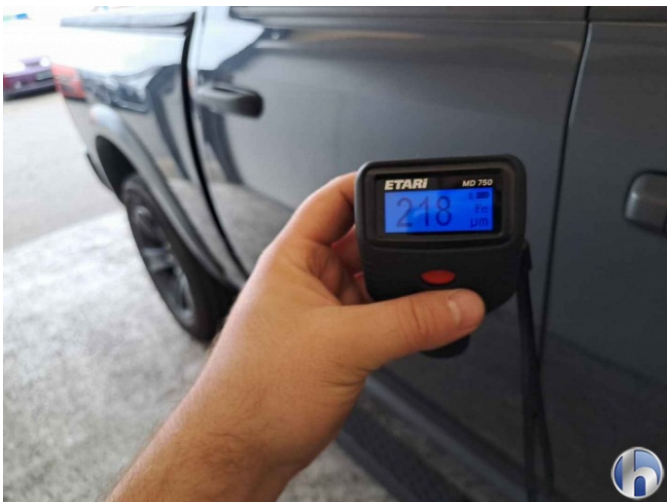
5. Door Rear - right

| 40. | Door Rear - right | Execution defect | Refurbish and paint |

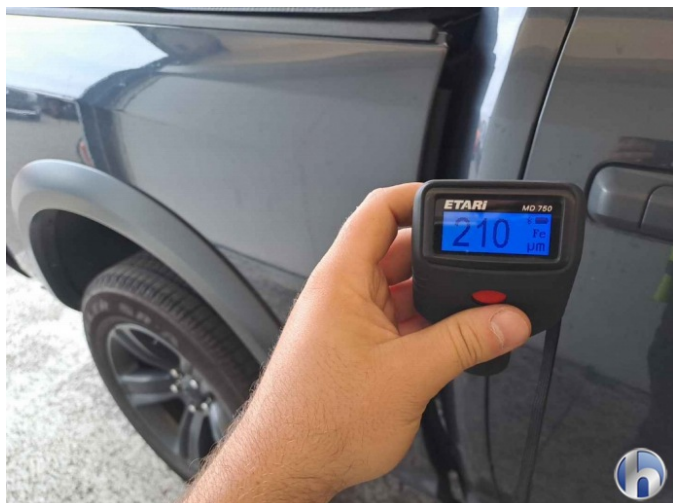
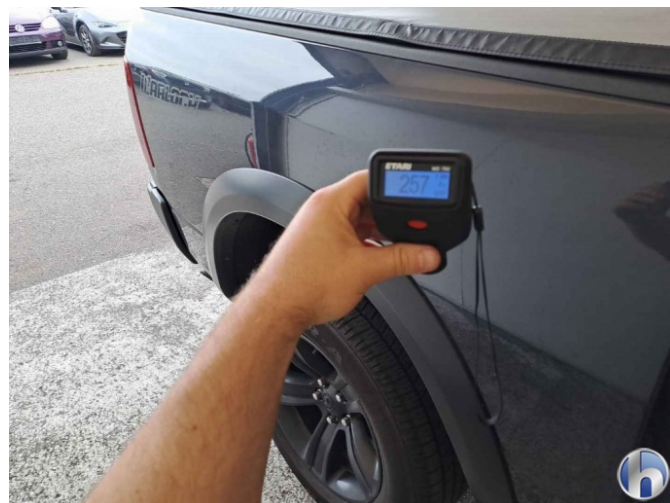
7. Sidewall - Rear - right

| 41. | Sidewall - Rear - right | Execution defect | Refurbish and paint |

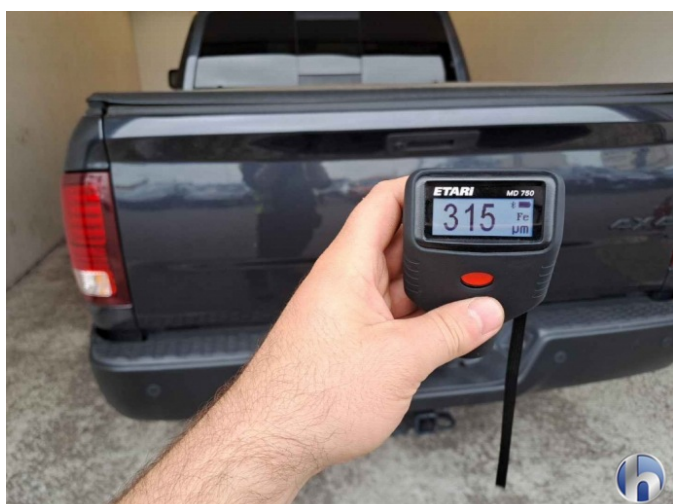
8. tailgate

| component | Damage | Rep kind |
|---|---|---|
| 20. tailgate | Execution defect | Paint |

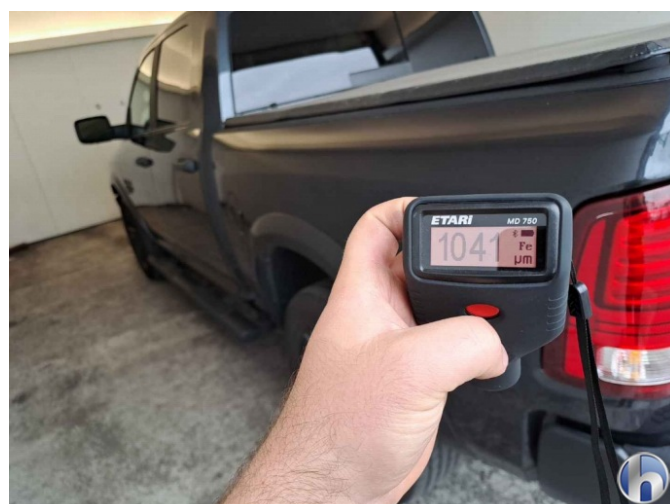
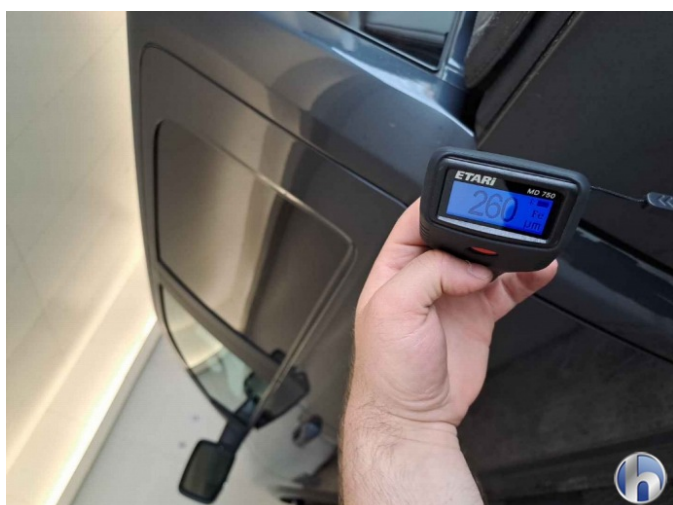
9. Sidewall - Rear - Left

| component | Damage | Rep kind |
|---|---|---|
| 22. Sidewall - Rear - Left | Execution defect | Refurbish and paint |

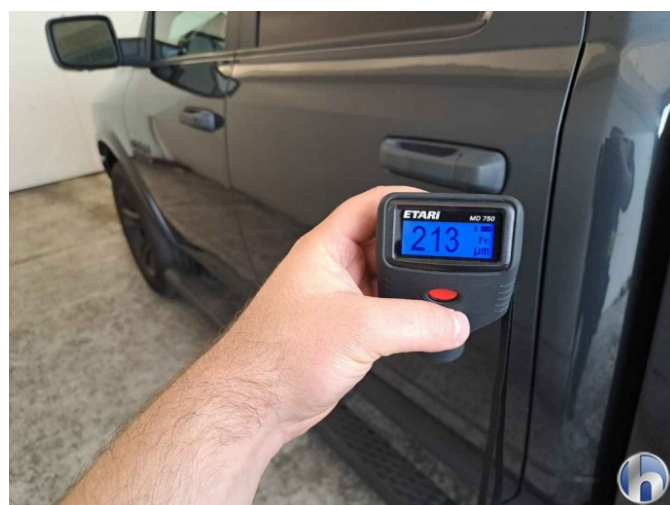
10. Rear door - left

| component | Damage | Rep kind |
|---|---|---|
| 25. Rear door - left | Execution defect | Refurbish and paint |

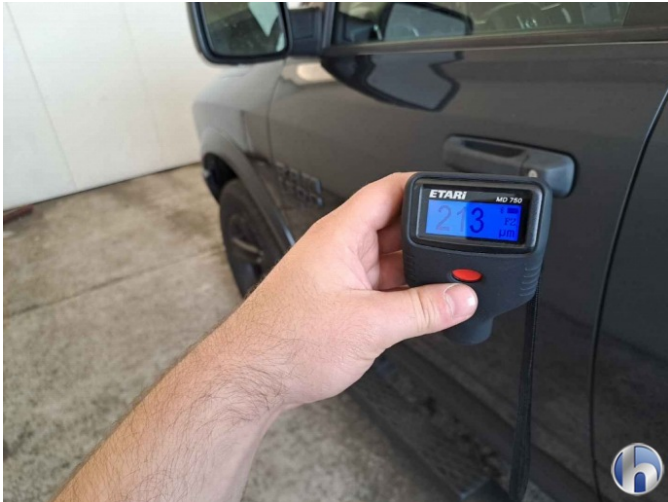
11. Front door - left

| component | Damage | Rep kind |
|---|---|---|
| 28. Front door - left | Execution defect | Refurbish and paint |

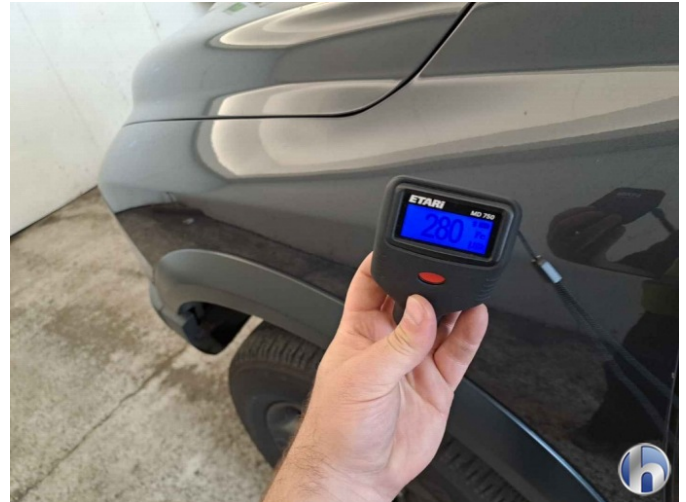
12. Front fender - left

| component | Damage | Rep kind |
|---|---|---|
| 30. Front fender - left | Execution defect | Refurbish and paint |

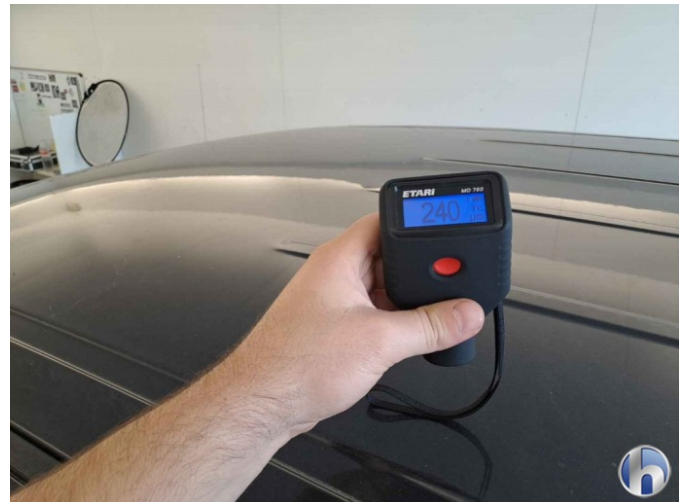
14. roof

| component | Damage | Rep kind |
|---|---|---|
| 36. roof | Execution defect | Refurbish and paint |

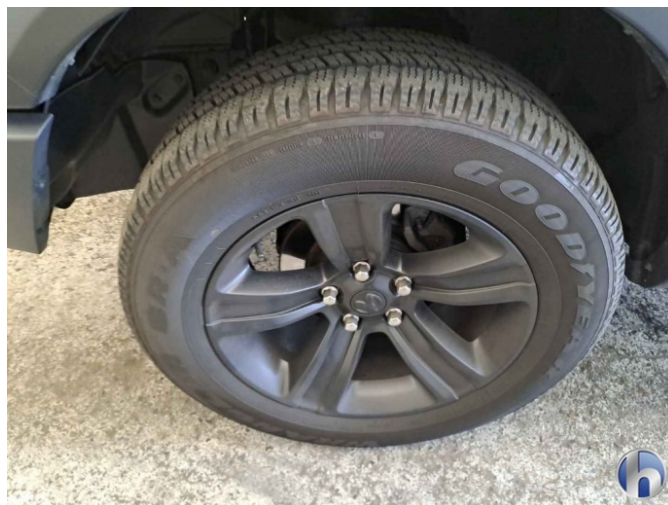
| component | Damage | Rep kind |
|---|---|---|
| 17. tire front - left | Not safe for road traffic | Replace |

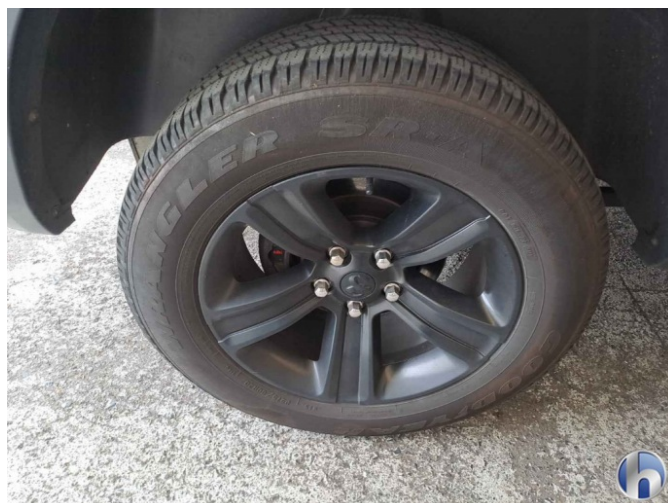
| component | Damage | Rep kind |
|---|---|---|
| 19. tire rear - right | Not safe for road traffic | Replace |

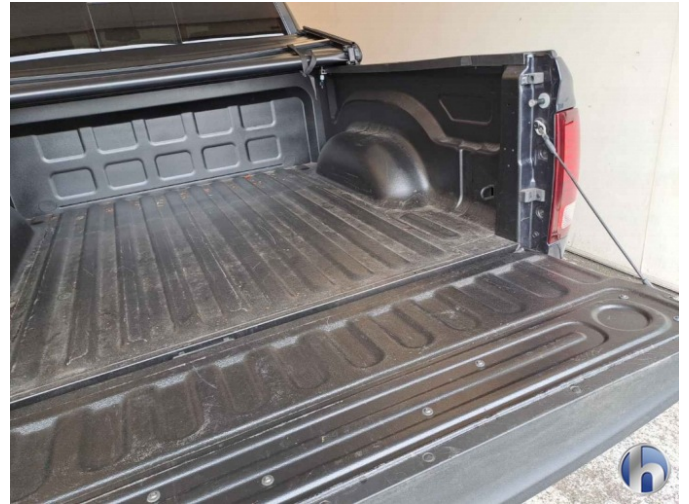
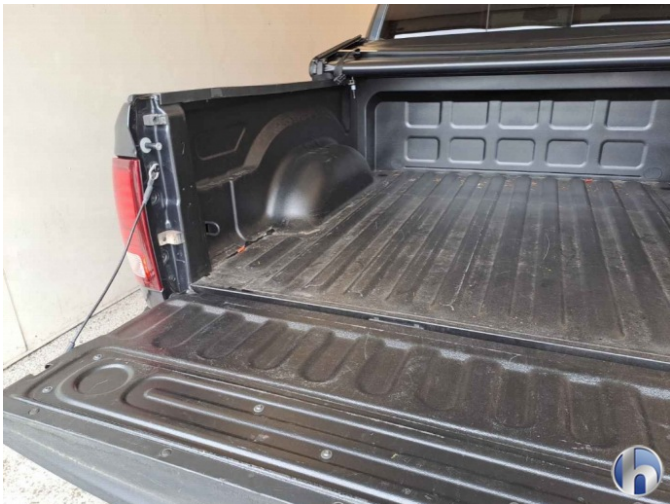
| component | Damage | Rep kind |
|---|---|---|
| 21. | Wear and tear | acceptable |

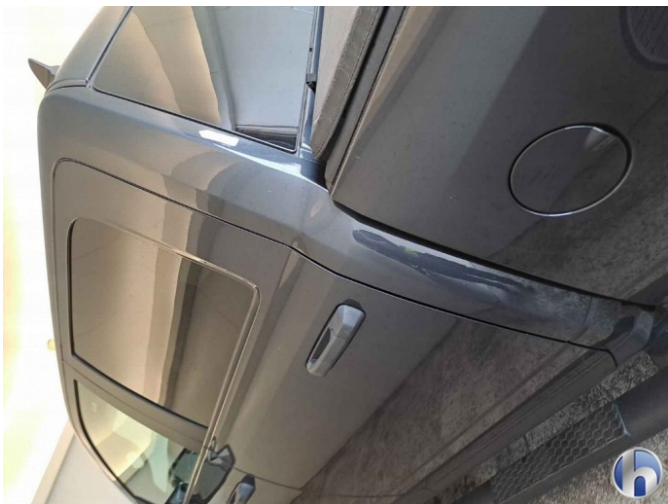
| component | Damage | Rep kind |
|---|---|---|
| 23. Taillight left | Scratch(es) | Replace |

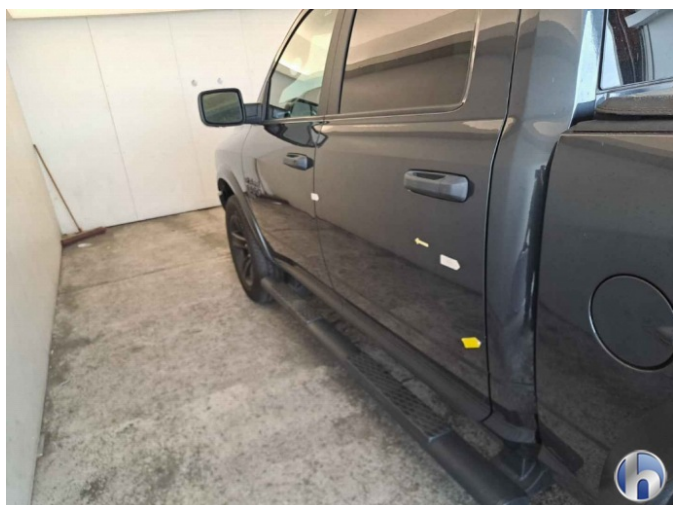
| component | Damage | Rep kind |
|---|---|---|
| 24. C-pillar back - left | Execution defect | Refurbish and paint |

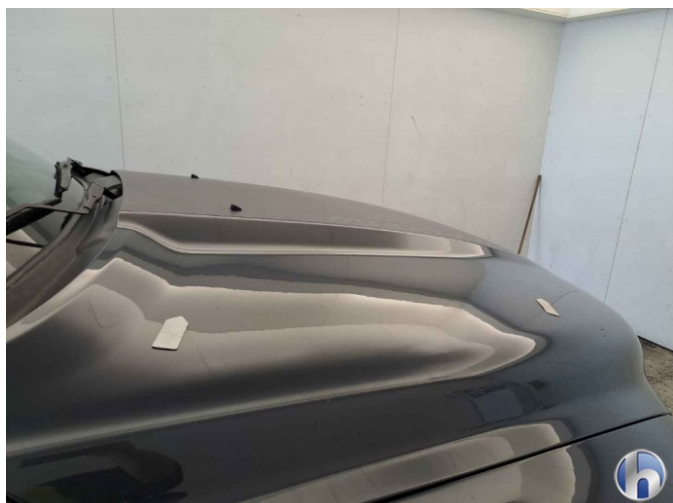
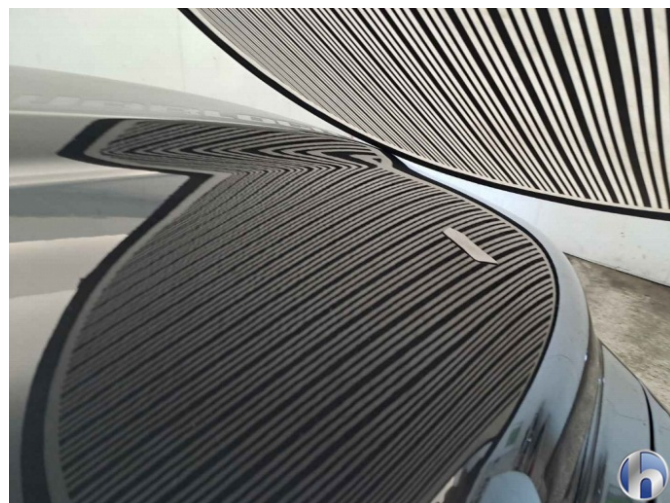
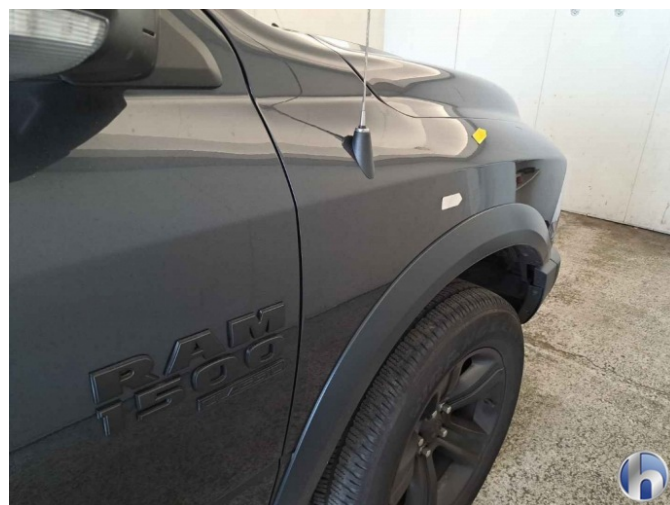
| component | Damage | Rep kind |
|---|---|---|
| 31. hood | Execution defect | Refurbish and paint |

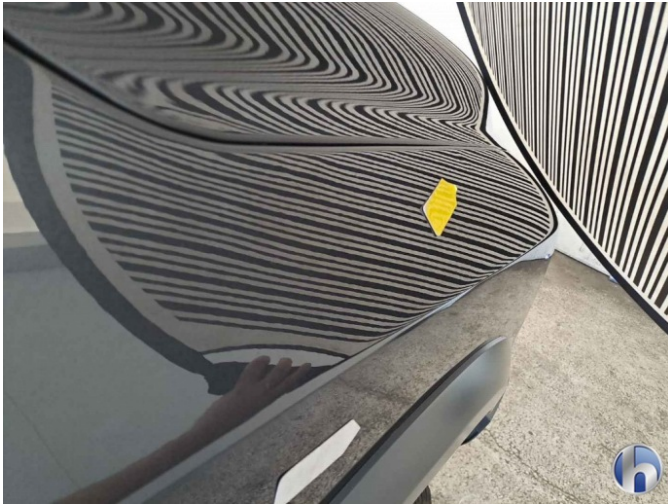
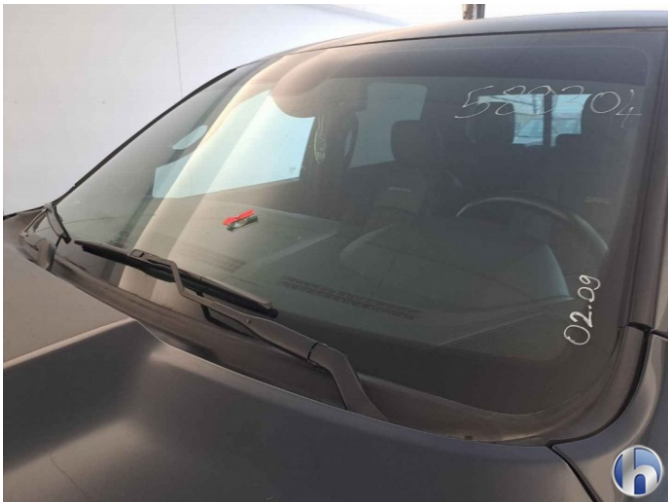
| component | Damage | Rep kind |
|---|---|---|
| 32. Front fender - right | Execution defect | Refurbish and paint |

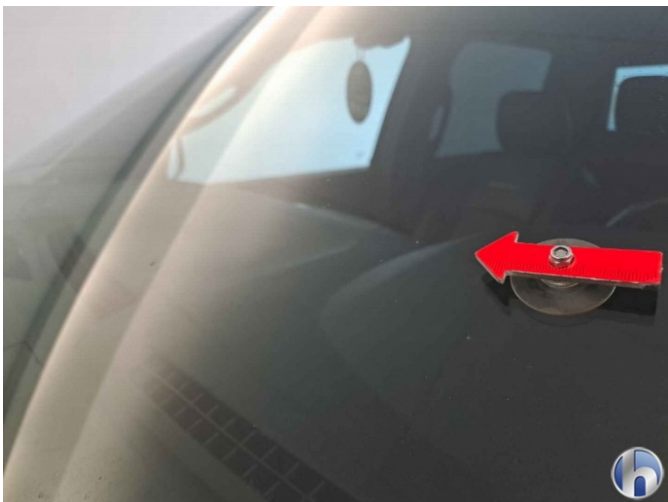
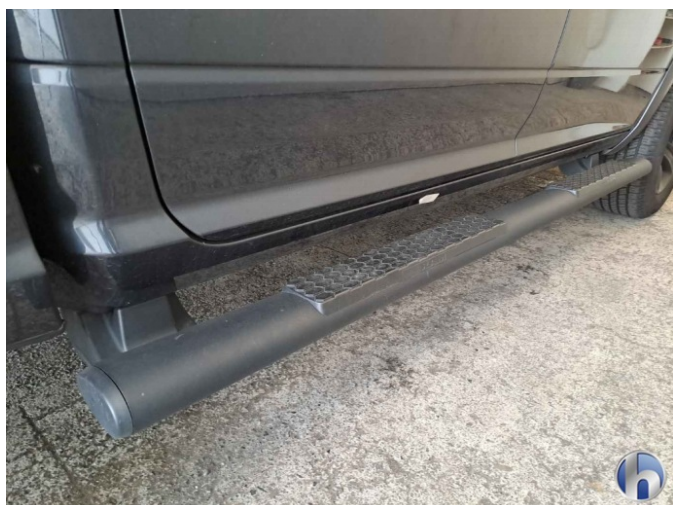
| component | Damage | Rep kind |
|---|---|---|
| 33. Windshield | Chipping from stones in field of view | Replace |

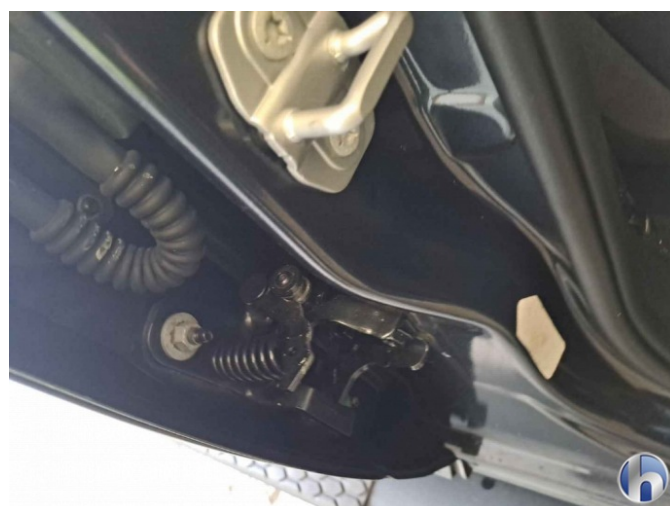
| component | Damage | Rep kind |
|---|---|---|
| 35. Türeinstieg Vorne - Rechts | Execution defect | Paint |

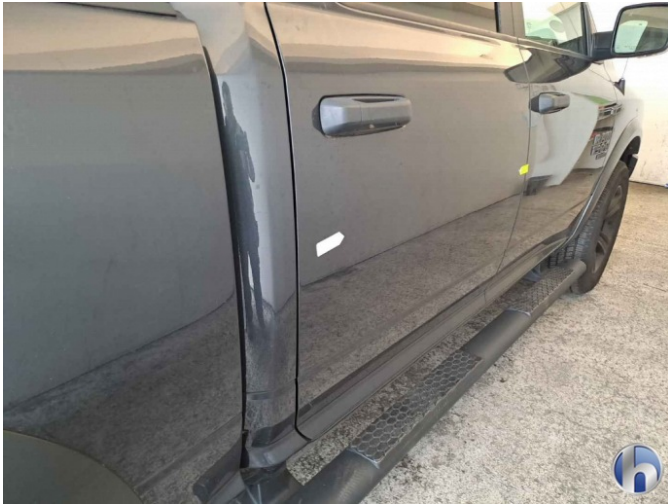
39. exterior body

| 39. | exterior body | Damaged | |

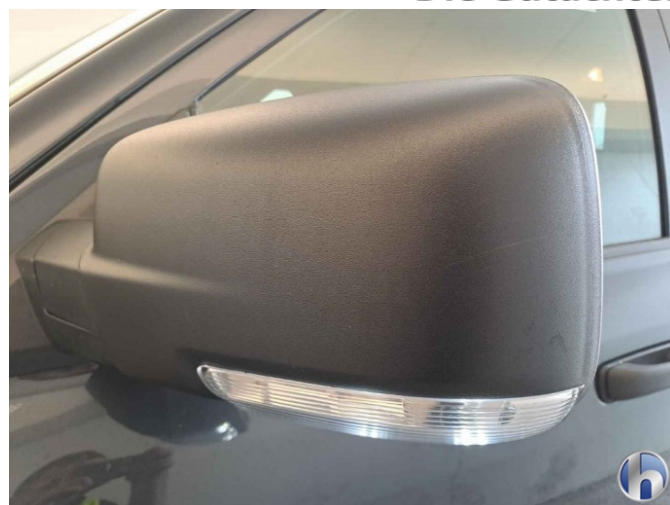
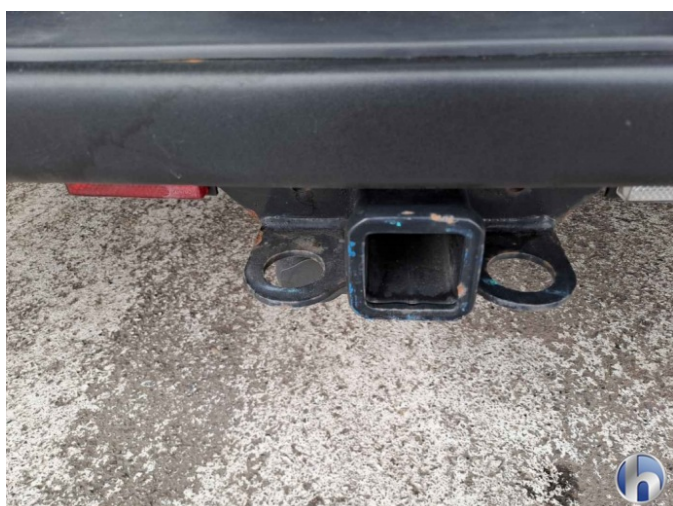
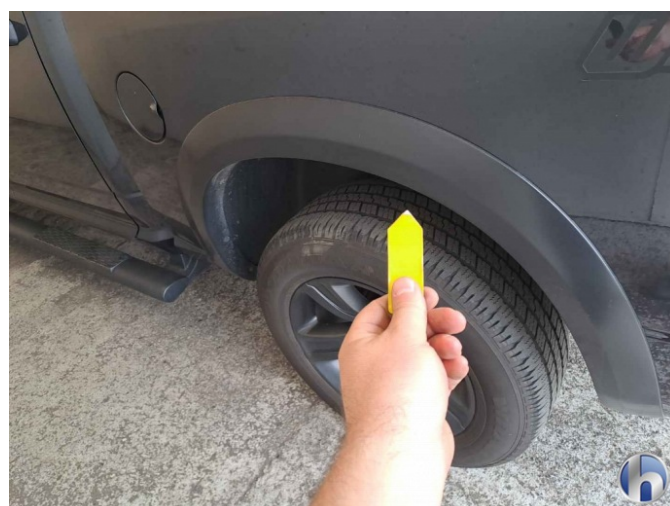
42. exterior body

| 42. | exterior body | Wear and tear | acceptable |

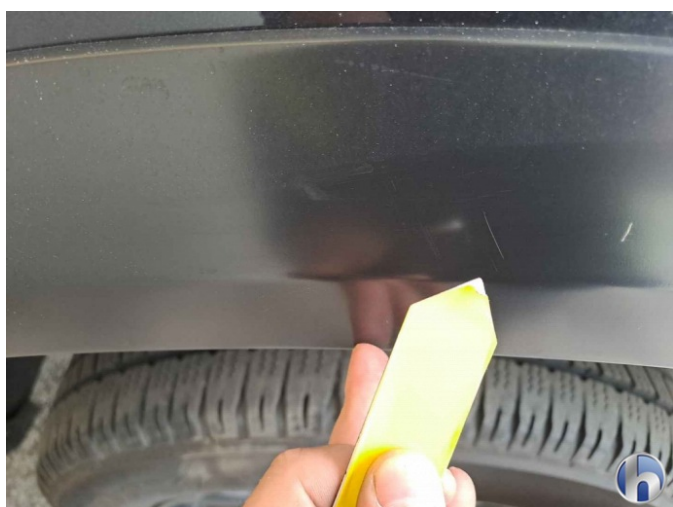
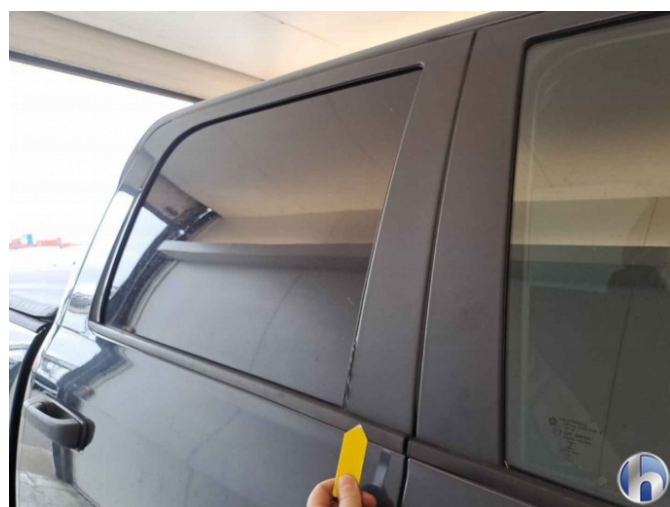
| 46. | | Scratch(es) | Replace |

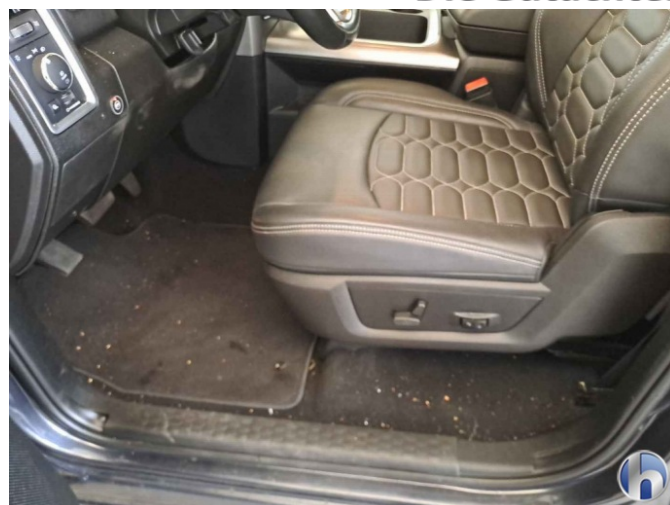
47. B-säule Mitte - Rechts Folierung

| 47. | B-säule Mitte - Rechts Folierung | Damaged | Replace |

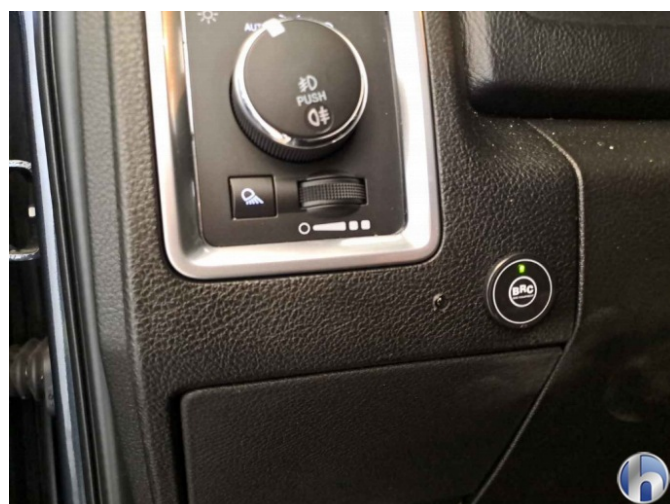
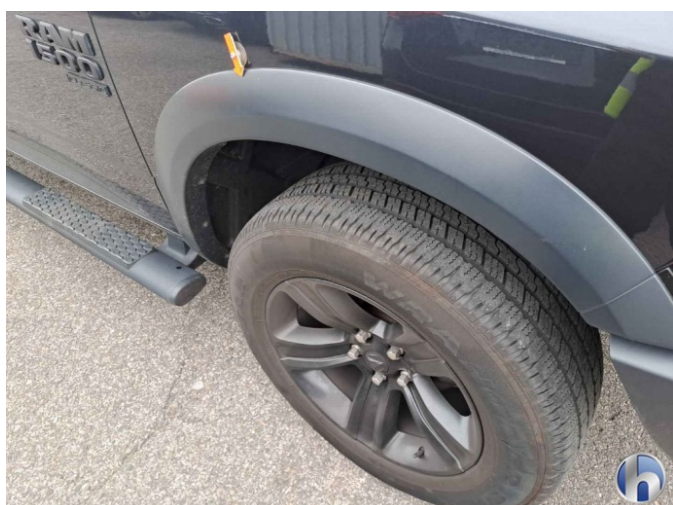
49. covering

| 49. | covering | Damaged | Replace |

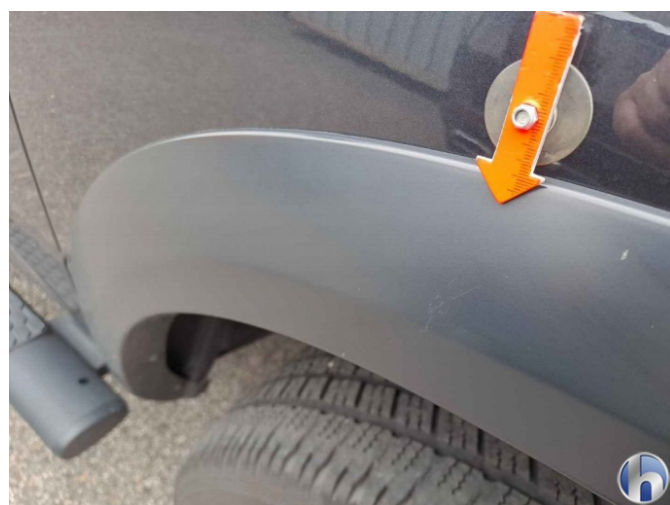
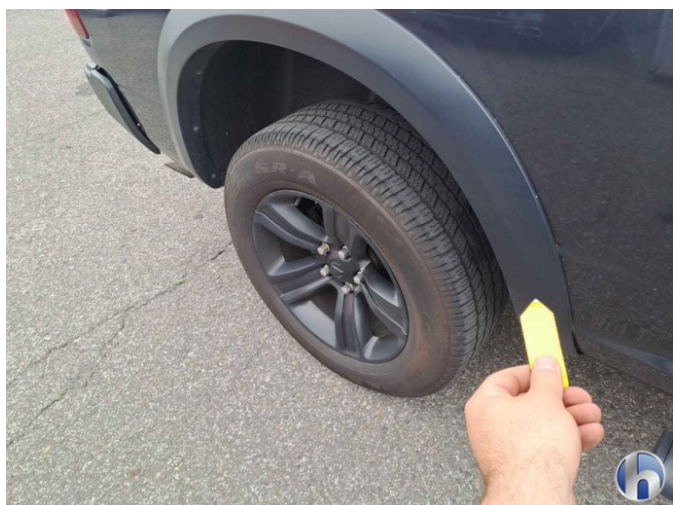
| 50. | | Scratch(es) | Replace |

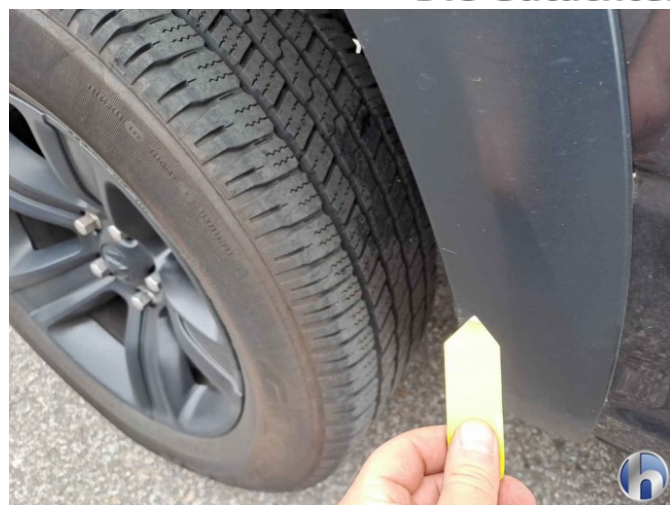
| 51. | | Scratch(es) | Replace |

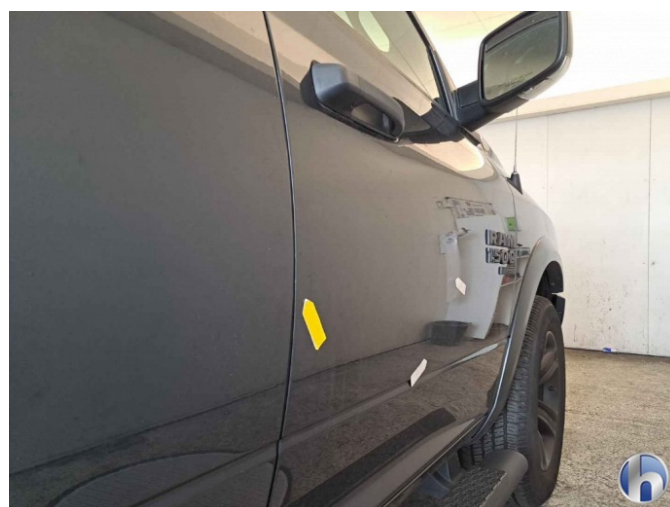
52. Türeinstieg Hinten - Rechts

| 52. | Türeinstieg Hinten - Rechts | Execution defect | Paint |
