## status report

| vehicle data | | | |
|---|---|---|---|
| <b>Ford Ranger Wildtrak Doppelkabine 4x4</b> | | | |
| Vehicle identification number | <b>6FPXJM2PLD18117</b> | mileage read: | <b>96499 km</b> |
| First Registration / construction year: | <b>15.10.2020 / 2020</b> | Visit Date / place of birth: | <b>23.09.2025 Dorfmark</b> |

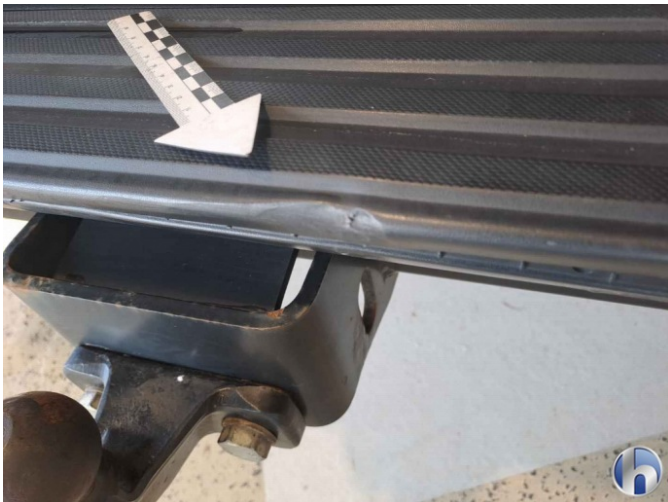
| Accident injury assessment | |
|---|---|
| <b>Existing collision damage:</b> | <b>found</b><br>At the unrepaired vehicle accident damage were observed on visual examination on the body skin . |
| <b>reference:</b> | Stoßfänger Hinten. Fahrzeug mit bestehenden Unfallschaden, zur Schadensermittlung wurden keine Demontagearbeiten durchgeführt, verborgen gebliebene Schäden können nicht ausgeschlossen werden. Unfallschaden Kosten wurden überschlägig Kalkuliert, Kostenerweiterung möglich. |

| component | Damage | Rep kind |
|---|---|---|
| 7. Rear bumper | Accident damage | Replace |

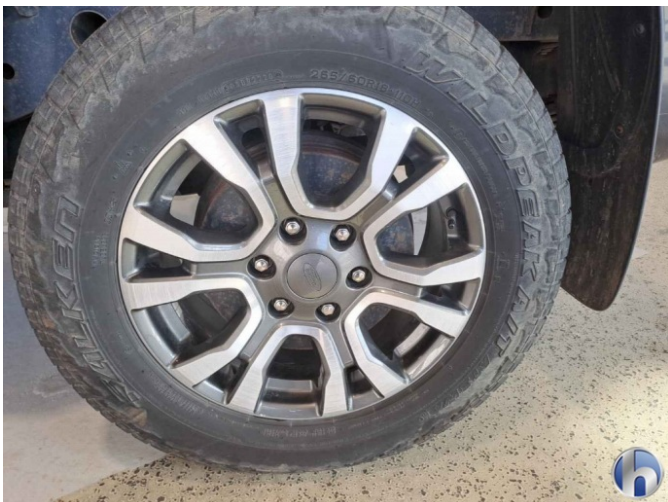
| component | Damage | Rep kind |
|---|---|---|
| 8. Rim rear - left | Damaged | Replace |

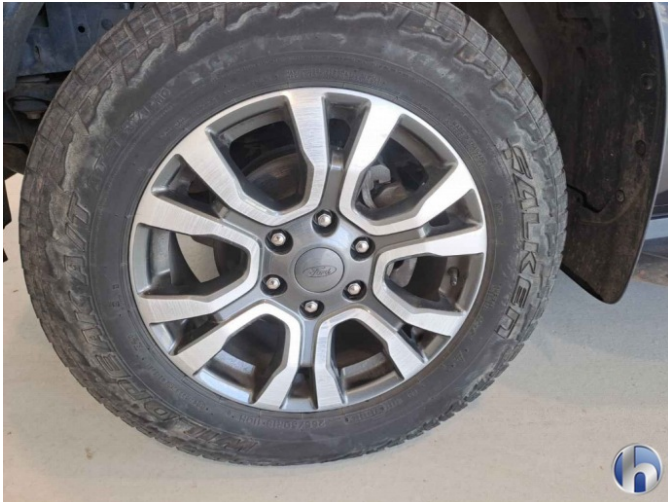
| component | Damage | Rep kind |
|---|---|---|
| 11. Rim front - left | Damaged | Replace |

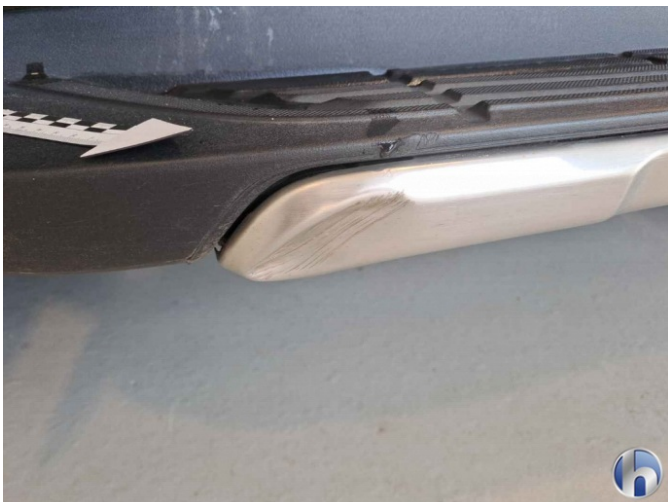
| component | Damage | Rep kind |
|---|---|---|
| 12. Trittstufe links | Damaged | Replace |

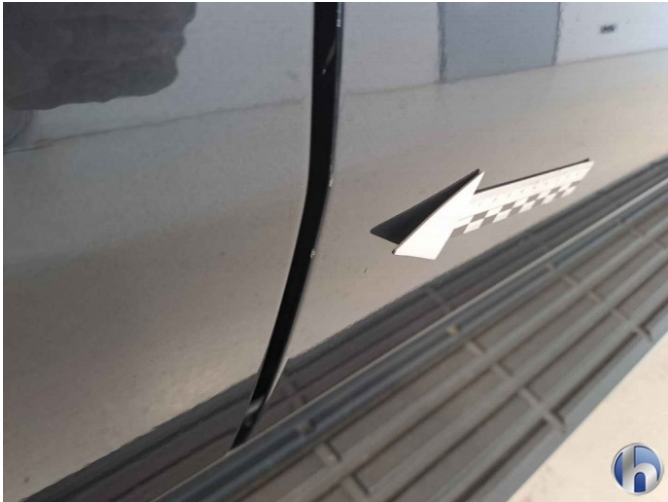
| component | Damage | Rep kind |
|---|---|---|
| 15. Front door - right | Scrape | Smart repair |

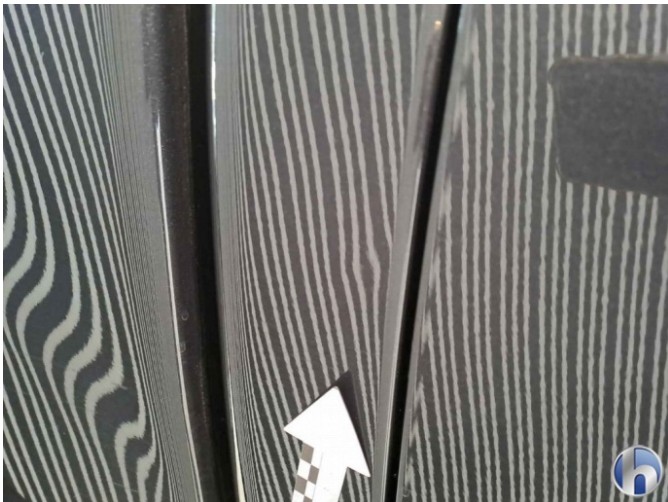
| component | Damage | Rep kind |
|---|---|---|
| 16. C-pillar rear - right | | Smart repair |

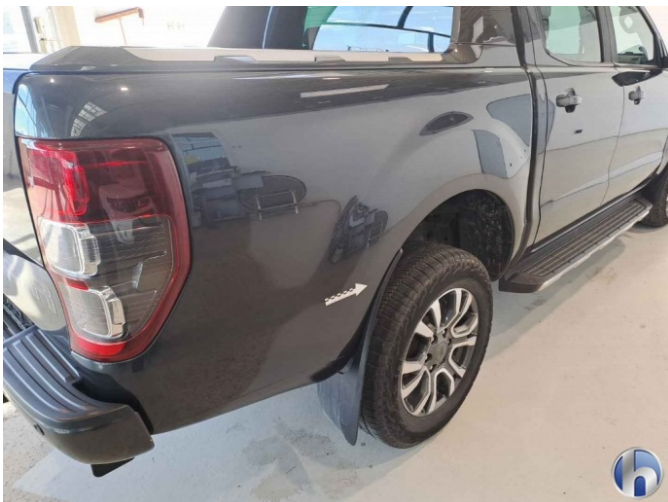
| component | Damage | Rep kind |
|---|---|---|
| 17. Sidewall - Rear - right | Scratch(es) | Smart repair |

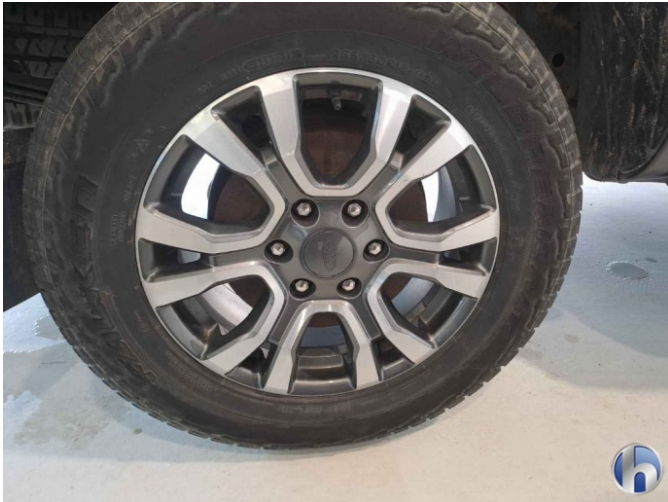
| component | Damage | Rep kind |
|---|---|---|
| 18. Rim rear - right | Damaged | Replace |

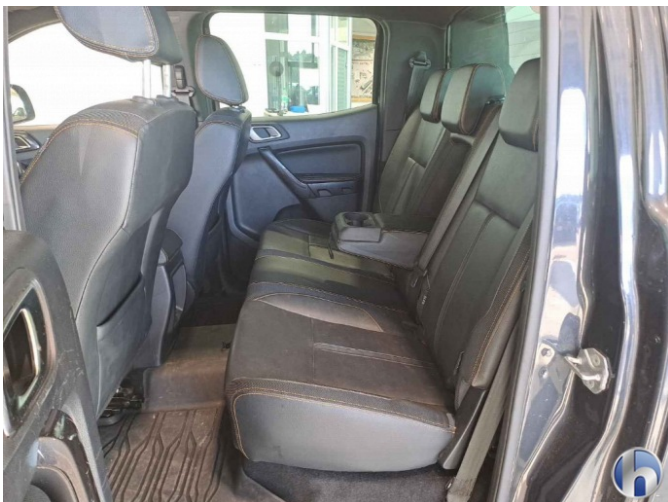
| component | Damage | Rep kind |
|---|---|---|
| 20. | Wear and tear | acceptable |

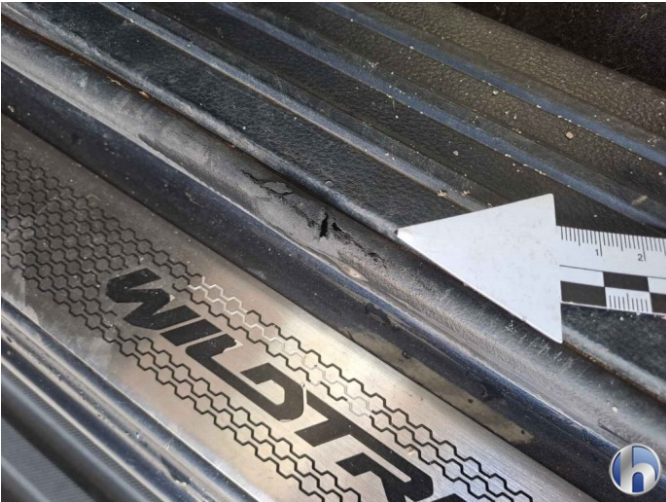
| component | Damage | Rep kind |
|---|---|---|
| 24. Front door seal - left | Damaged | Replace |

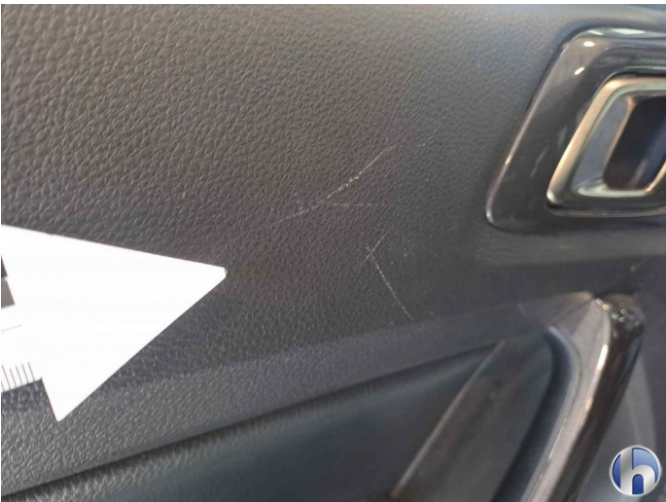
| component | Damage | Rep kind |
|---|---|---|
| 25. Front door trim - left | Scratch(es) | Replace |

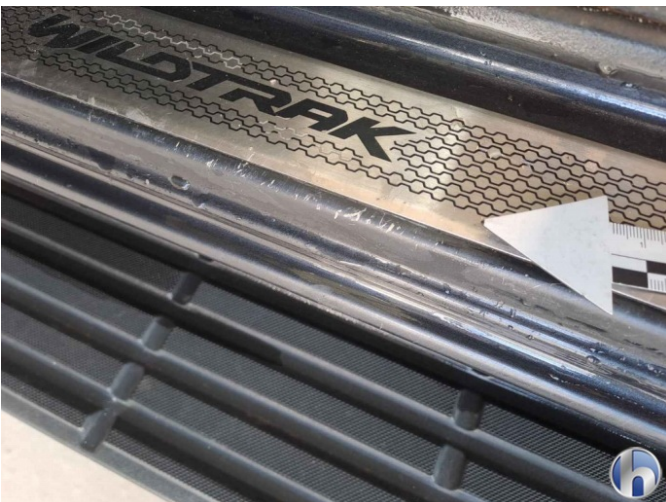
| component | Damage | Rep kind |
|---|---|---|
| 26. Türeinstieg Vorne - Links | Scrape | Smart repair |
