## status report

#### Mazda CX-5 Nakama Intense AWD

| Vehicle identification number | <b>JMZKEN92800527450</b> | mileage read: | <b>105748 km</b> |

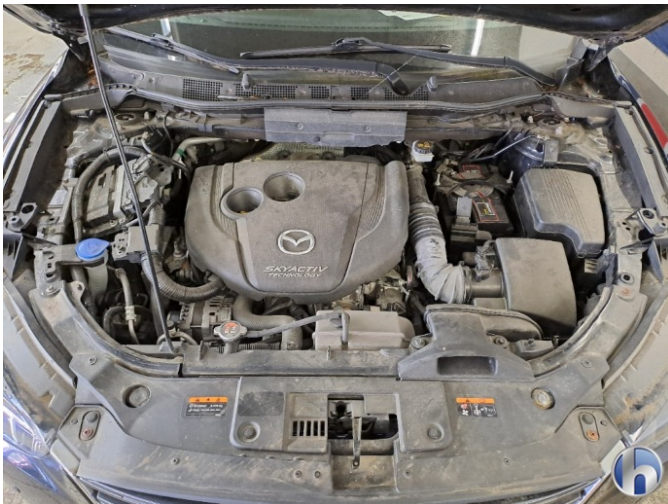
engine compartment

| Performed testing technology | |
|---|---|
| <b>engine running:</b> | A field test of the engine had to acoustic or visual defects for visiting time .<br>**Engine warning light. Engine run out of round. |

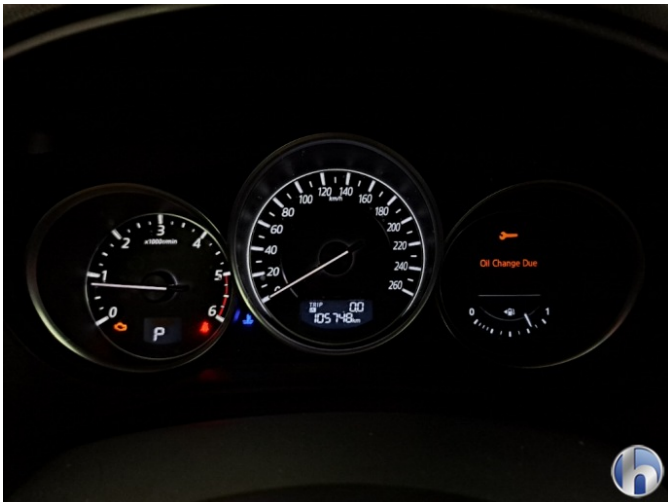
| component | Damage | Rep kind |
|---|---|---|
| 3. maintenance | Due | Replace |

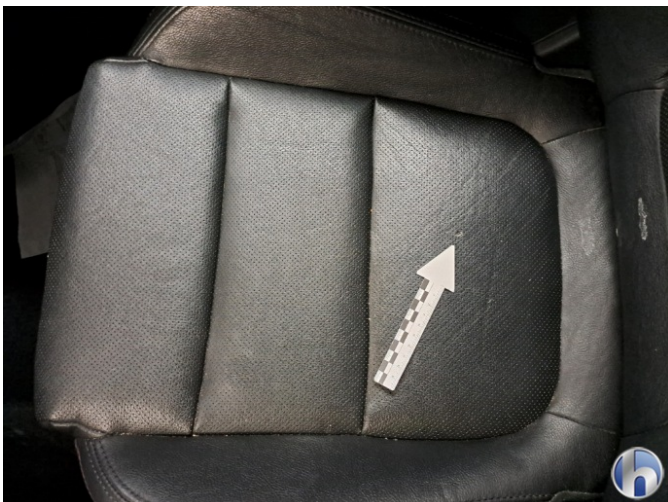
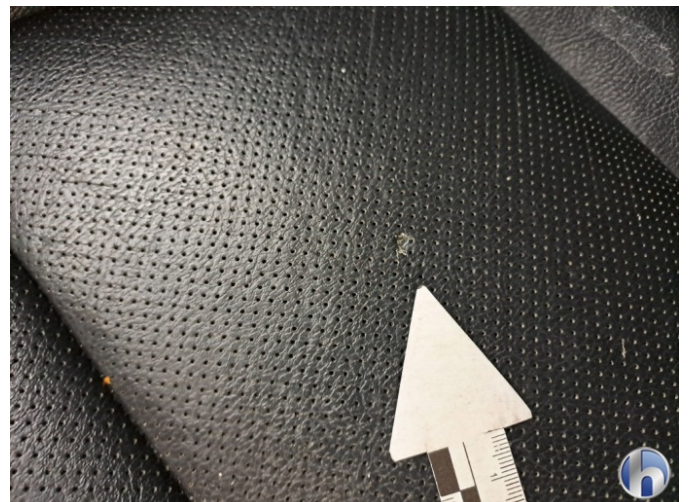
| component | Damage | Rep kind |
|---|---|---|
| 5. | Burn hole | Replace |

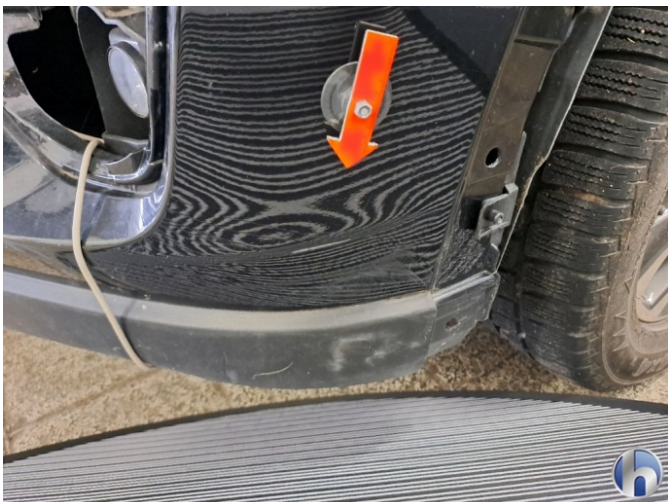
| component | Damage | Rep kind |
|---|---|---|
| 8. Front bumper | Damaged | Replace |

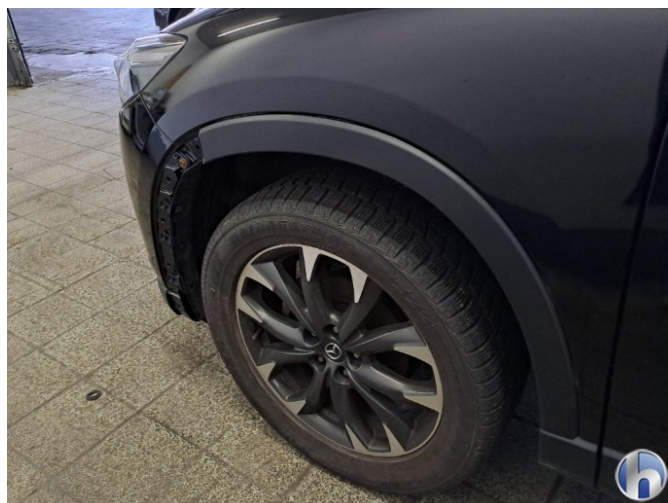
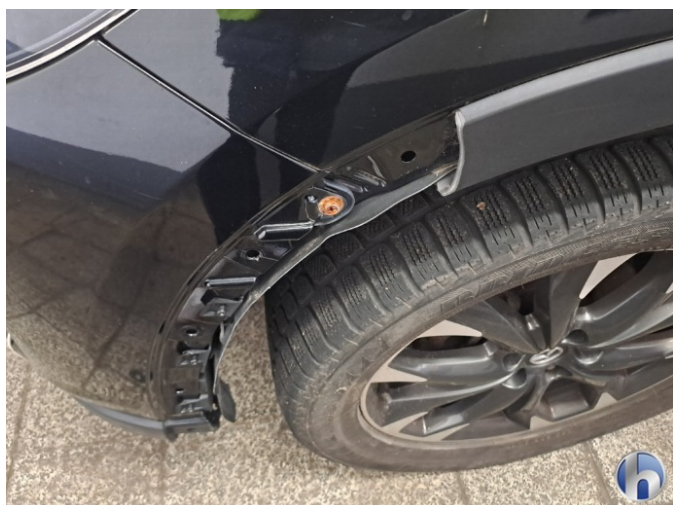
| component | Damage | Rep kind |
|---|---|---|
| 11. | Breakage | Replace |

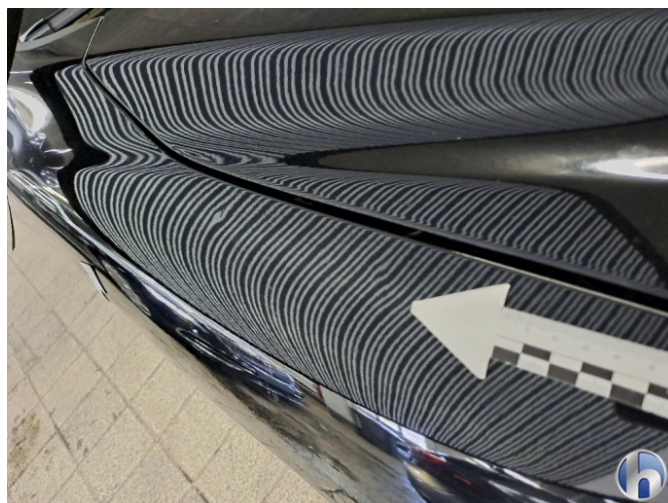
14. Kotflügel Vorne - Rechts (6×10mm)

| component | Damage | Rep kind |
|---|---|---|
| 14. Kotflügel Vorne - Rechts (6x10mm) | Hail damage | Gentle refurbishing |

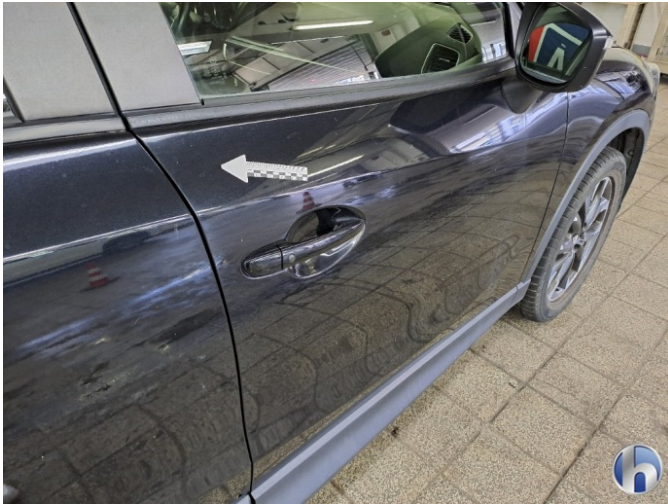
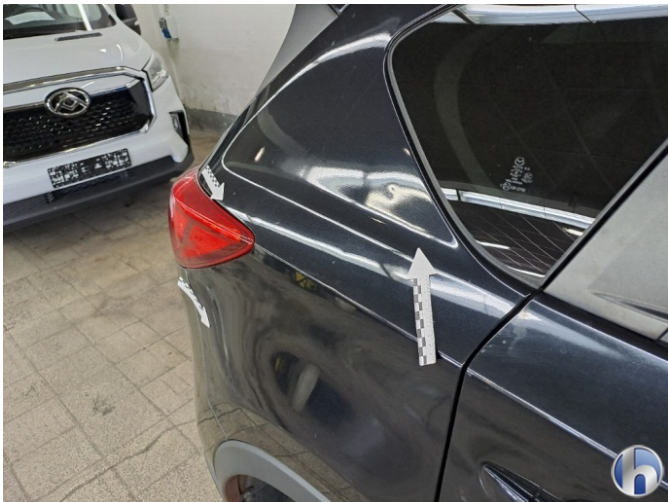
16. Tür Vorne - Rechts (1×20mm)

| component | Damage | Rep kind |
|---|---|---|
| 16. Tür Vorne - Rechts (1x20mm) | Hail damage | Gentle refurbishing |

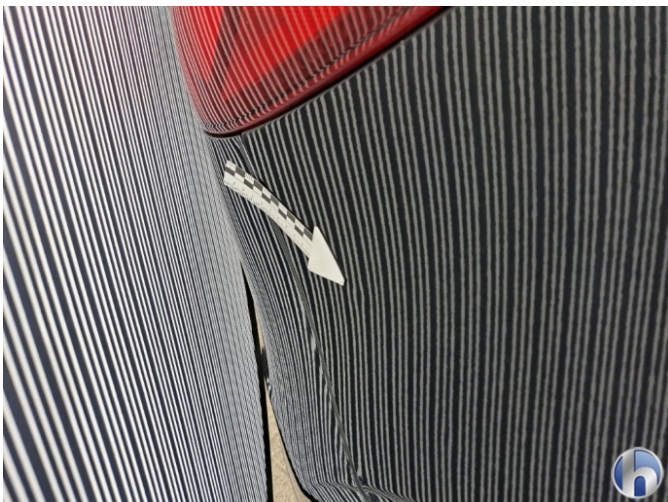
17. Seitenwand - Hinten - Rechts (13×10mm)

| component | Damage | Rep kind |
|---|---|---|
| 17. Seitenwand - Hinten - Rechts (13x10mm) | Hail damage | Gentle refurbishing |

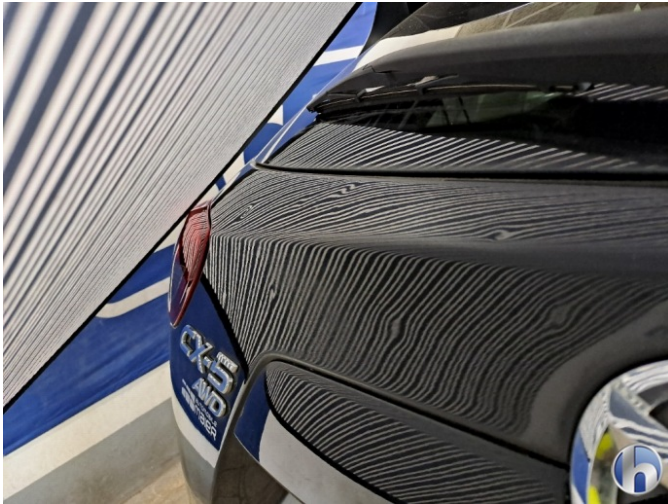
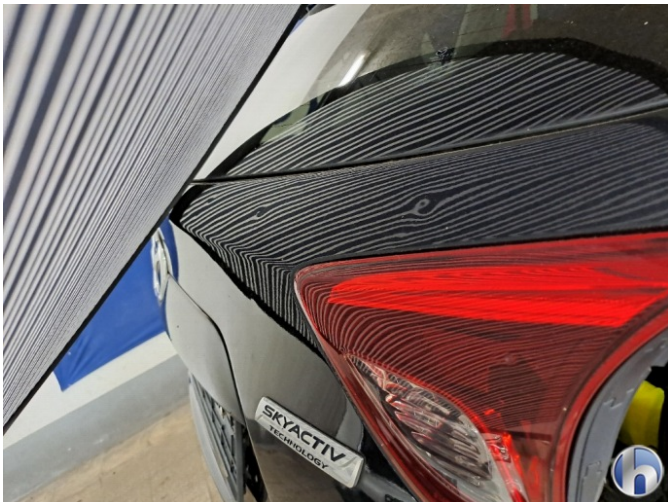
| component | Damage | Rep kind |
|---|---|---|
| 18. Heckklappe (ca.50x20mm) | Hail damage | Gentle refurbishing |

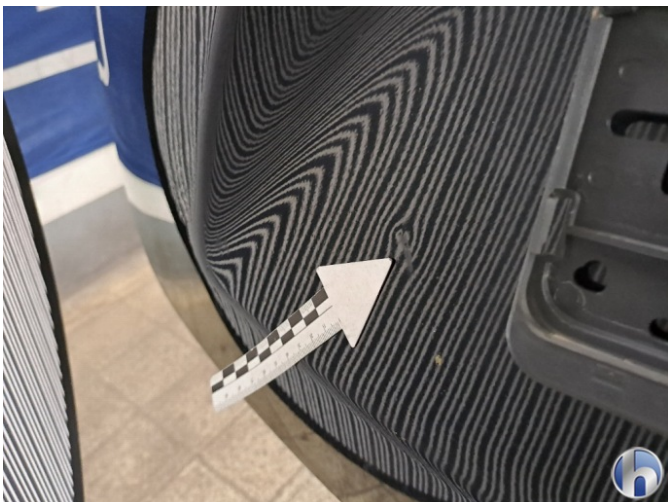
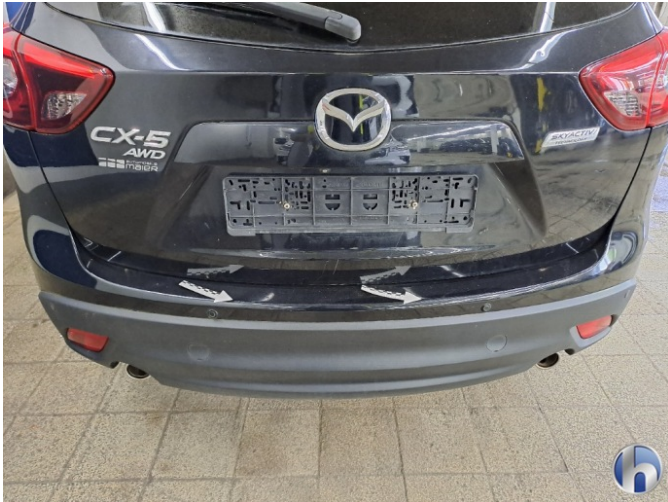
| component | Damage | Rep kind |
|---|---|---|
| 19. tailgate | Damaged | Refurbish and paint |

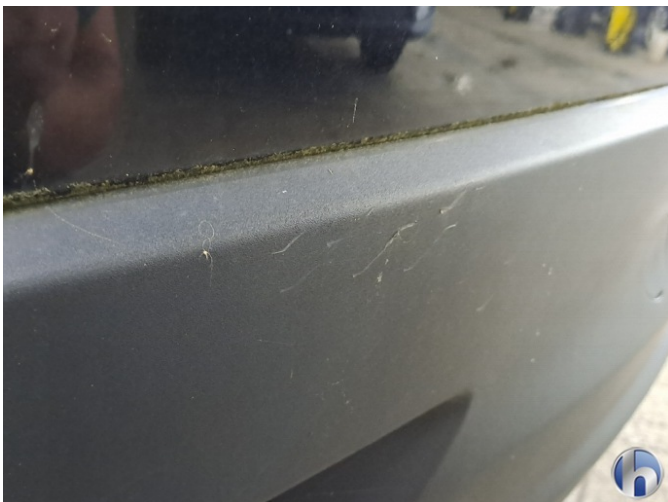
| component | Damage | Rep kind |
|---|---|---|
| 21. | Scratch(es) | Replace |

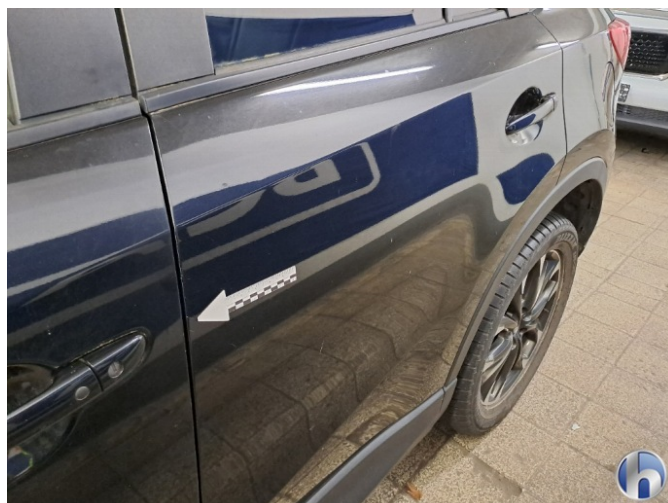
| component | Damage | Rep kind |
|---|---|---|
| 30. Rear door - left | Scratch(es) | Smart repair |
