## status report

#### Suzuki Swift Comfort

| Vehicle identification number | <b>JSAAZC23S00300486</b> | mileage read: | <b>59189 km</b> |
| First Registration / construction year: | <b>12.12.2019 / 2019</b> | Visit Date / place of birth: | <b>16.05.2025 Heidenheim</b> |

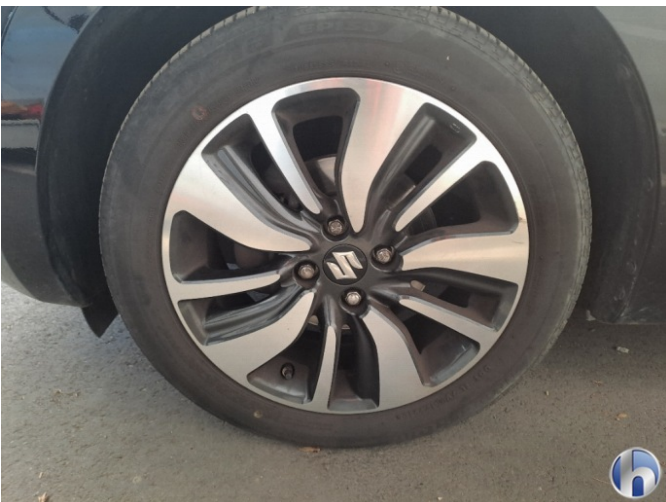
rims

| | component | Damage | Rep kind |
|---|---|---|---|
| 7. | Felge vorn links | Scratch(es) | Replace |

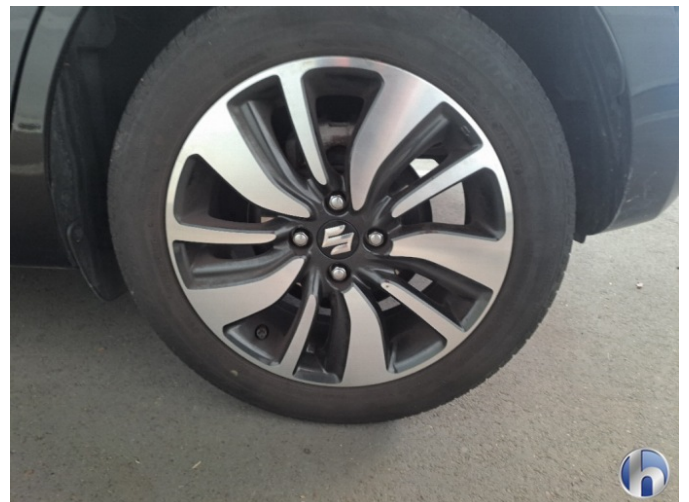
rims

| | component | Damage | Rep kind |
|---|---|---|---|
| 9. | Felge Hinten links | Scratch(es) | Replace |

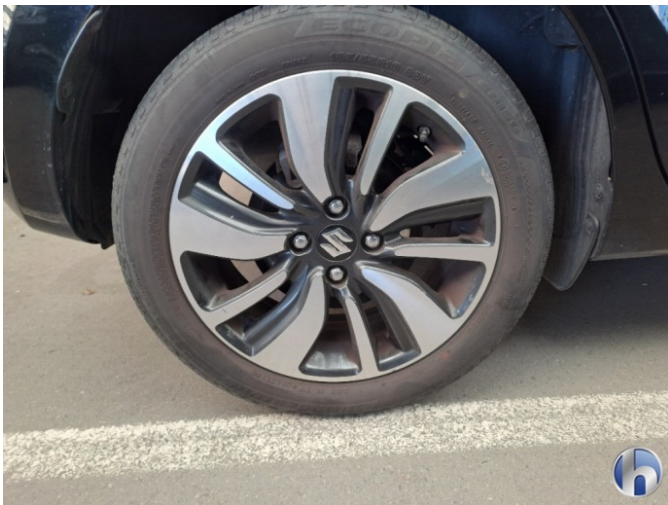
rims

| | component | Damage | Rep kind |
|---|---|---|---|
| 13. | Felge Hinten rechts | Scratch(es) | Replace |

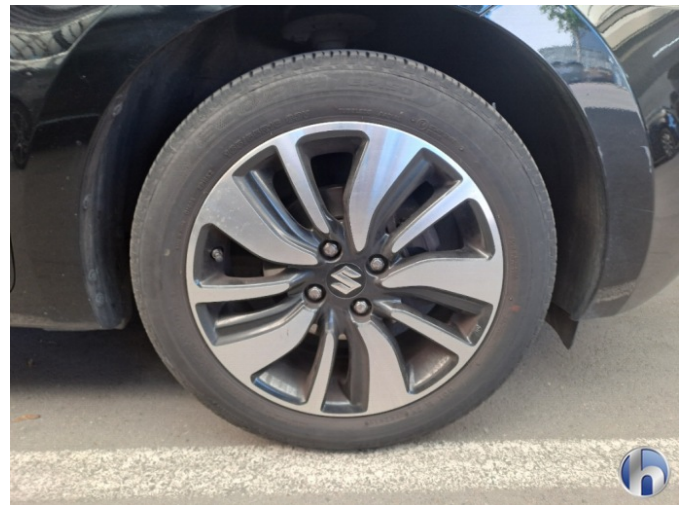
rims

| | component | Damage | Rep kind |
|---|---|---|---|
| 15. | Felge vorn rechts | Scratch(es) | Replace |
