## status report

**customer:** Bank 11, Neuss  
**contract number:** 1065801730  
**reference:**

#### Kia Rio Dream Team

| Vehicle identification number | <b>KNADC512AJ6130205</b> | mileage read: | <b>62153 km</b> |

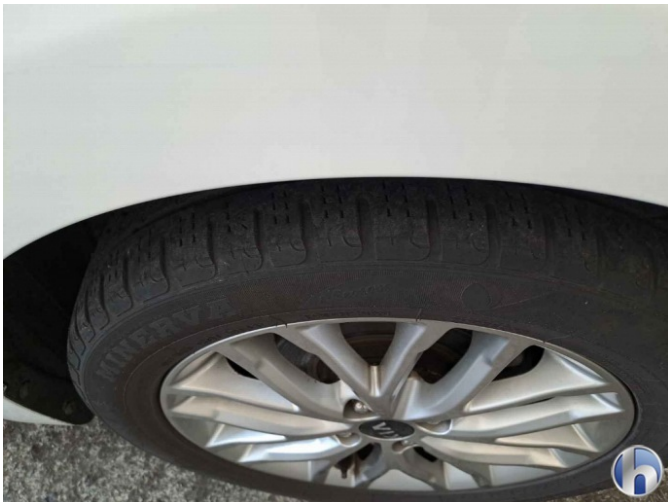
| component | Damage | Rep kind |
|---|---|---|
| 5. tire front - right | Worn | Replace |

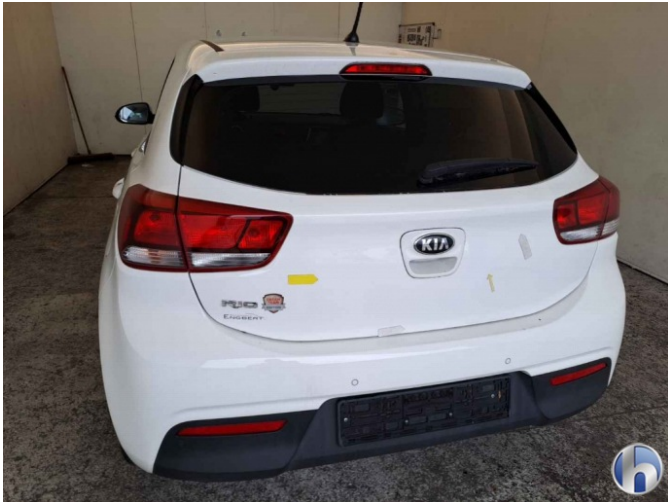
| component | Damage | Rep kind |
|---|---|---|
| 13. tailgate | Damaged | Refurbish and paint |

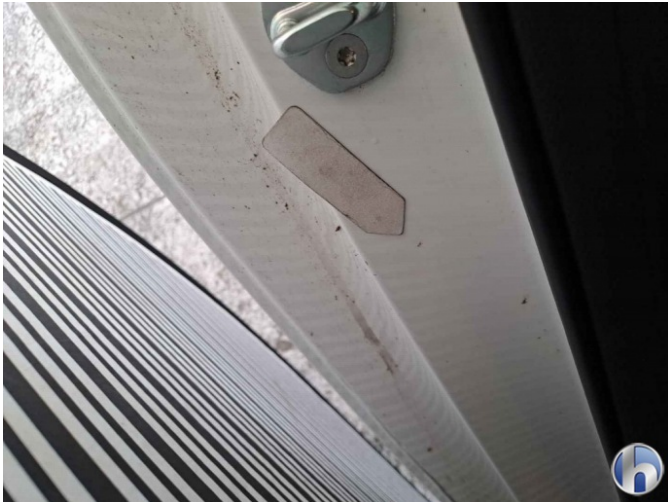
| component | Damage | Rep kind |
|---|---|---|
| 27. Türeinstieg Hinten - Rechts | Damaged | Refurbish and paint |

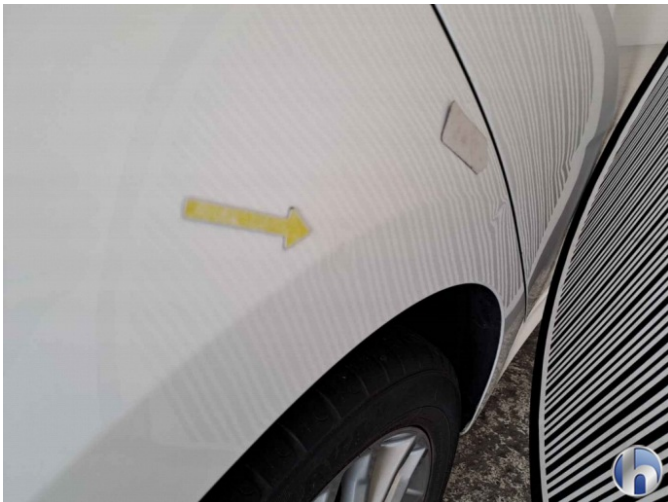
| component | Damage | Rep kind |
|---|---|---|
| 28. Sidewall - Rear - right | Damaged | Refurbish and paint |

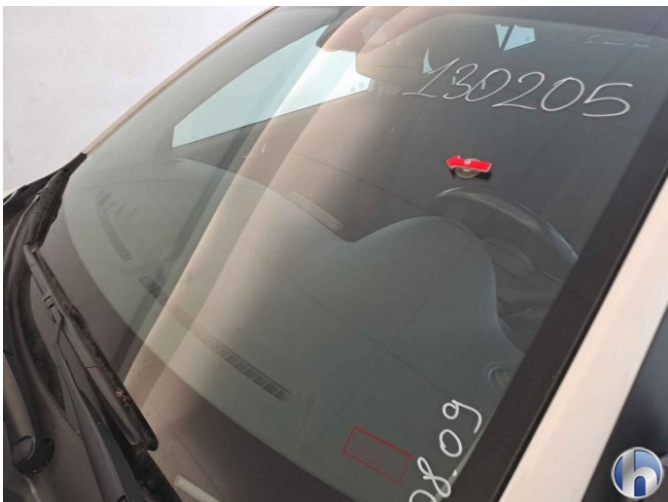
| component | Damage | Rep kind |
|---|---|---|
| 29. Windshield | Damaged | Replace |
