Expertise

Protocol number: 41470144
Order No. / Reference: 25161314
Inspection date: 9 Sept 2025

Manufacturer: Volvo	Model: XC60 T6 AWD Recharge Geartronic R-Design
VIN: LYVUZH1UDNB043417

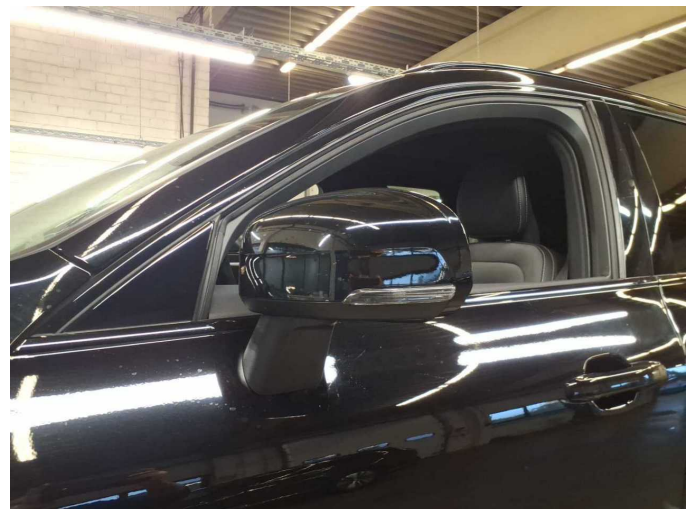
Damage 1: Wing mirror - left side: Cap - Scratch(es) - Smart repair
