## status report

**customer:** Bank 11, Neuss  
**contract number:** 314375931  
**reference:**

#### Hyundai i30

| Vehicle identification number | <b>TMAD351AADJ021891</b> | mileage read: | <b>131320 km</b> |

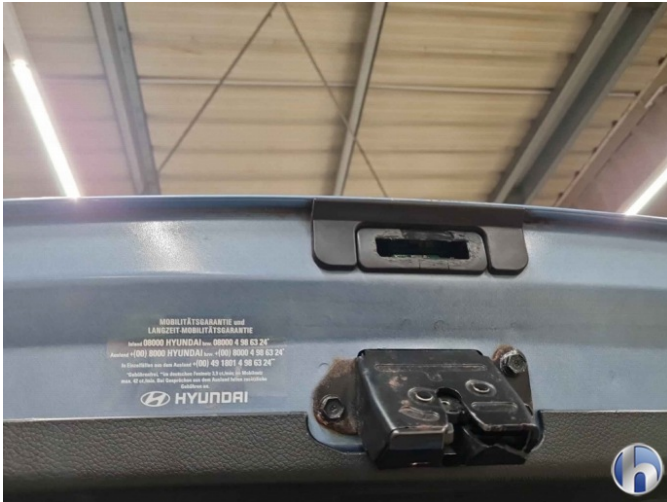
| component | Damage | Rep kind |
|---|---|---|
| 1. Heckklappentaster (Kofferraum nur von Innen über Notentriegelung zu öffnen) | Damaged | Replace |

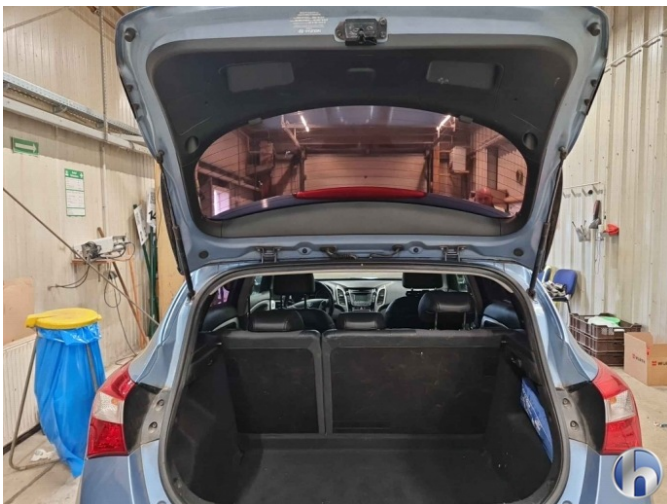
| component | Damage | Rep kind |
|---|---|---|
| 3. Kofferraum und Innenraum | Wear and tear | acceptable |

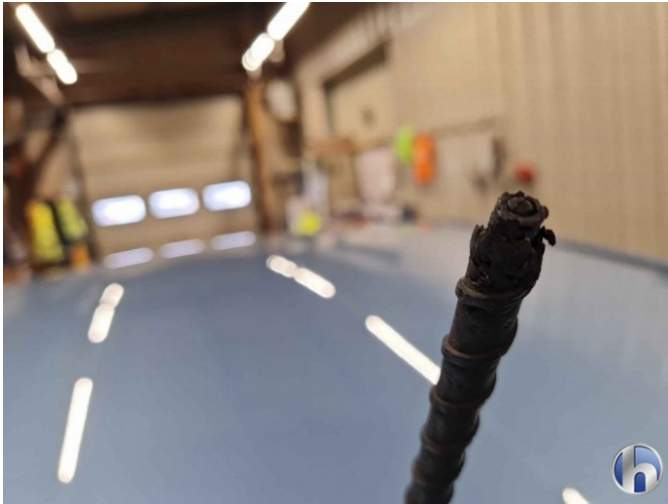
| component | Damage | Rep kind |
|---|---|---|
| 4. | Damaged | Replace |

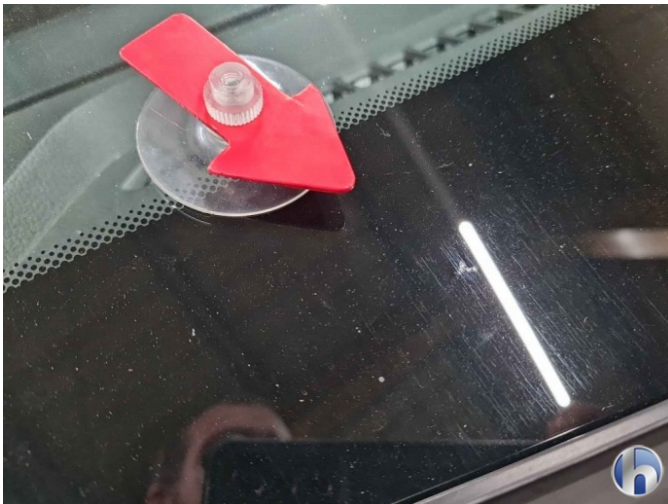
| component | Damage | Rep kind |
|---|---|---|
| 5. Windshield | Chipping from stones | Replace |

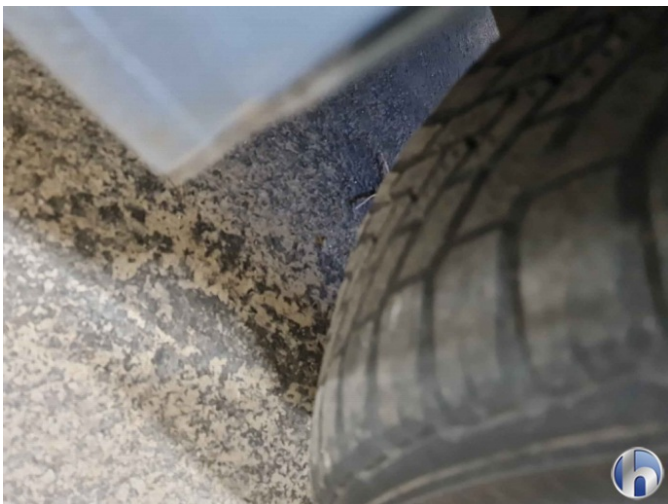
| component | Damage | Rep kind |
|---|---|---|
| 6. tire front - right | Worn | Replace |

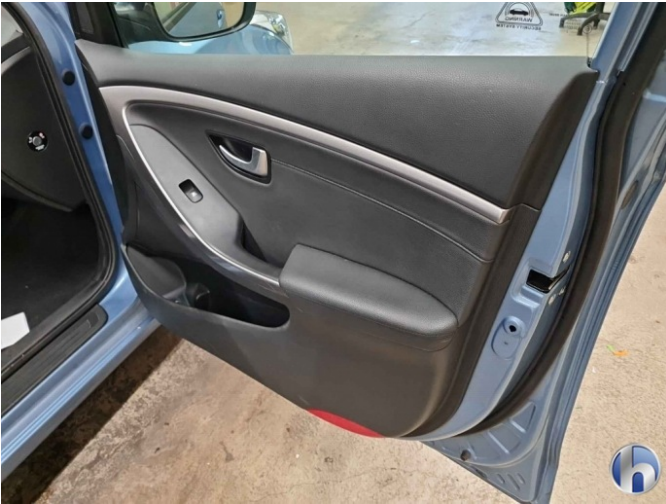
| component | Damage | Rep kind |
|---|---|---|
| 11. Front door - right | Damaged | Refurbish and paint |

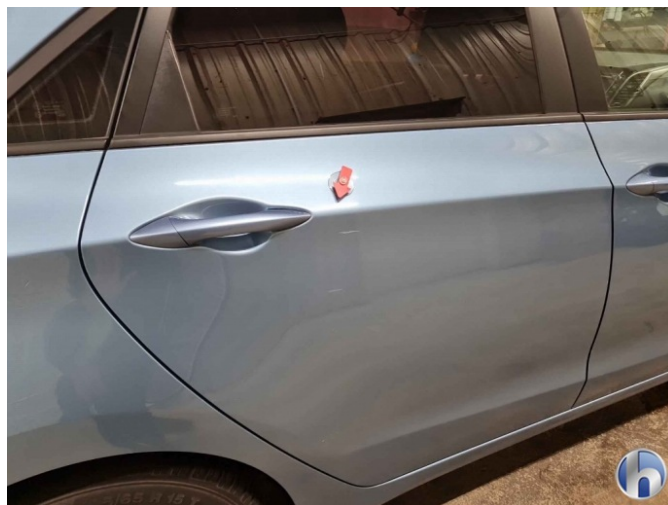
| component | Damage | Rep kind |
|---|---|---|
| 12. Door Rear - right | Damaged | Refurbish and paint |

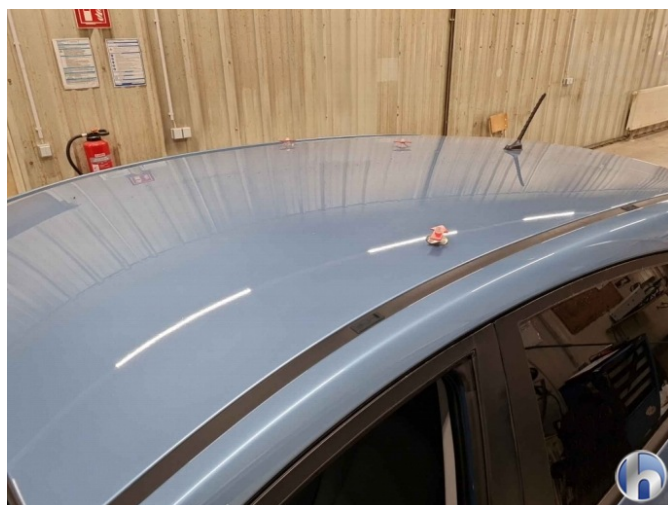
| component | Damage | Rep kind |
|---|---|---|
| 13. roof | Damaged | Refurbish and paint |

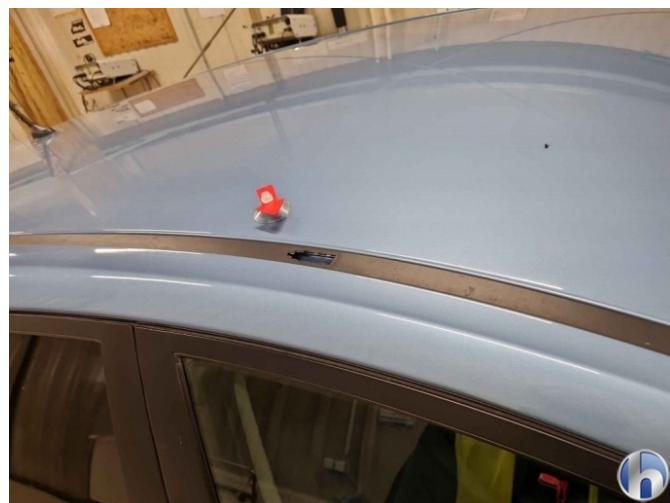
| component | Damage | Rep kind |
|---|---|---|
| 14. Dachleiste rechts: Abdeckkappe | Missing | Replace |

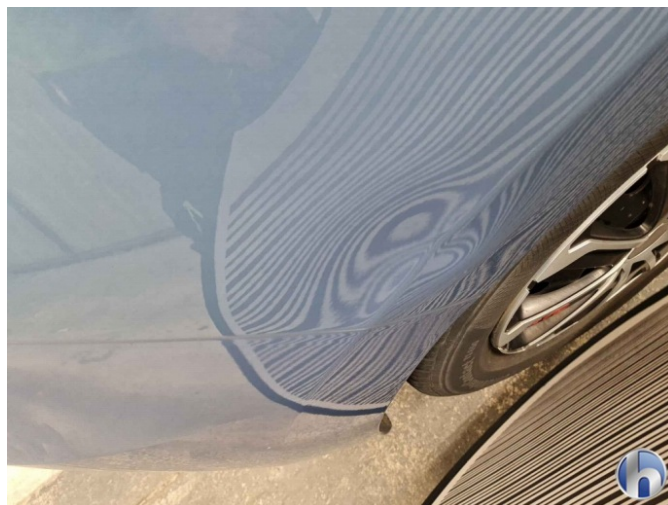
| component | Damage | Rep kind |
|---|---|---|
| 15. Sidewall - Rear - right | Damaged | Refurbish and paint |

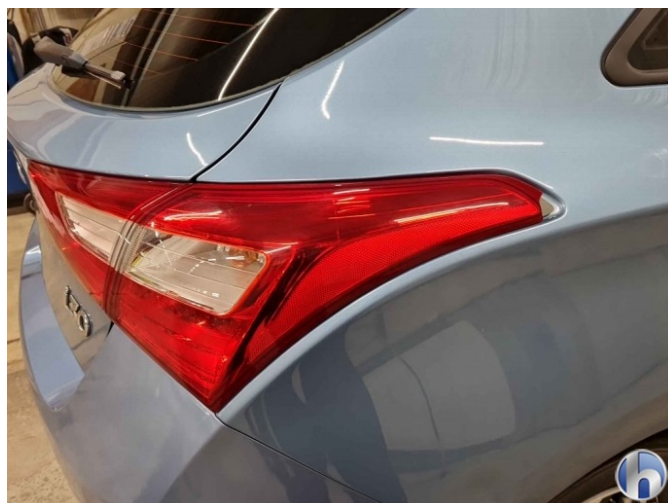
| component | Damage | Rep kind |
|---|---|---|
| 16. Taillight right | Damaged | Replace |

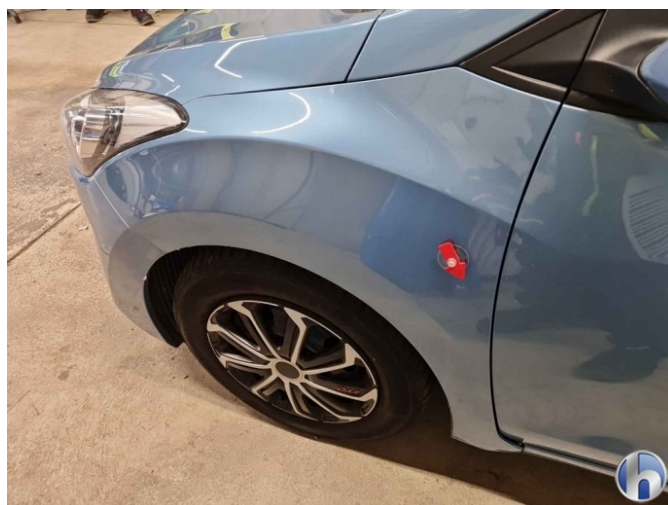
| component | Damage | Rep kind |
|---|---|---|
| 17. Front fender - left | Damaged | Refurbish and paint |

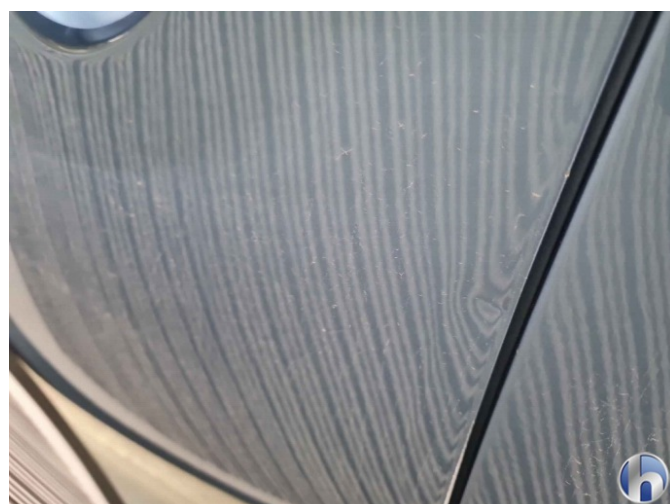
| component | Damage | Rep kind |
|---|---|---|
| 19. Front door - left | Damaged | Refurbish and paint |

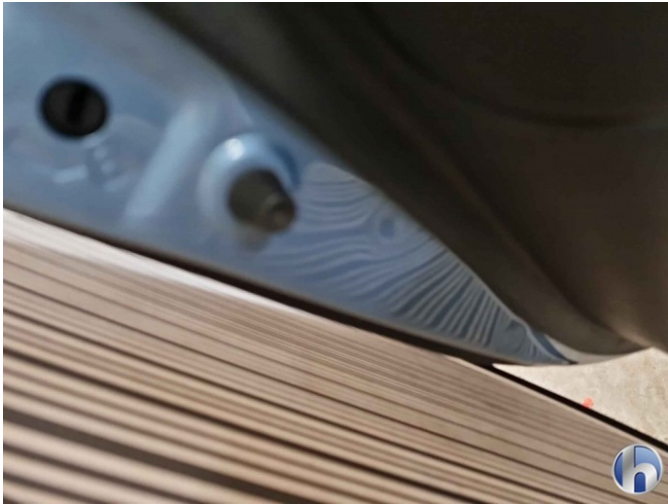
| component | Damage | Rep kind |
|---|---|---|
| 20. Rear door - left | Damaged | Refurbish and paint |

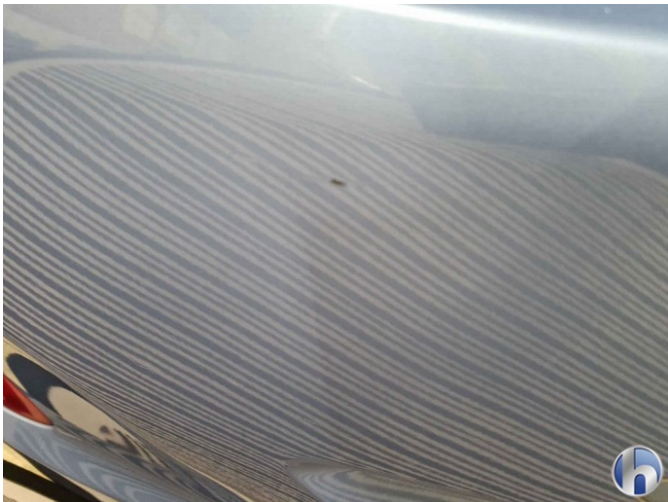
| component | Damage | Rep kind |
|---|---|---|
| 23. Rear bumper | Damaged | Refurbish and paint |

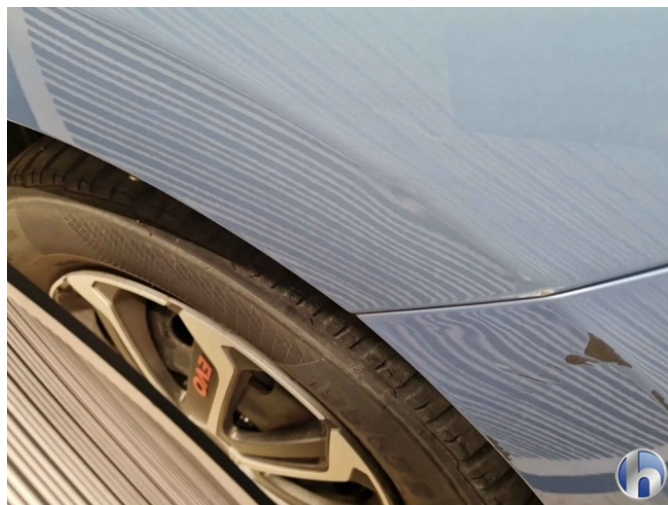
At the unrepaired vehicle accident damage were observed on visual examination on the body skin .

| component | Damage | Rep kind |
|---|---|---|
| 25. Fahrzeug vorn | Accident damage | Replace |

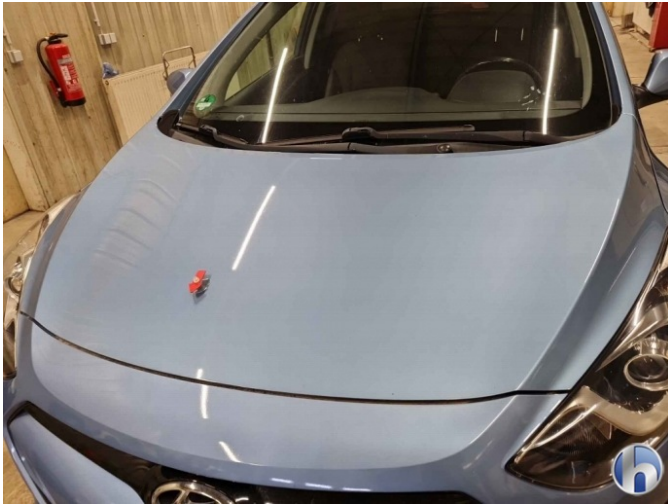
| component | Damage | Rep kind |
|---|---|---|
| 26. hood | Rust | Paint |

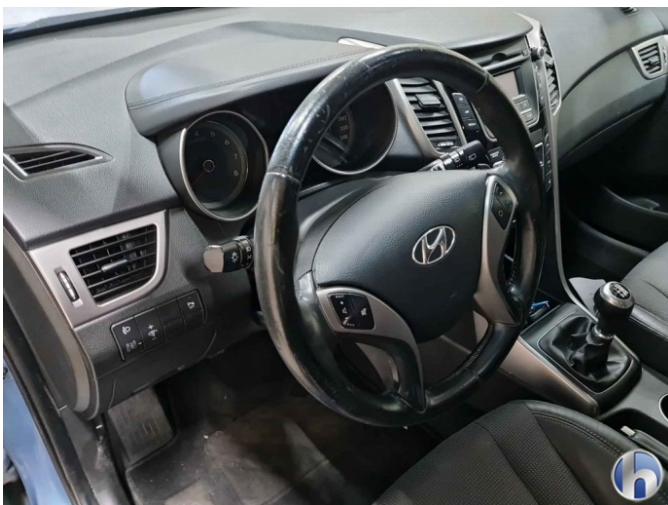
| component | Damage | Rep kind |
|---|---|---|
| 28. steering wheel | Material wear | Replace |

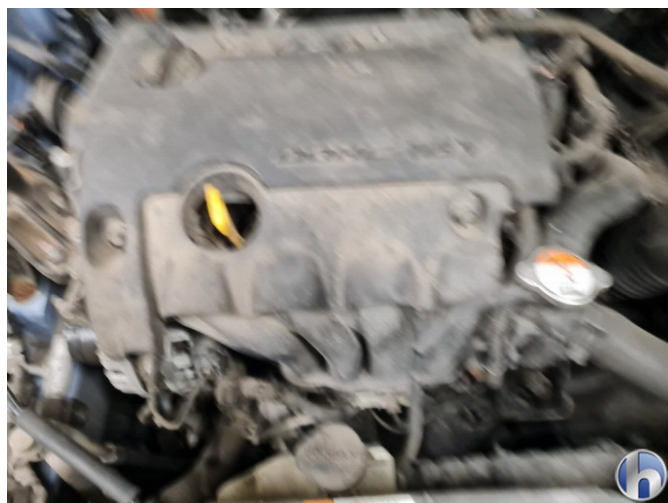
| component | Damage | Rep kind |
|---|---|---|
| 30. Kühlwasserschlauch | Damaged | Replace |
