## status report

**customer:** Bank 11, Neuss  
**contract number:** 84559031-INSO  
**reference:**

#### Hyundai I30

| Vehicle identification number | <b>TMAH2811ALJ065677</b> | mileage read: | <b>46195 km</b> |

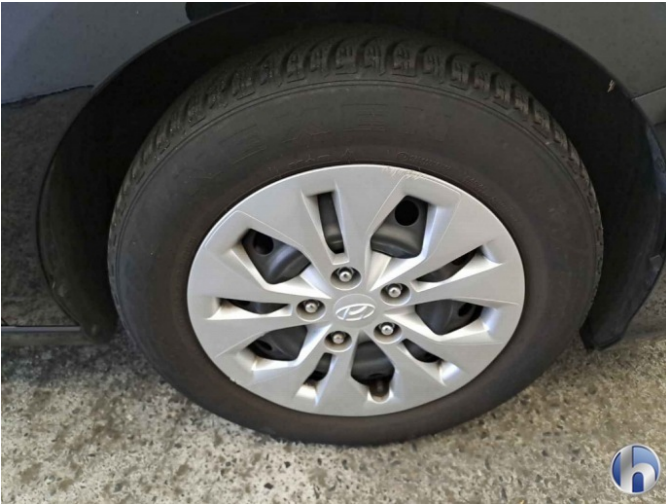
| component | Damage | Rep kind |
|---|---|---|
| 1. Radkappe - Vorne - Rechts | Scrape | Replace |

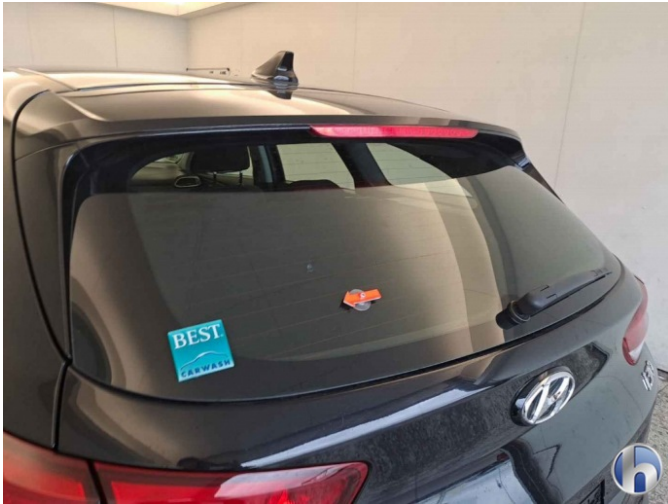
| component | Damage | Rep kind |
|---|---|---|
| 6. rear window | Scratch(es) | Replace |

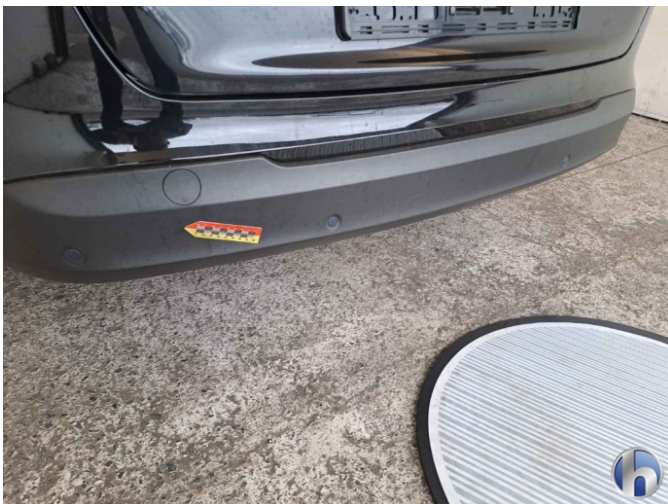
| component | Damage | Rep kind |
|---|---|---|
| 8. Diffusor | Scratch(es) | Replace |

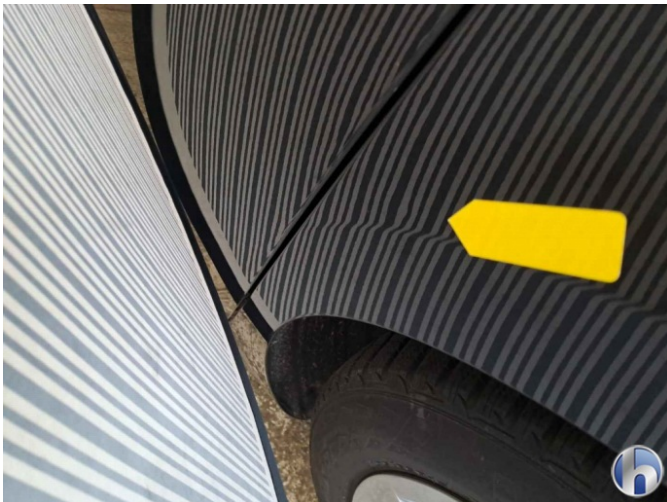
| component | Damage | Rep kind |
|---|---|---|
| 9. Sidewall - Rear - Left | Damaged | Refurbish and paint |

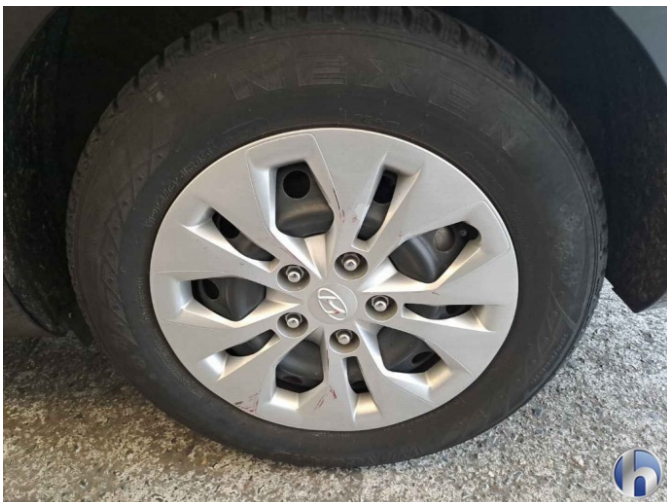
| component | Damage | Rep kind |
|---|---|---|
| 10. Radkappe - Hinten - Links | Damaged | Replace |

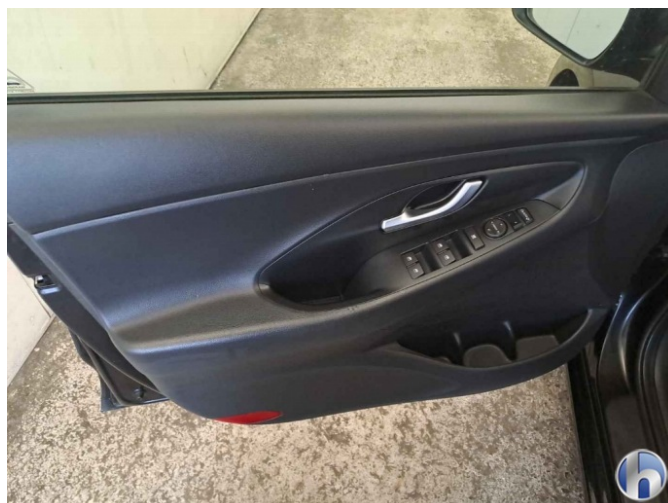
| component | Damage | Rep kind |
|---|---|---|
| 14. Front door trim - left | Damaged | Replace |

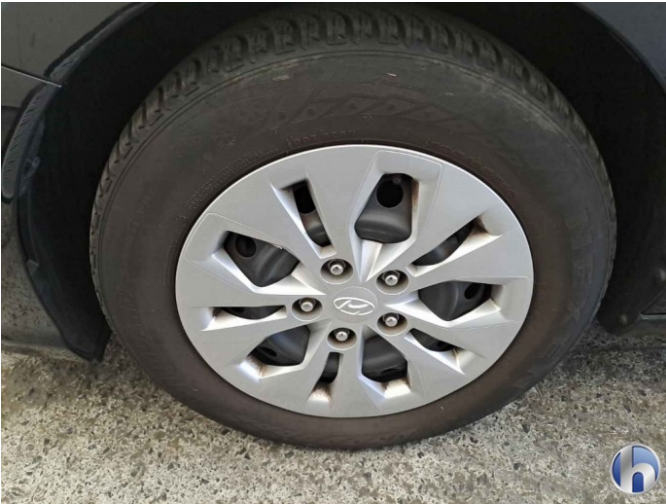
| component | Damage | Rep kind |
|---|---|---|
| 18. Radkappe - Vorne - Links | chipped paint | Replace |

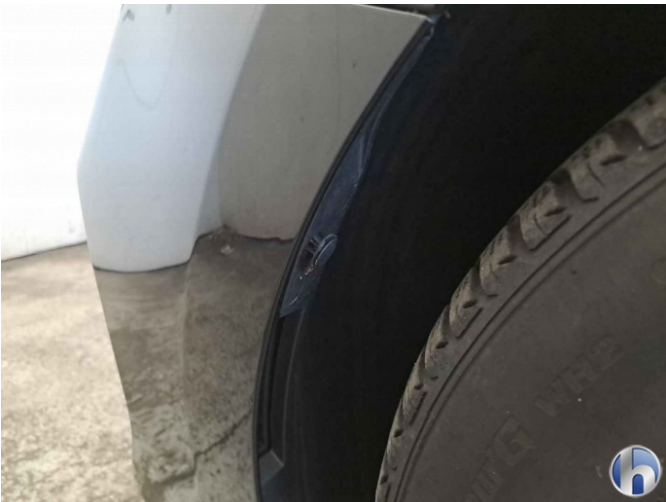
| component | Damage | Rep kind |
|---|---|---|
| 19. Front left wheel housing liner | Not okay | Replace |

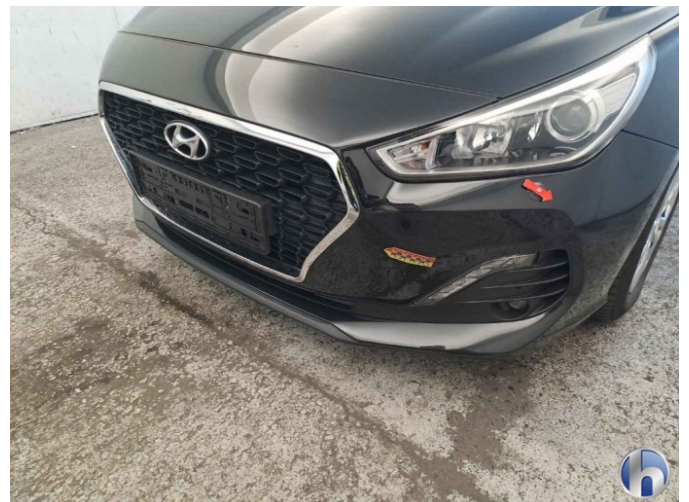
| component | Damage | Rep kind |
|---|---|---|
| 21. Front bumper | Damaged | Replace |

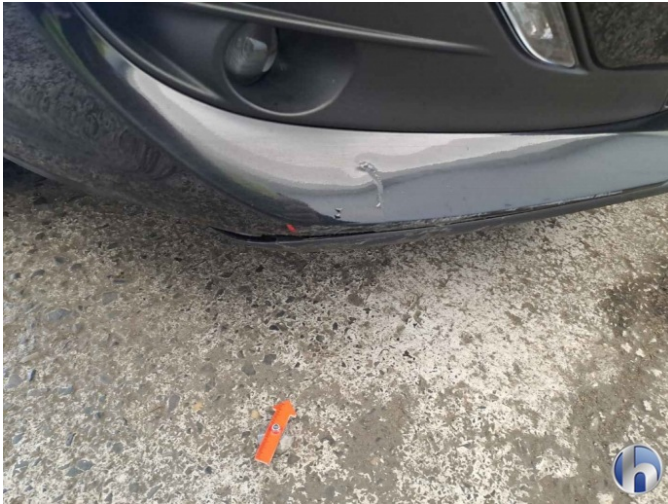
| component | Damage | Rep kind |
|---|---|---|
| 22. spoiler | Damaged | Replace |

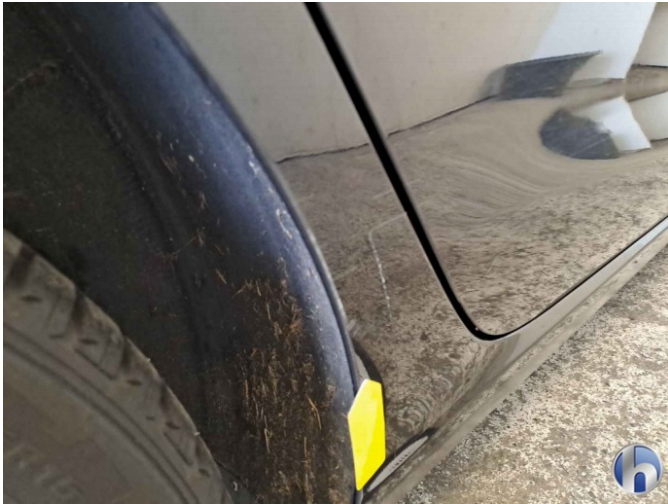
| component | Damage | Rep kind |
|---|---|---|
| 27. Sidewall - Rear - right | Damaged | Refurbish and paint |

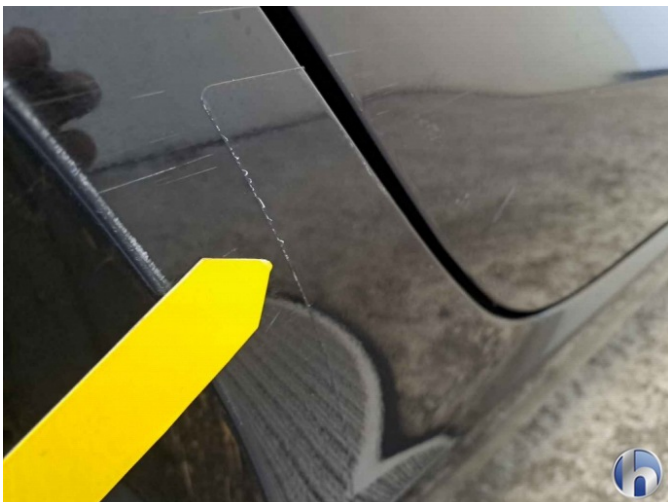
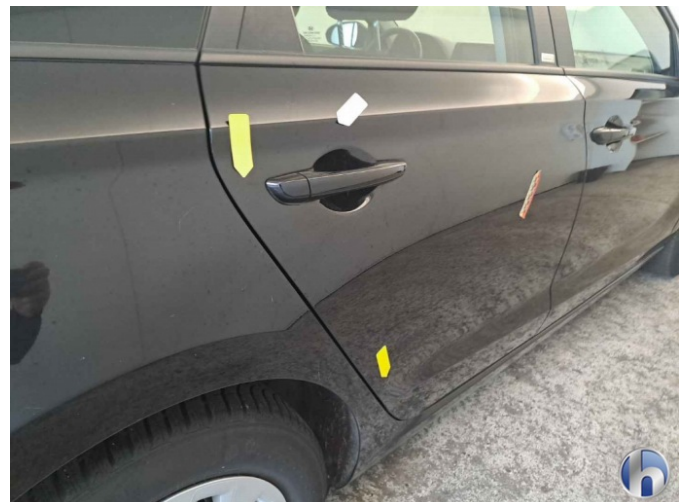
| component | Damage | Rep kind |
|---|---|---|
| 28. | Scrape | Replace |

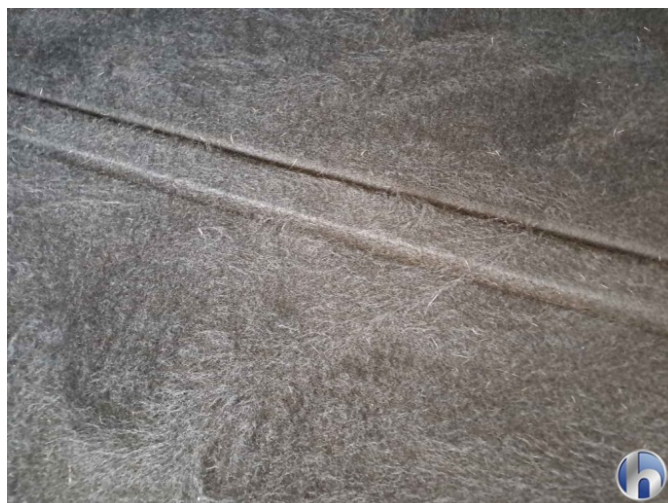
| component | Damage | Rep kind |
|---|---|---|
| 32. headlining | Damaged | Replace |

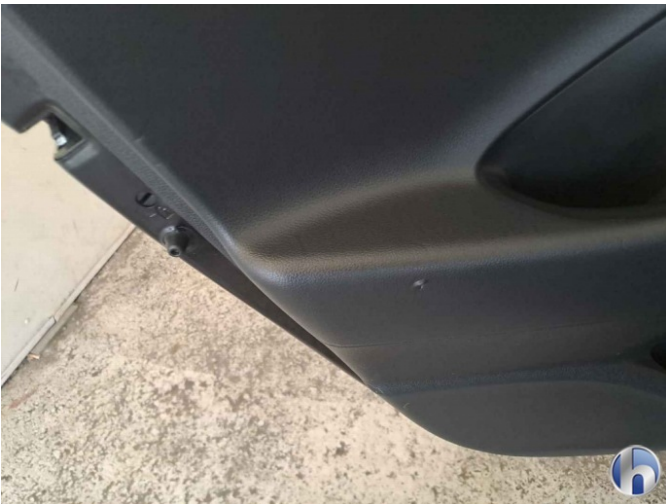
| component | Damage | Rep kind |
|---|---|---|
| 34. Rear door trim - left | Damaged | Replace |
