## status report

| <b>customer:</b> | <b>Bank 11, Neuss</b> |

| vehicle data | | | |
|---|---|---|---|
| <b>Hyundai i30 N Performance</b> | | | |
| Vehicle identification number | <b>TMAHC51AALJ018670</b> | mileage read: | <b>120005 km</b> |

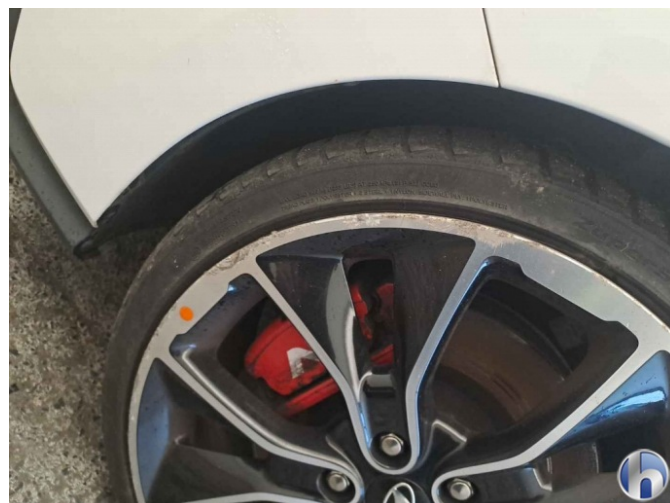
| component | Damage | Rep kind |
|---|---|---|
| 3. Rim front - left | Scratch(es) | Replace |

3. Rim front - left

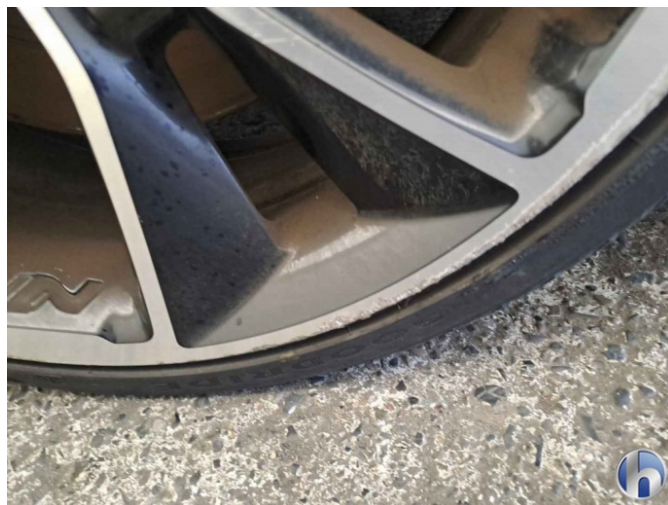
| component | Damage | Rep kind |
|---|---|---|
| 4. tire front - left | Damaged | Replace |

4. tire front - left

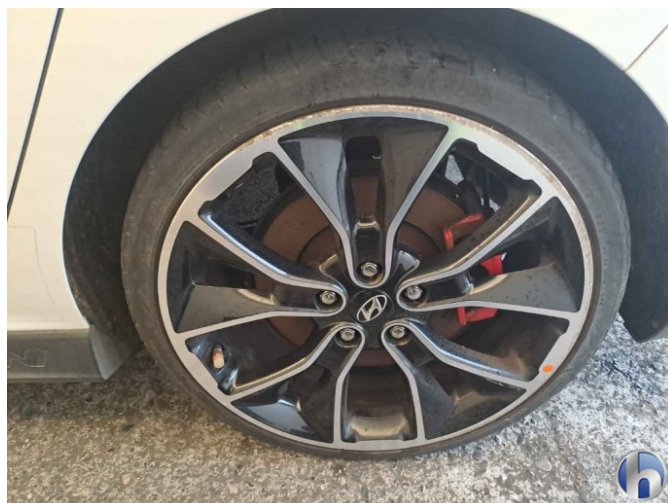
| component | Damage | Rep kind |
|---|---|---|
| 6. Rim rear - left | Scratch(es) | Replace |

6. Rim rear - left

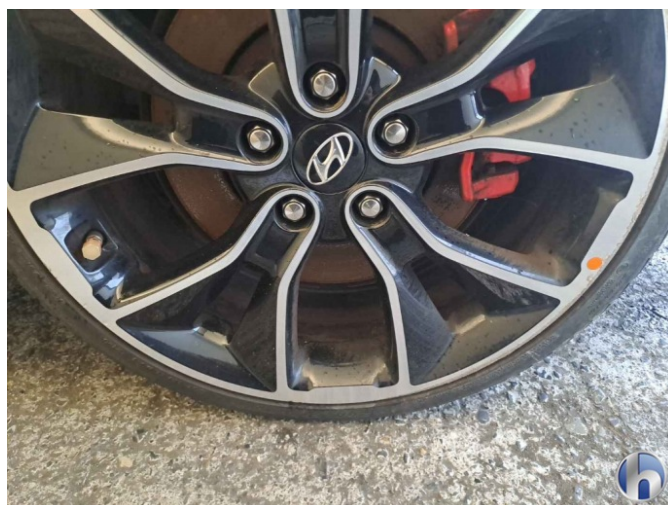
6. Rim rear - left

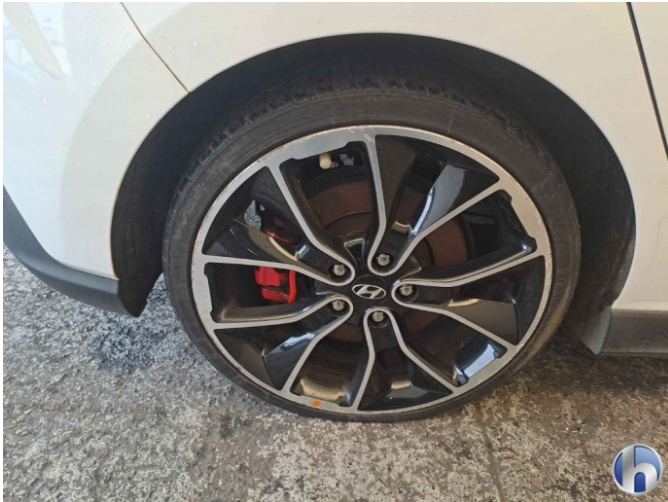
| component | Damage | Rep kind |
|---|---|---|
| 7. Rim rear - right | Scratch(es) | Replace |

7. Rim rear - right

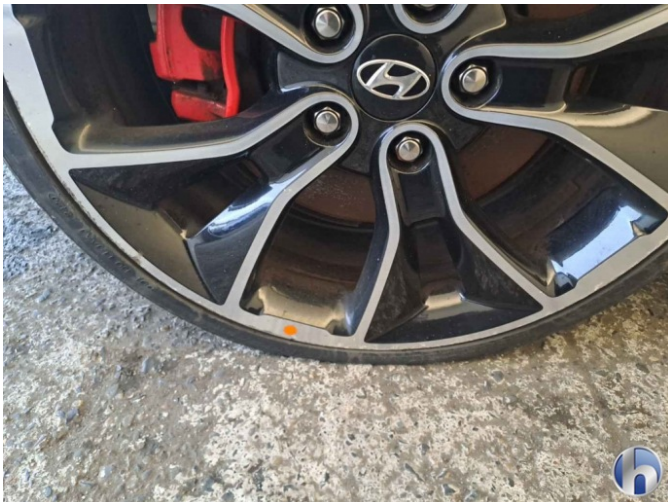
7. Rim rear - right

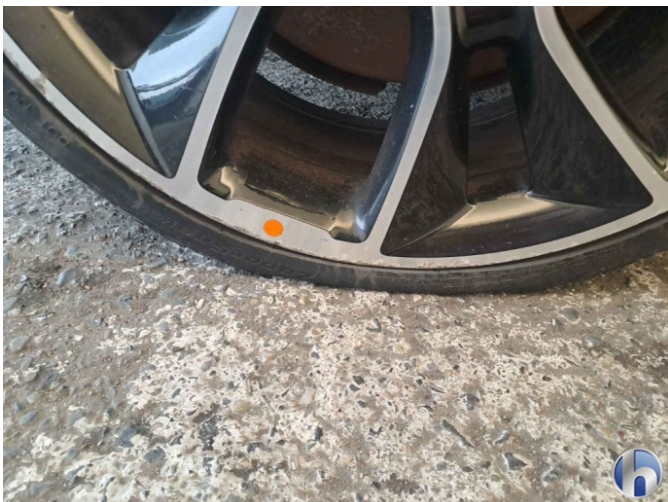
| component | Damage | Rep kind |
|---|---|---|
| 8. tire rear - right | Damaged | Replace |

8. tire rear - right

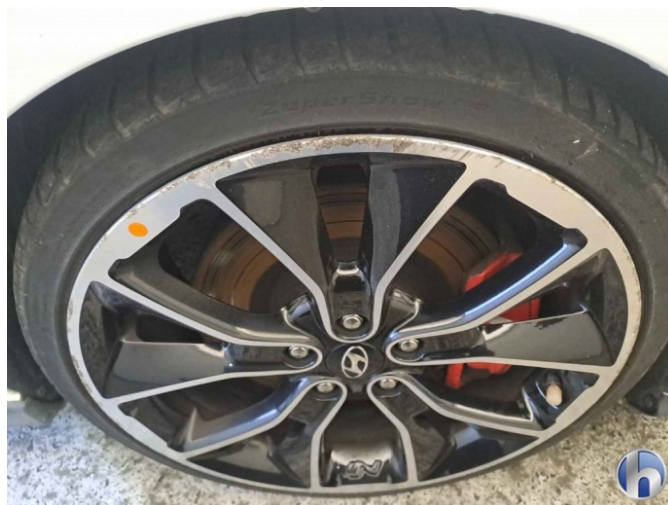
| component | Damage | Rep kind |
|---|---|---|
| 9. Rim front - right | Scratch(es) | Replace |

9. Rim front - right

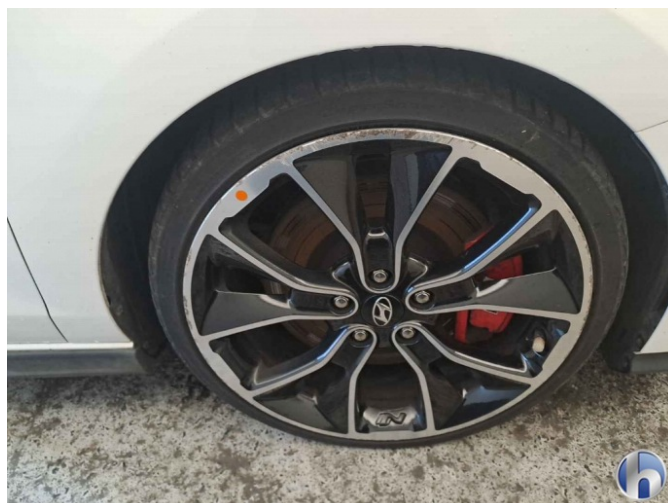
| component | Damage | Rep kind |
|---|---|---|
| 10. tire front - right | Worn | Replace |

10. tire front - right

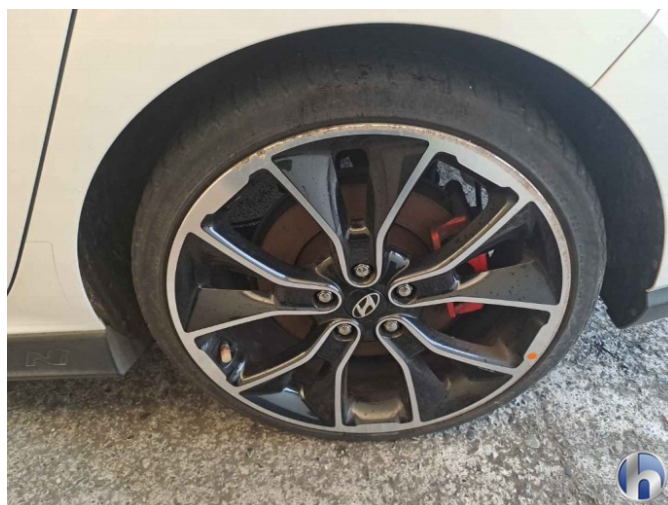
| component | Damage | Rep kind |
|---|---|---|
| 11. tire rear - left | Damaged | Replace |

11. tire rear - left

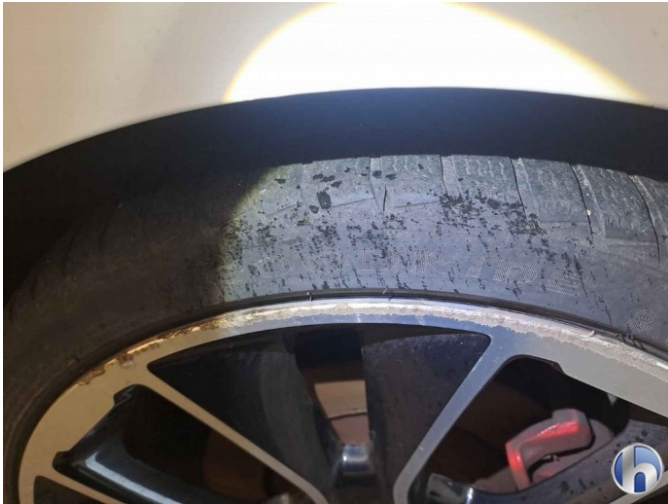
11. tire rear - left

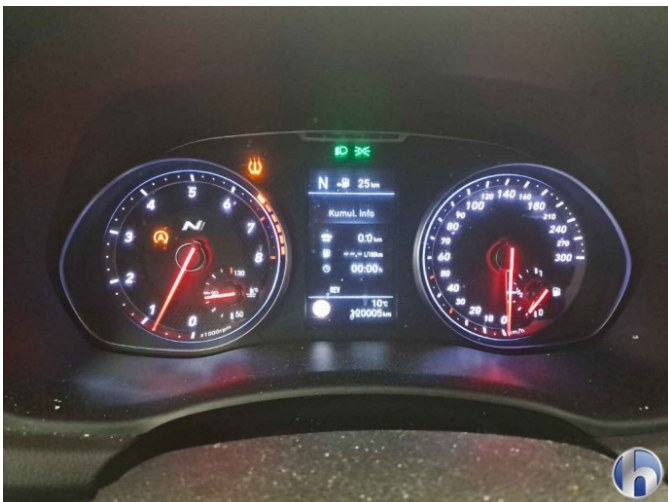
17. warning light

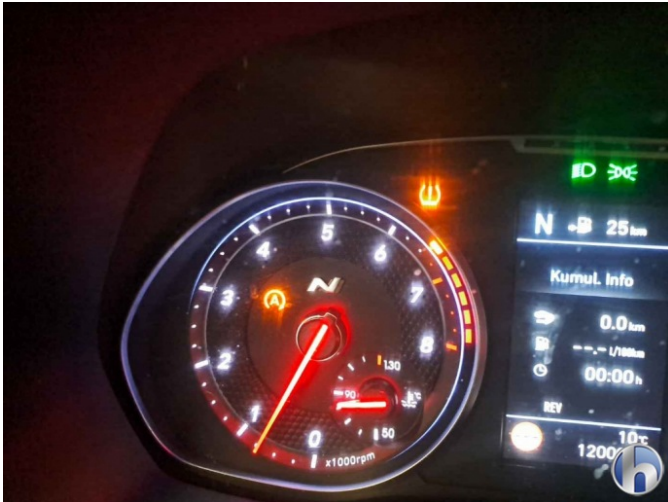
18. warning light

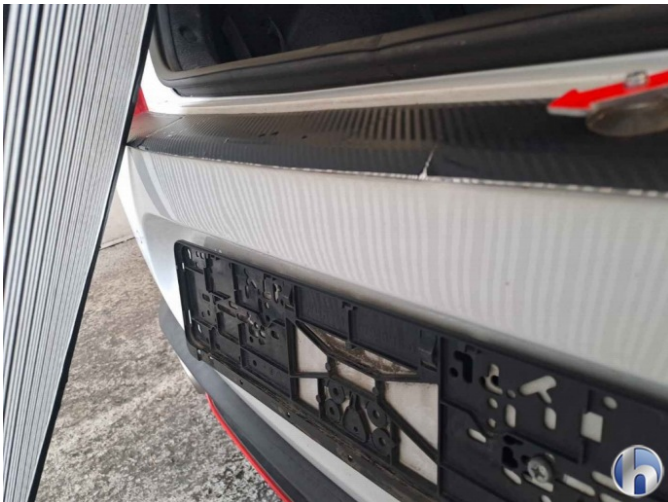
| component | Damage | Rep kind |
|---|---|---|
| 19. Rear bumper | Damaged | Replace |

19. Rear bumper

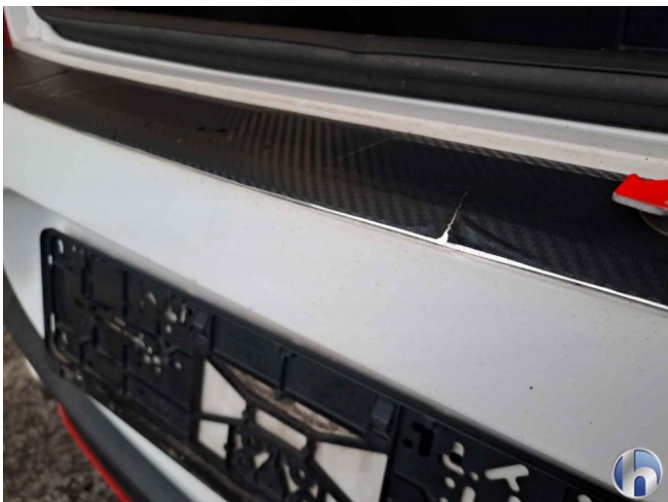
| component | Damage | Rep kind |
|---|---|---|
| 20. Laderaum Kantenschutz | Damaged | Replace |

20. Laderaum Kantenschutz

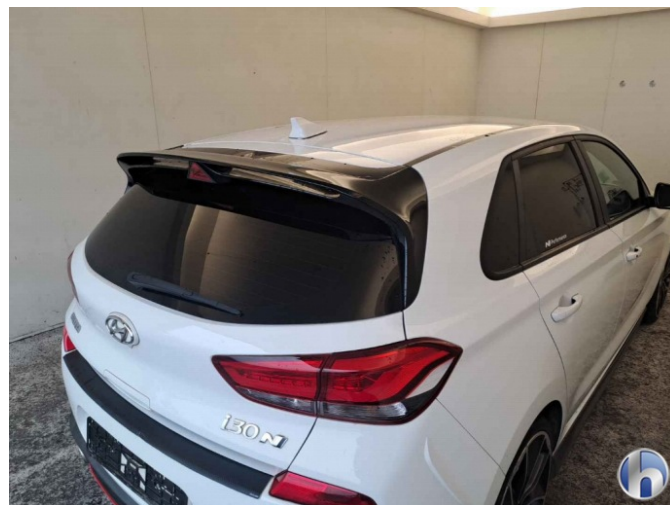
22. Scheiben

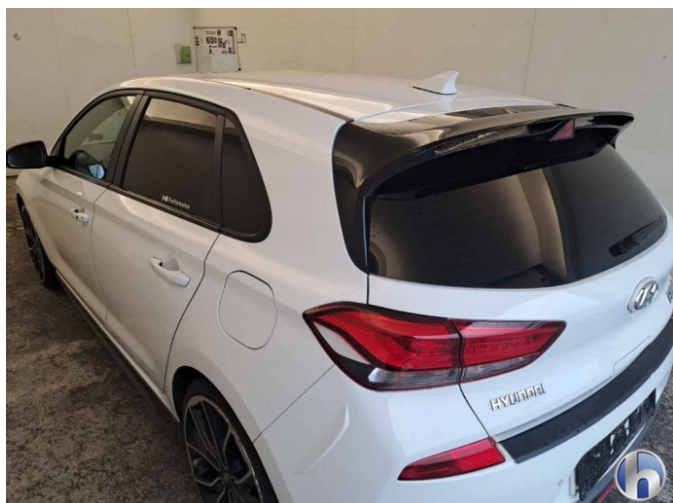
22. Scheiben

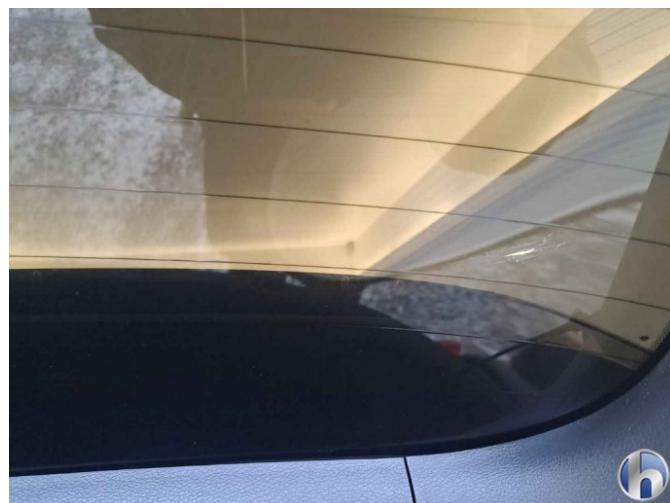
22. Scheiben

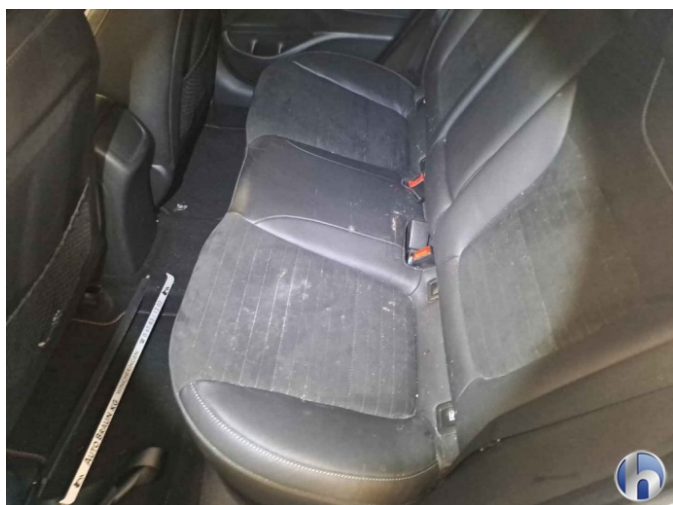
| component | Damage | Rep kind |
|---|---|---|
| 23. | Burn hole | Replace |

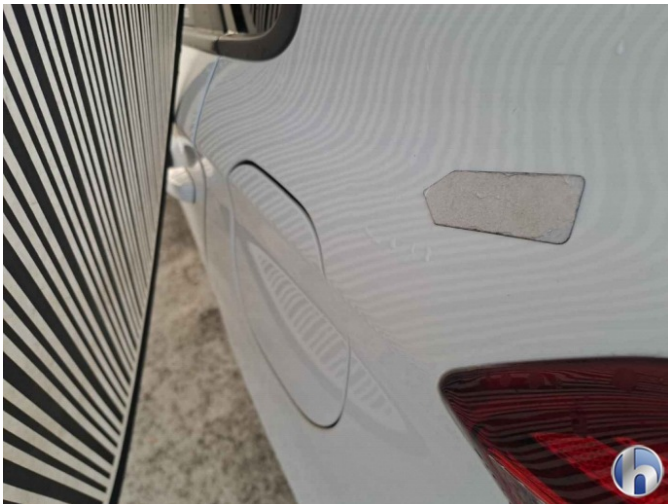
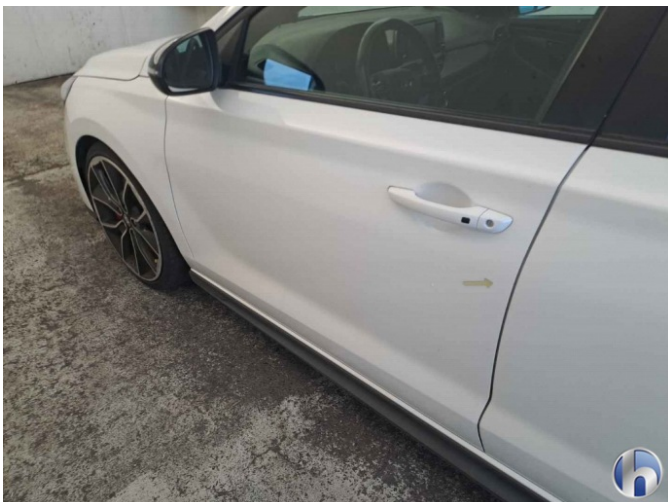
| component | Damage | Rep kind |
|---|---|---|
| 25. Sidewall - Rear - Left | Damaged | Refurbish and paint |

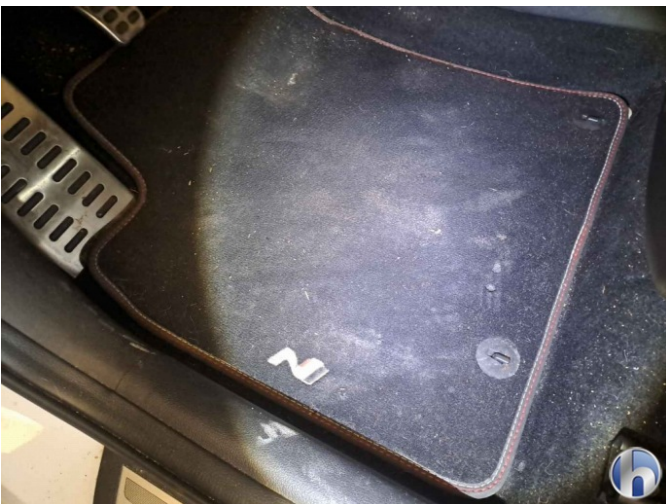
| component | Damage | Rep kind |
|---|---|---|
| 29. flooring | Burn hole | Replace |

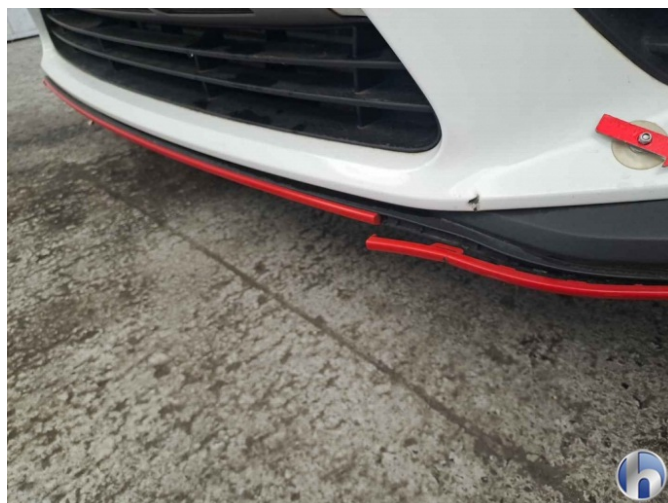
| component | Damage | Rep kind |
|---|---|---|
| 35. spoiler | Damaged | Replace |

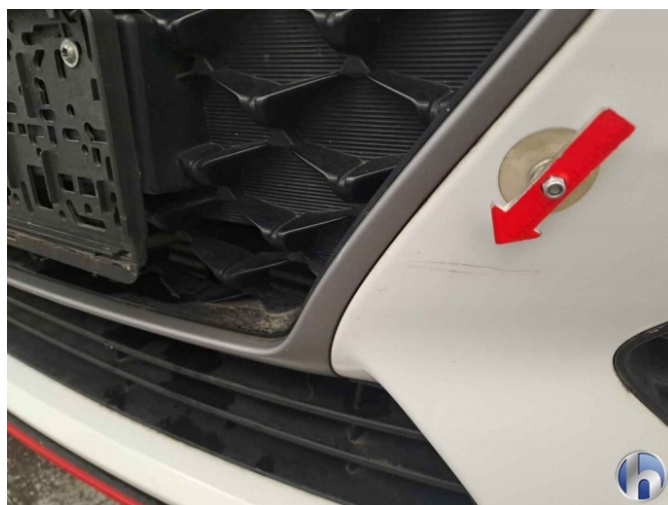
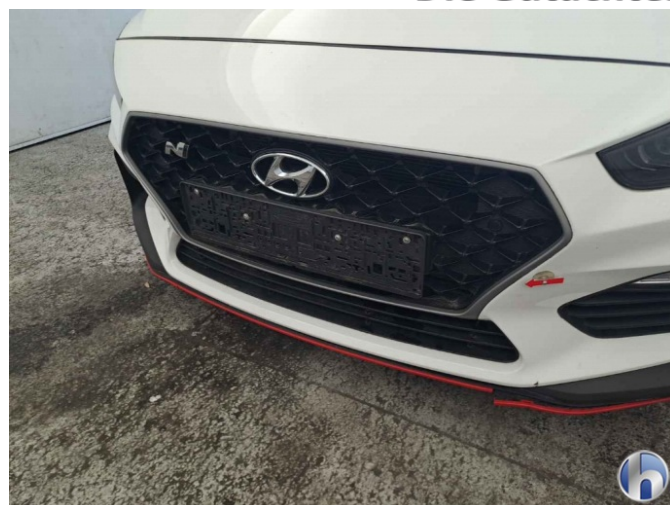
| component | Damage | Rep kind |
|---|---|---|
| 36. Front bumper | Damaged | Replace |

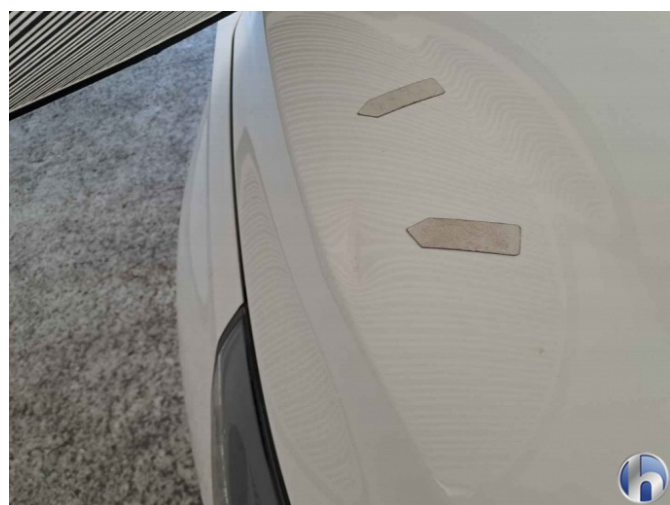
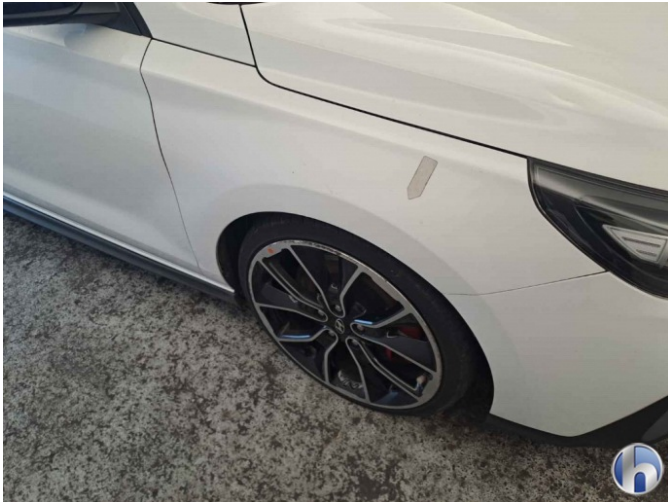
| component | Damage | Rep kind |
|---|---|---|
| 38. hood | Damaged | Refurbish and paint |

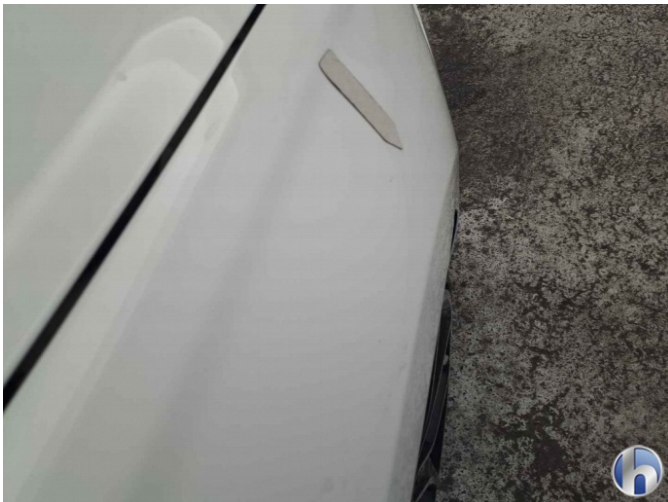
| component | Damage | Rep kind |
|---|---|---|
| 39. Front fender - right | Execution defect | Replace |

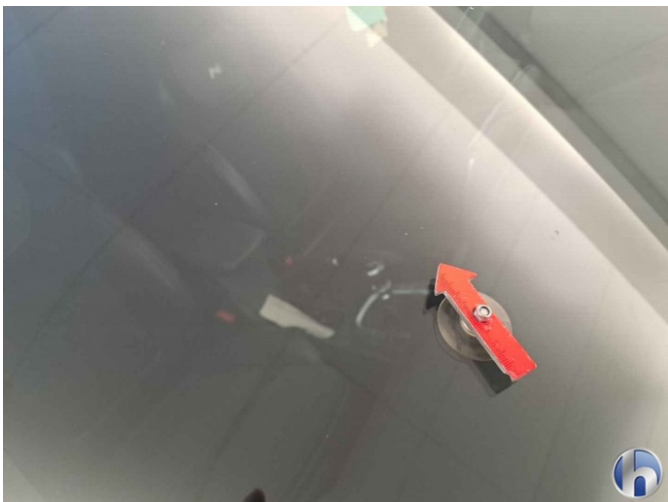
40. Windshield

| 40. | Windshield | Chipping from stones in field of view | Replace |

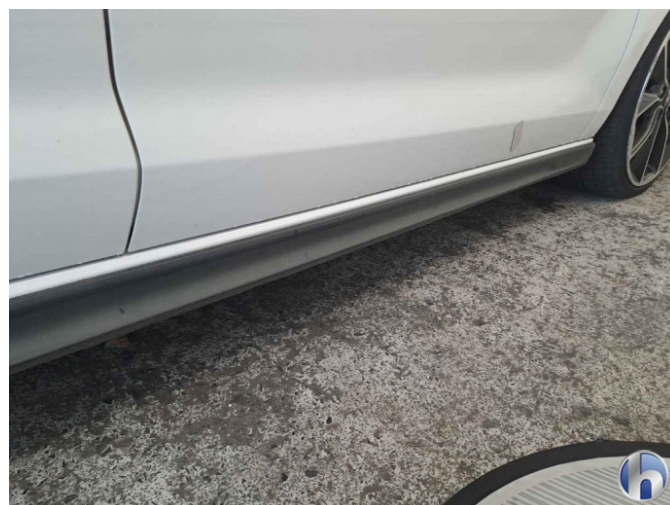
43. side skirt - right

| 43. | side skirt - right | Damaged | Refurbish and paint |

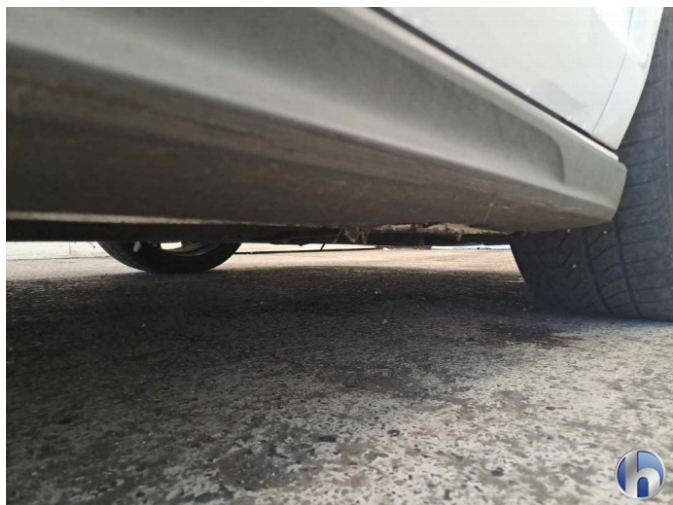
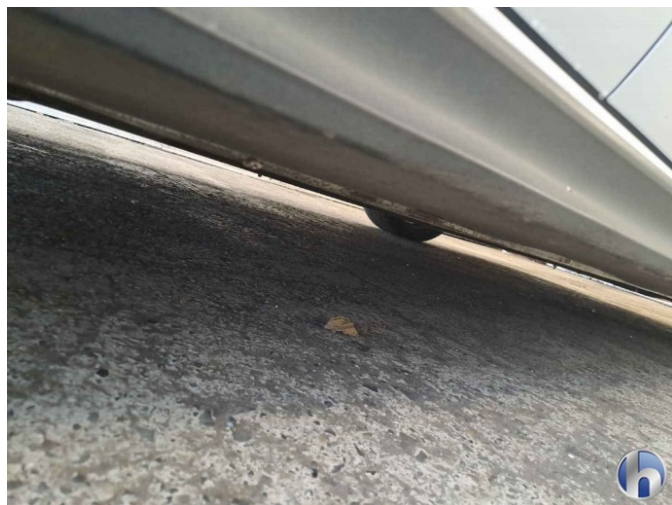
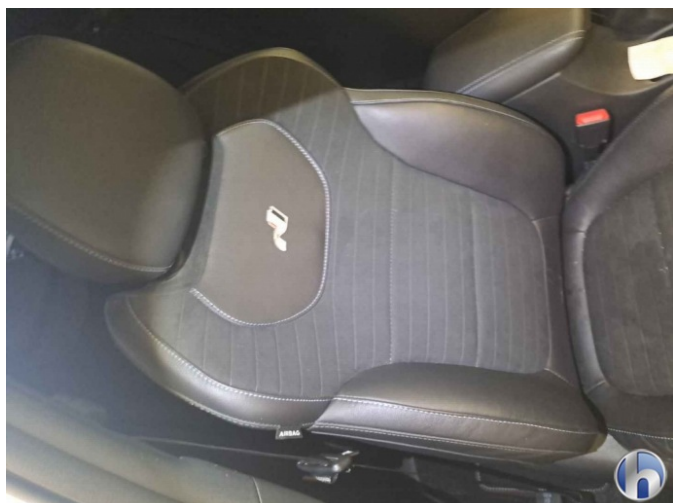
| 44. | | Damaged | Replace |

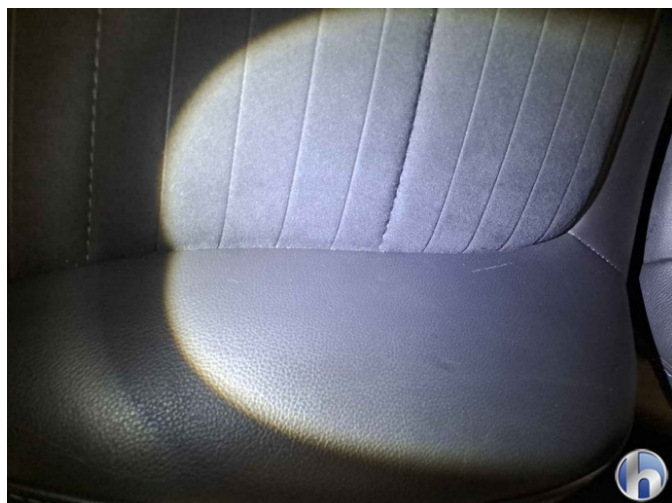
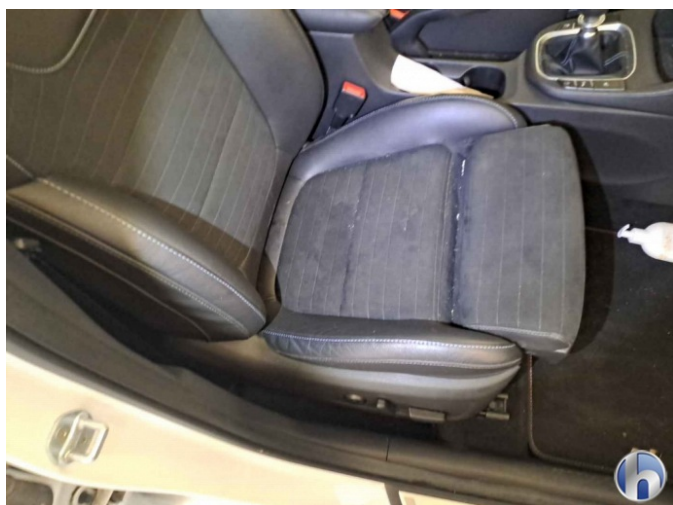
| 45. | | Scratch(es) | Replace |

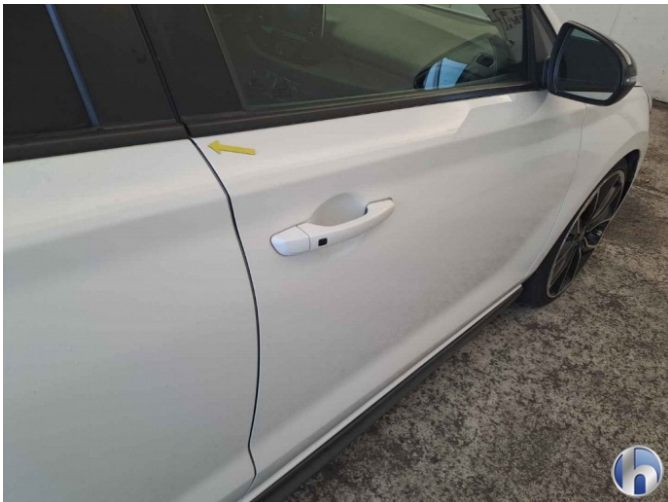
47. Sidewall - Rear - right

| 47. | Sidewall - Rear - right | Wear and tear | acceptable |

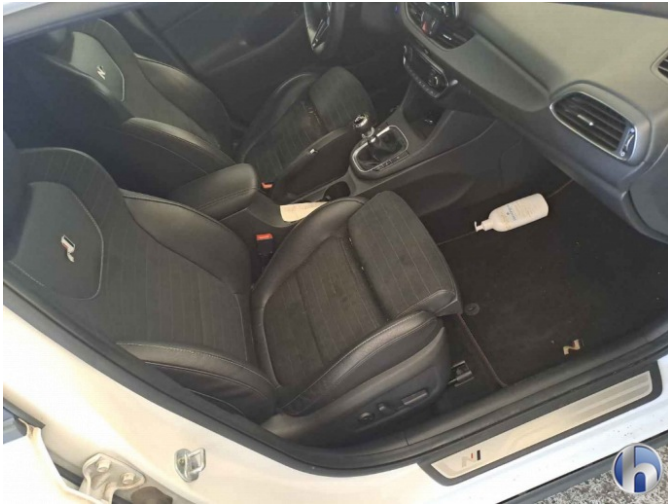
49. Sitz - Vorne - Rechts: Lehne (Verkleidung)

| 49. | Sitz - Vorne - Rechts: Lehne (Verkleidung) | Damaged | Replace |

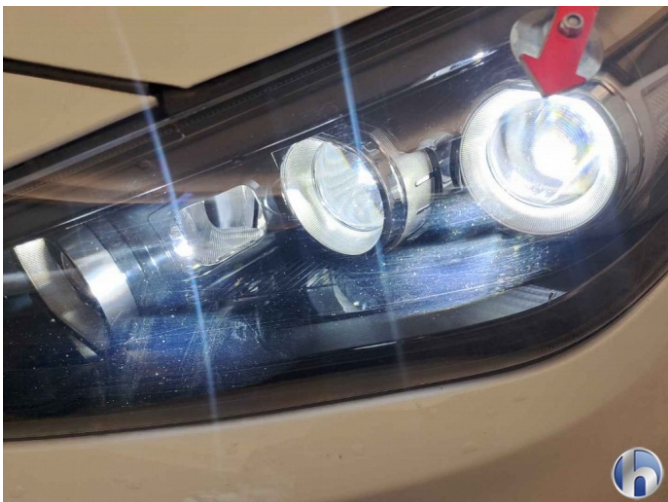
| 51. | | Scratch(es) | Replace |

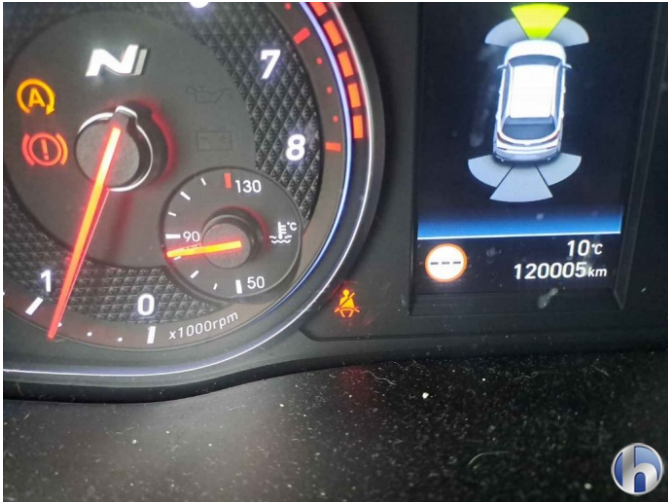
52. instrument cluster

| 52. | instrument cluster | Scratch(es) | Replace |
