## status report

#### Skoda Rapid Ambition

| Vehicle identification number | <b>TMBAN6NH5F4020723</b> | mileage read: | <b>95093 km</b> |

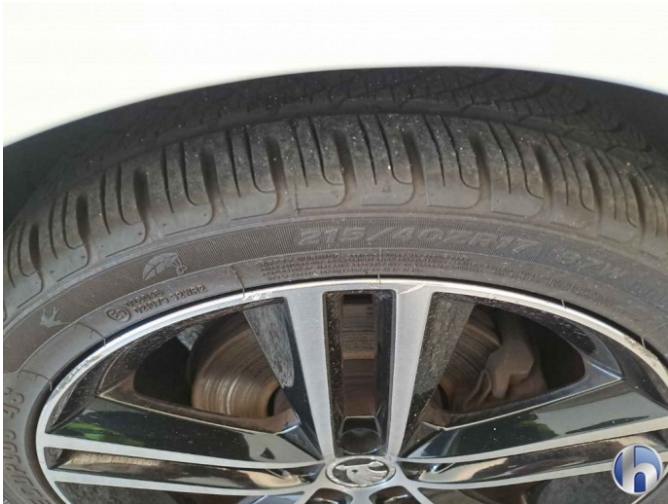
| component | Damage | Rep kind |
|---|---|---|
| 1. tire front - right | Worn | Replace |

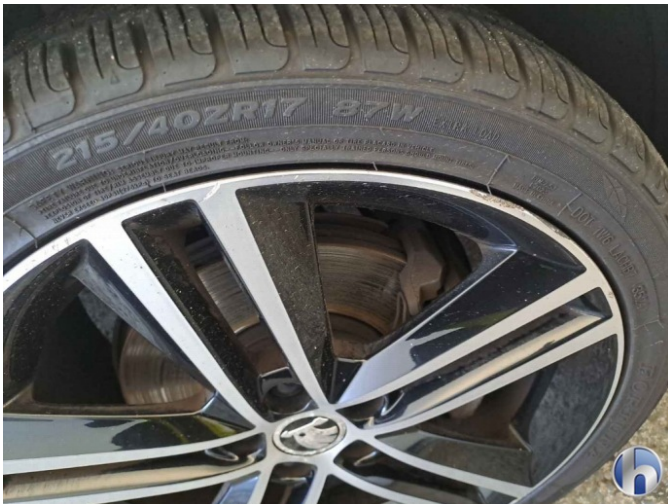
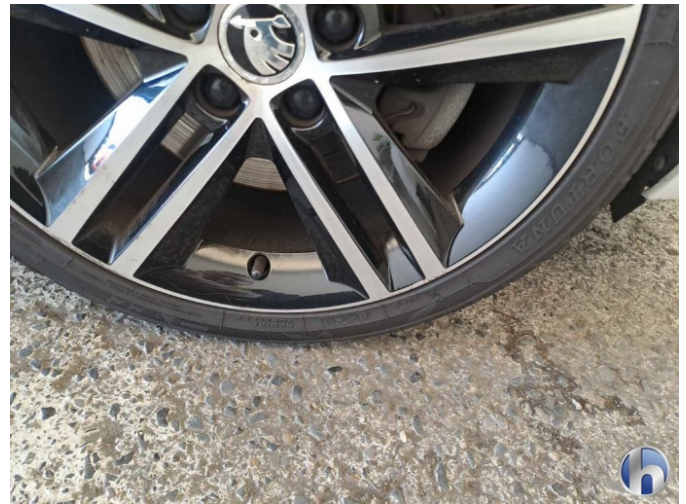
| component | Damage | Rep kind |
|---|---|---|
| 2. | Damaged | Replace |

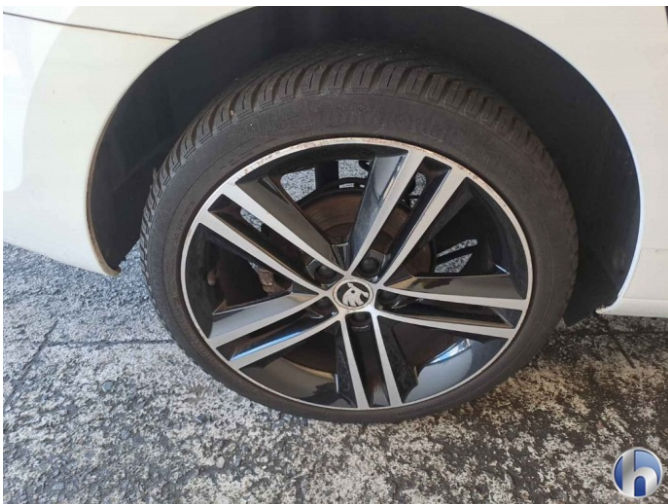
| component | Damage | Rep kind |
|---|---|---|
| 3. tire rear - right | Damaged | Replace |

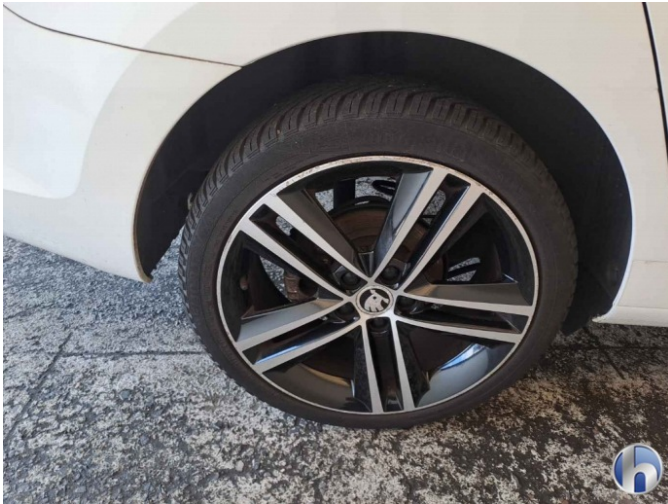
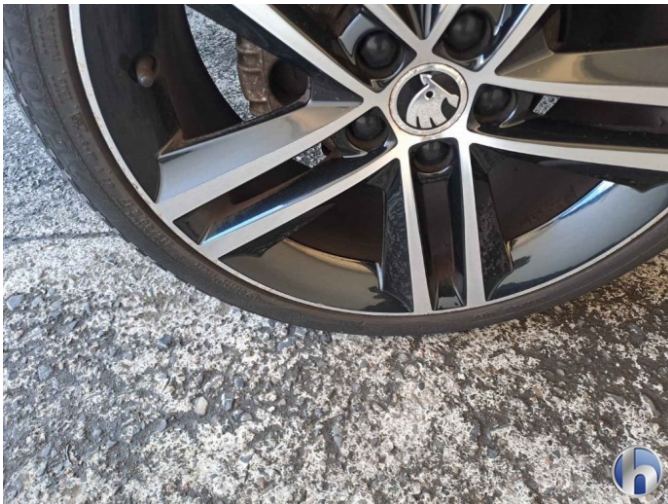
| component | Damage | Rep kind |
|---|---|---|
| 4. | Scratch(es) | Replace |

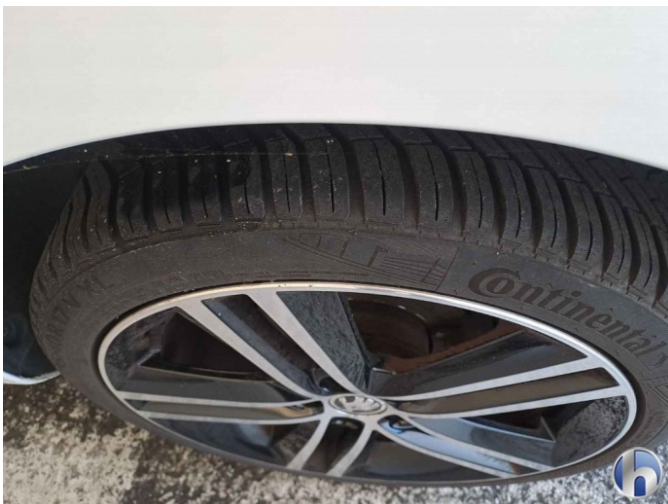
| component | Damage | Rep kind |
|---|---|---|
| 5. tire rear - left | Worn | Replace |

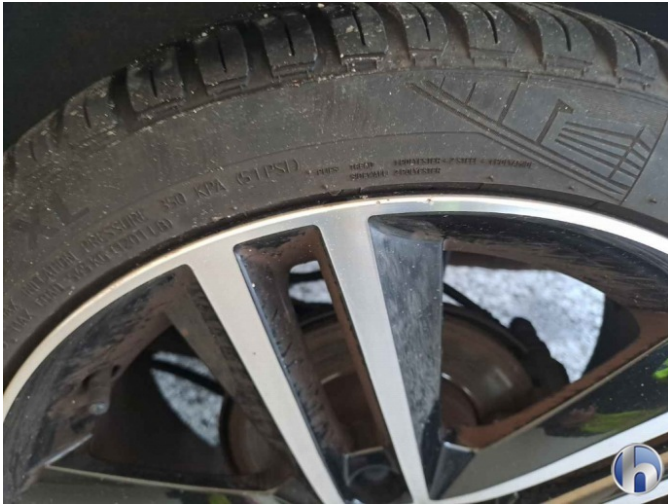
| component | Damage | Rep kind |
|---|---|---|
| 6. | Scratch(es) | Replace |

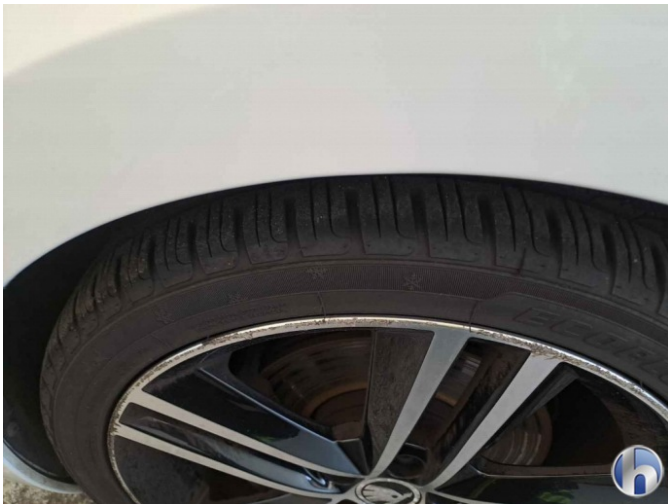
| component | Damage | Rep kind |
|---|---|---|
| 7. tire front - left | Worn | Replace |

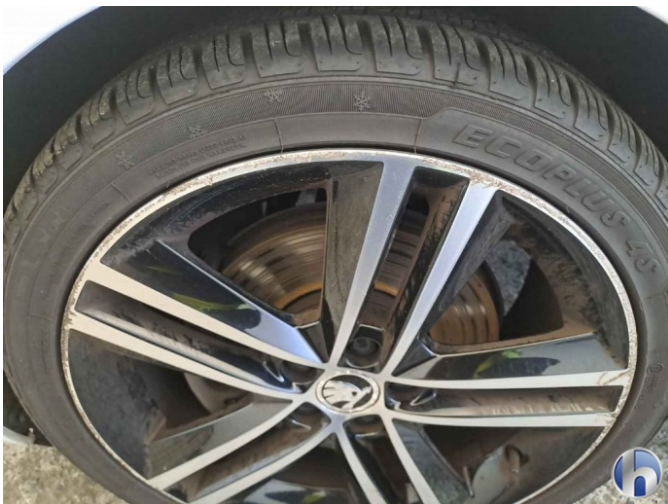
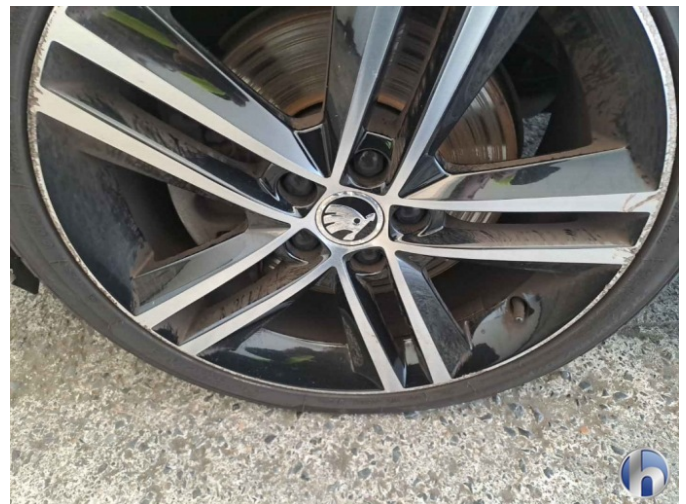
| component | Damage | Rep kind |
|---|---|---|
| 8. | Scratch(es) | Replace |

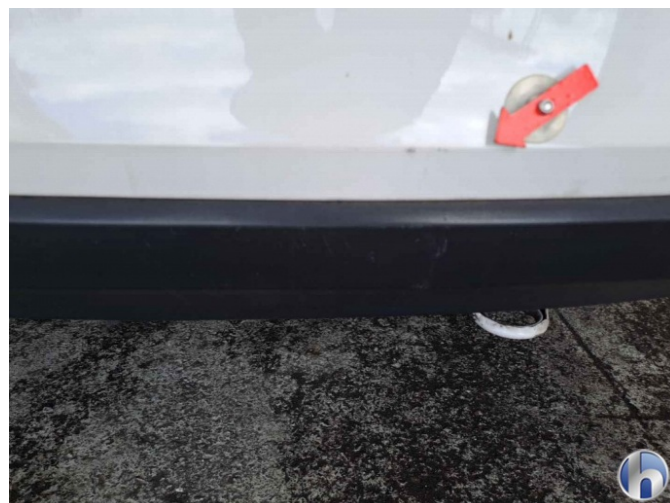
| component | Damage | Rep kind |
|---|---|---|
| 15. Diffusor | Scrape | Replace |

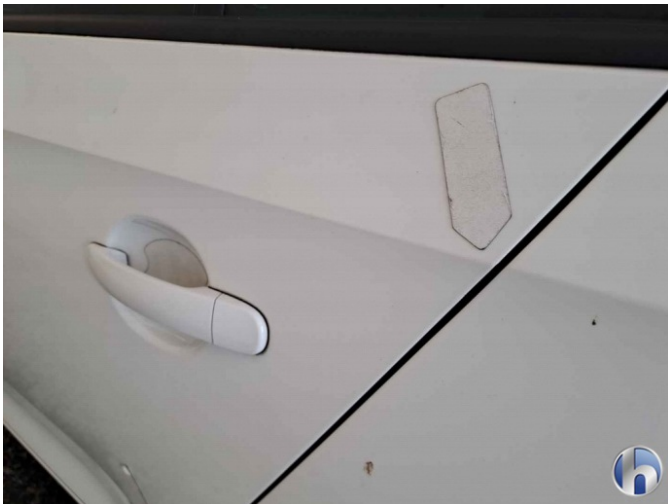
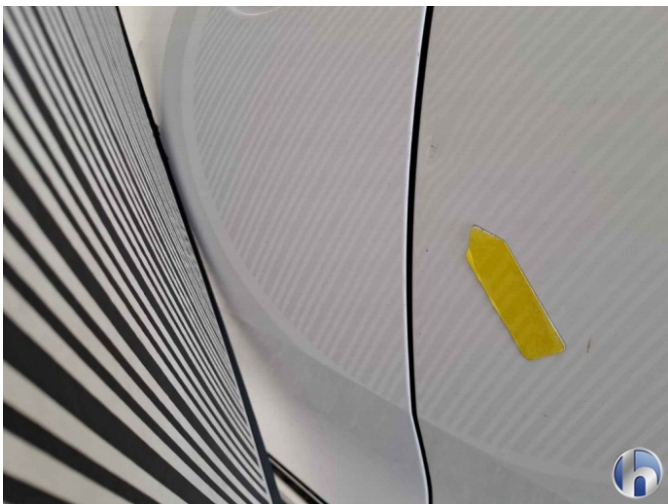
| component | Damage | Rep kind |
|---|---|---|
| 17. Rear door - left | Damaged | Refurbish and paint |

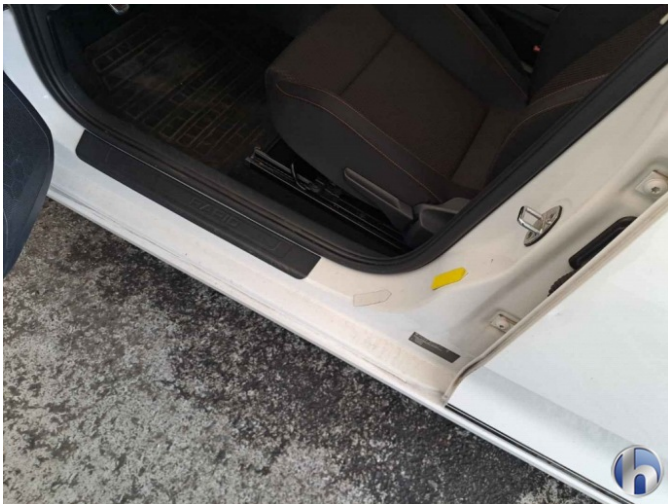
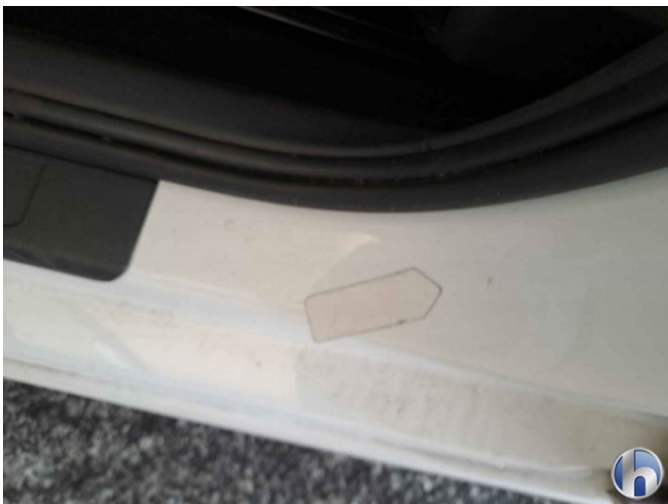
| component | Damage | Rep kind |
|---|---|---|
| 19. Türeinstieg Vorne - Links | Damaged | Refurbish and paint |

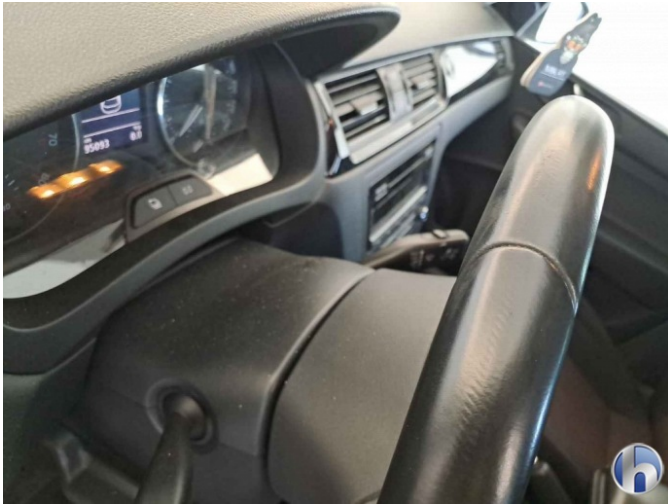
| component | Damage | Rep kind |
|---|---|---|
| 20. Steering wheel (leather) | Scratch(es) | Replace |

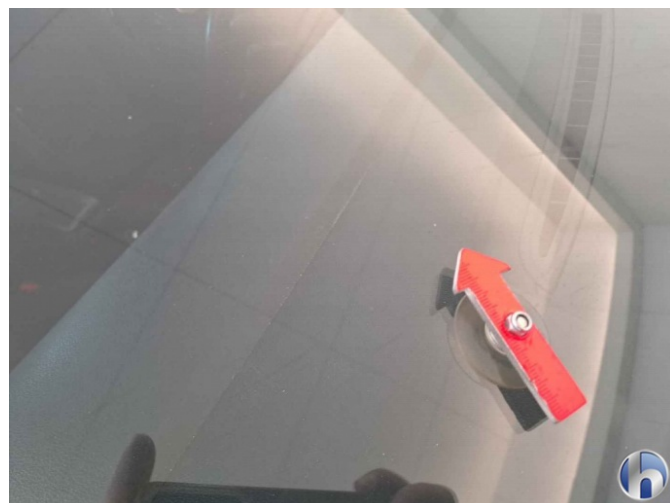
| component | Damage | Rep kind |
|---|---|---|
| 23. Windshield | Chipping from stones in field of view | Replace |

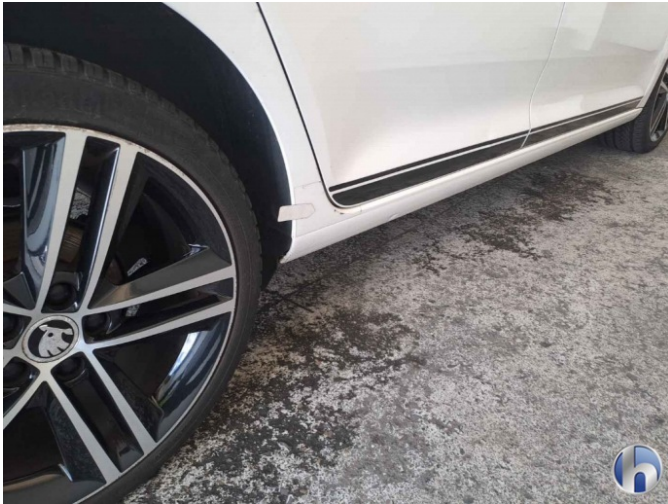
| component | Damage | Rep kind |
|---|---|---|
| 26. Door Rear - right | Damaged | Refurbish and paint |

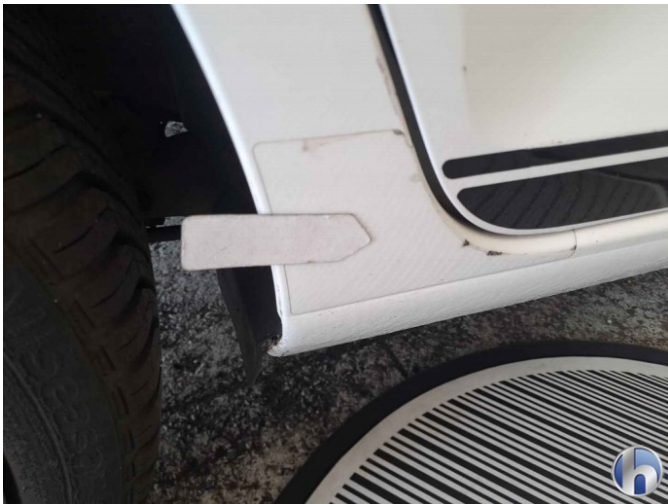
| component | Damage | Rep kind |
|---|---|---|
| 27. side skirt - right | Damaged | Refurbish and paint |

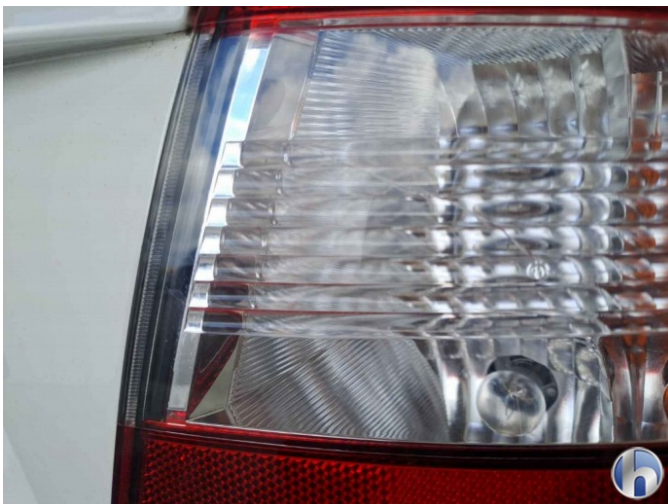
| component | Damage | Rep kind |
|---|---|---|
| 29. Taillight right | Breakage | Replace |

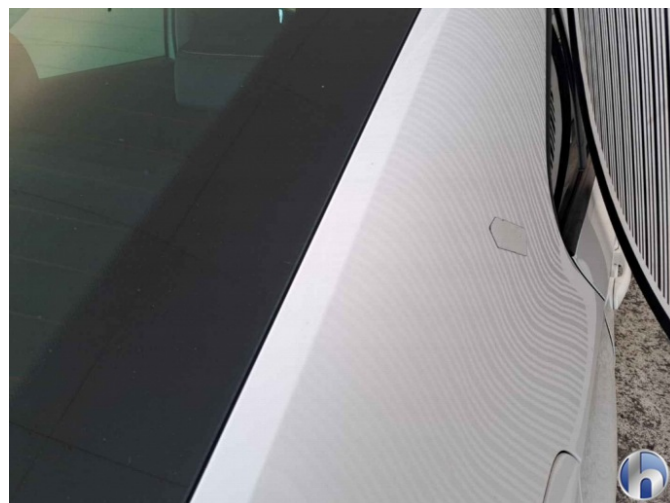
| component | Damage | Rep kind |
|---|---|---|
| 30. Sidewall - Rear - right | Damaged | Refurbish and paint |

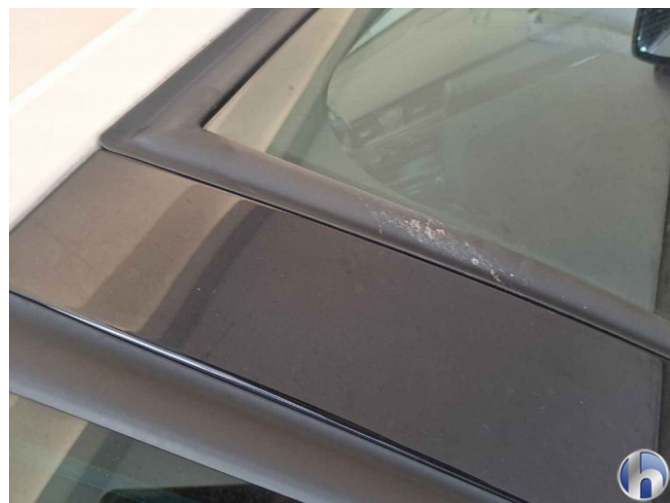
| component | Damage | Rep kind |
|---|---|---|
| 32. Seitenscheibe - Hinten - Rechts Dichtung | Damaged | Replace |

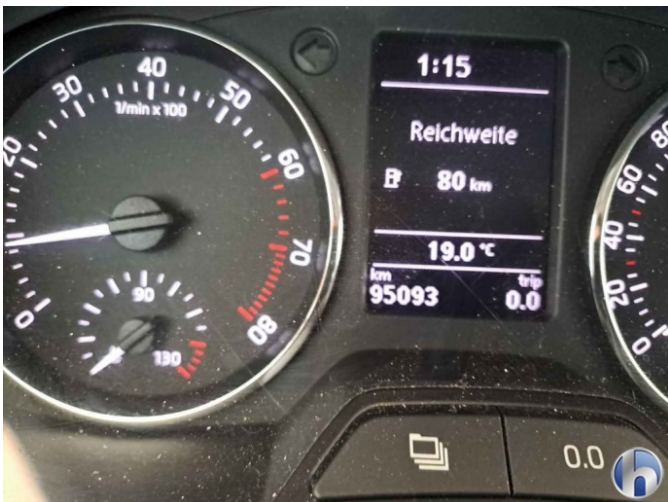
| component | Damage | Rep kind |
|---|---|---|
| 37. instrument cluster | Scratch(es) | Replace |

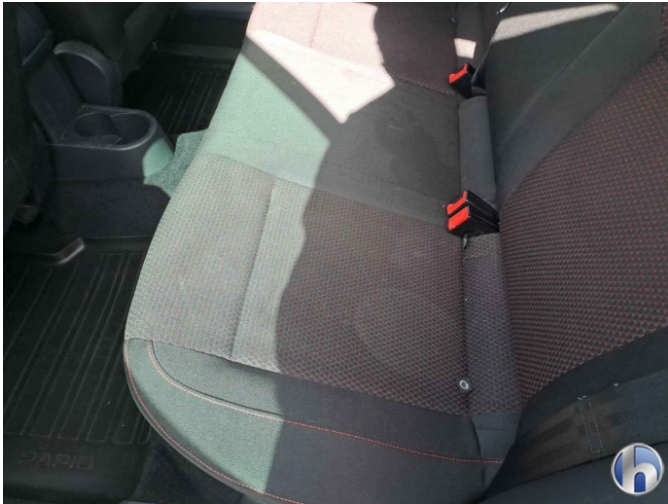
39. flooring

| 39. | flooring | Burn hole | Smart repair |

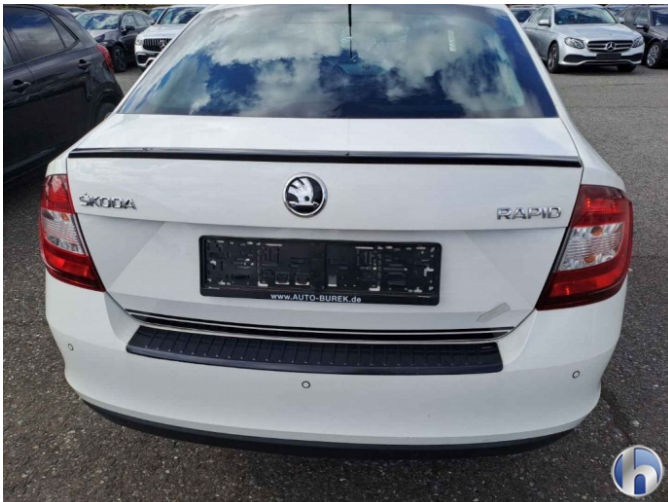
| 40. | | Burn hole | Replace |

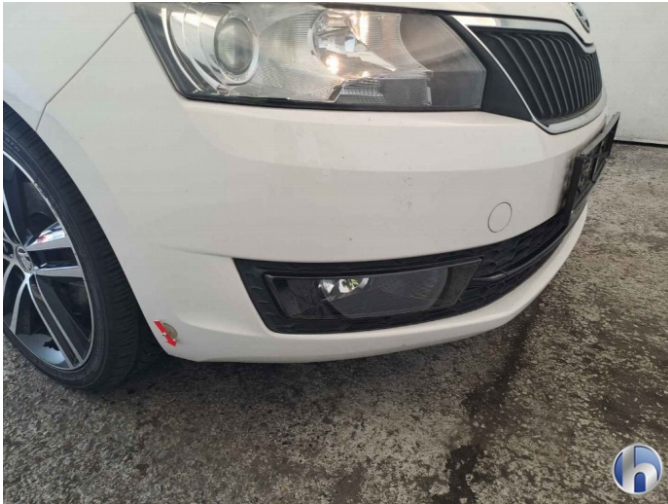
42. Xenon headlights - left

| 42. | Xenon headlights - left | Damaged | Replace |

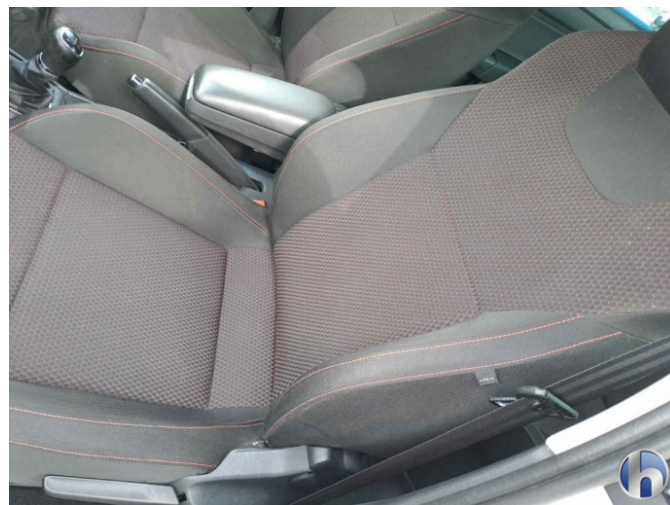
| 45. | | Wear and tear | acceptable |

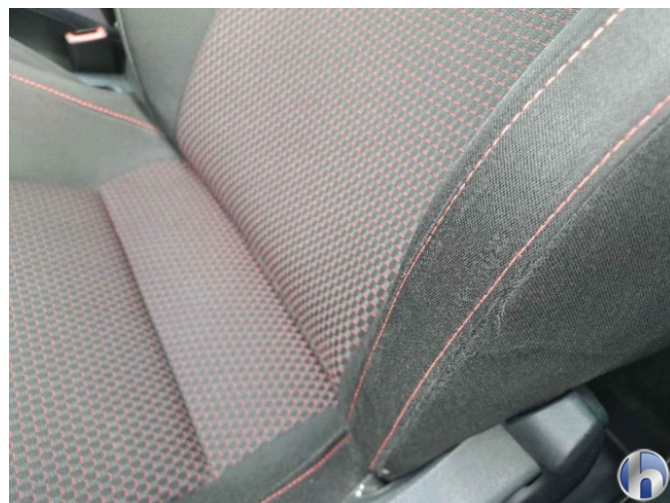
| 46. | | Damaged | Replace |
