Expertise

Protocol number: 41553571
Order No. / Reference: 25113544
Inspection date: 15 Sept 2025

Manufacturer: Skoda
VIN: TMBJH7NP4P7062689

Model: Superb Combi 2.0 TDI DSG Style

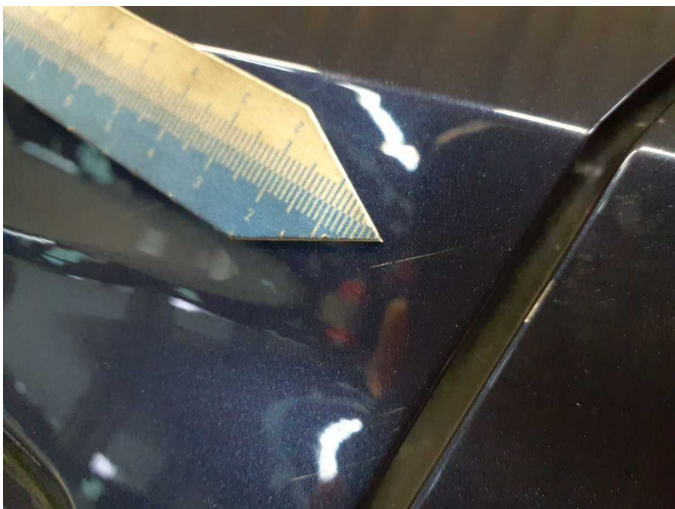
Damage 11: Door - front left side: Door (Kratzer) - Stone chips - Paint

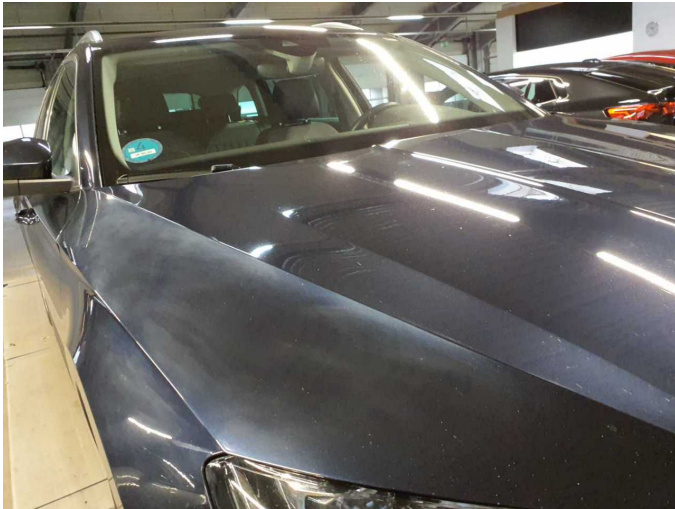
Damage 13: Bonnet: Bonnet - Scratched - Paint

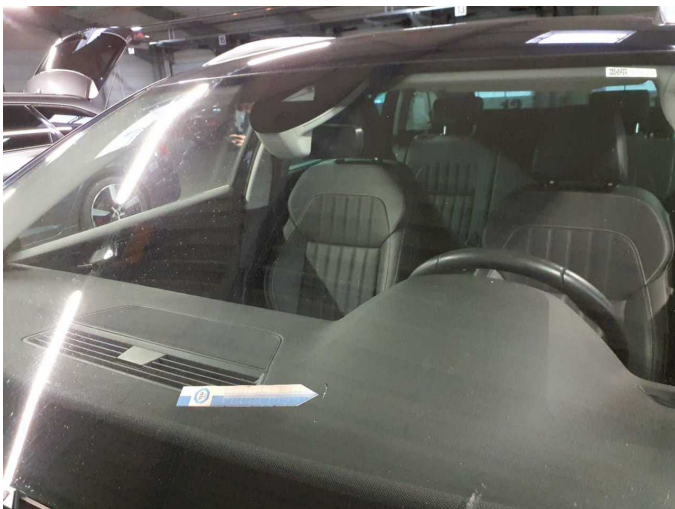
Damage 14: Vehicle glazing: Windscreen (Rissbildung) - Stone chips - repair according to calculation

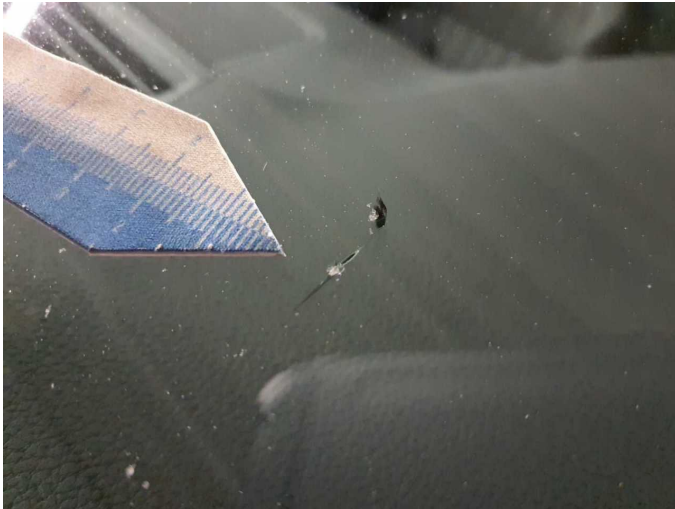
Damage 14: Vehicle glazing: Windscreen (Rissbildung) - Stone chips - repair according to calculation

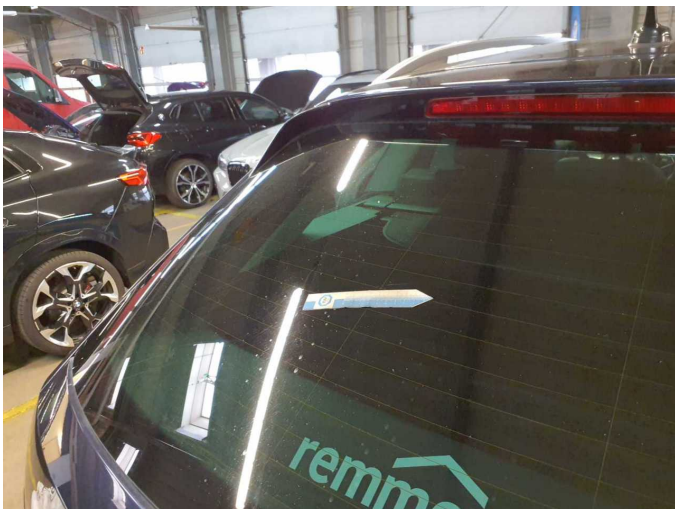
Wear and tear 5: Vehicle glazing: Rear window - Scratched - No deduction
