Expertise

Protocol number: 41667837  
Order No. / Reference: 25150159  
Inspection date: 22 Sept 2025

Manufacturer: Skoda  
VIN: TMBJH7NP8M7067647

Model: Superb Combi 2.0 TDI Ambition

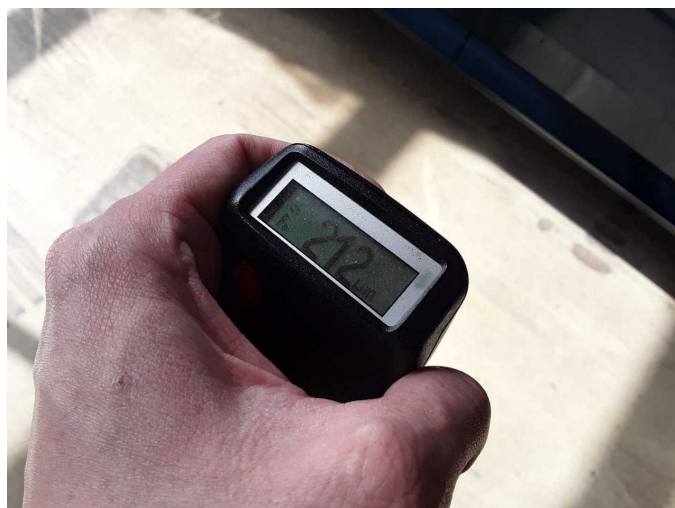
**Repainting 1:** Side panel - rear right side, Door - rear right side
