Expertise

Protocol number: 41225940
Order No. / Reference: 25019138
Inspection date: 25 Aug 2025

Manufacturer: Skoda	Model: Octavia Combi 2.0 TDI DSG First Edition
VIN: TMBJJ7NX5LY026034

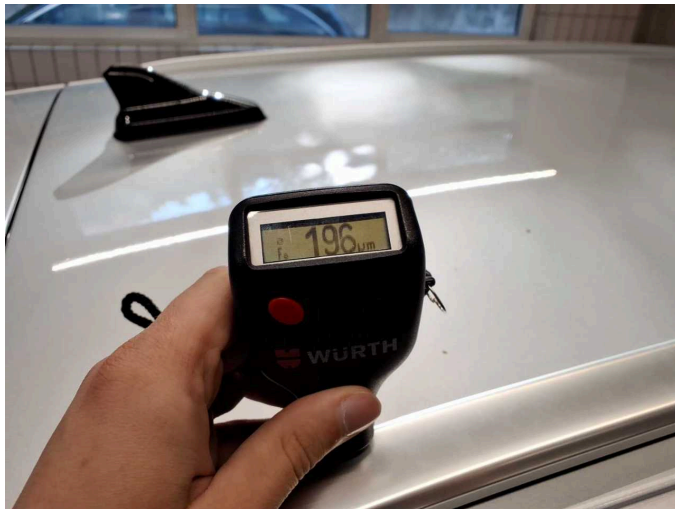
Repainting 1: Roof

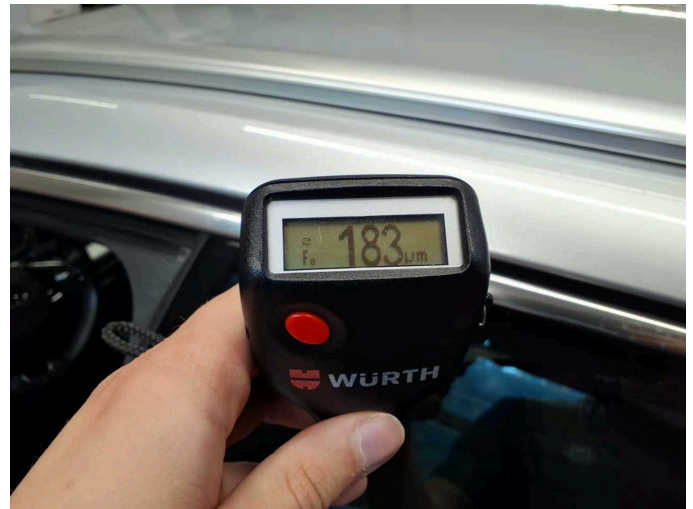
Repainting 2: Roof rail - left side

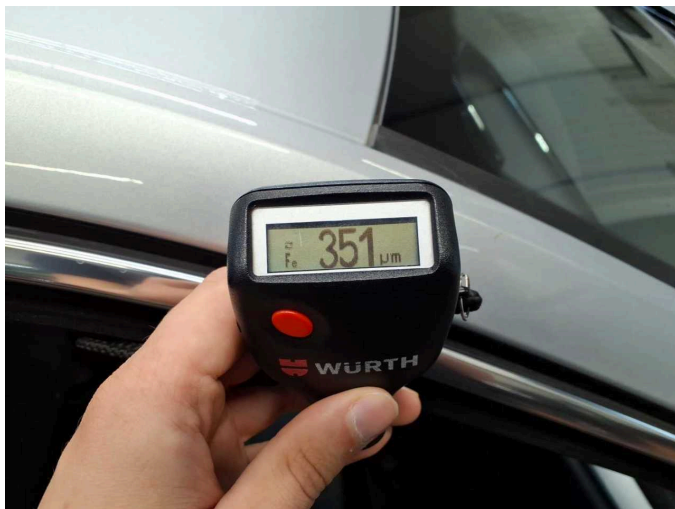
Repainting 3: Roof rail - right side

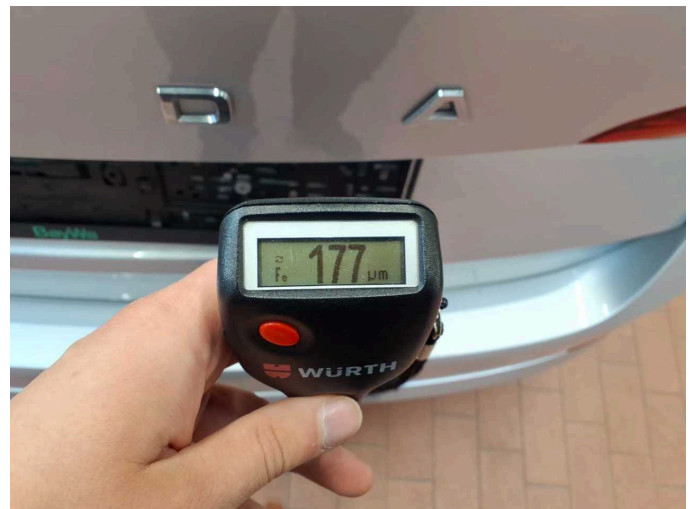
Repainting 4: Boot lid / rear door

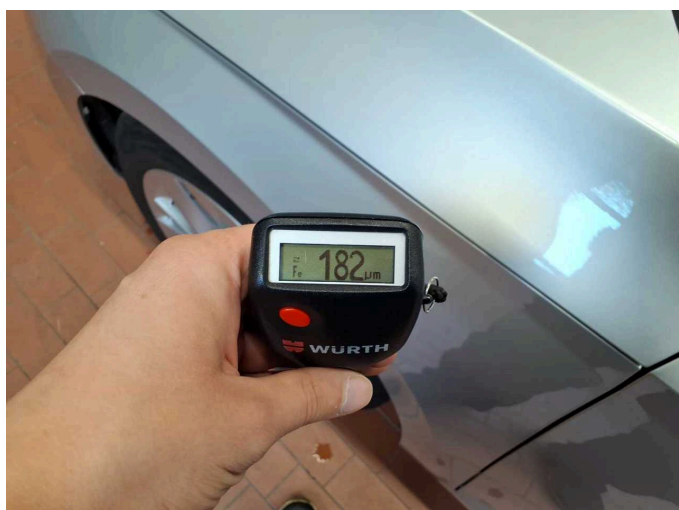
Repainting 5: Mudguard - left side

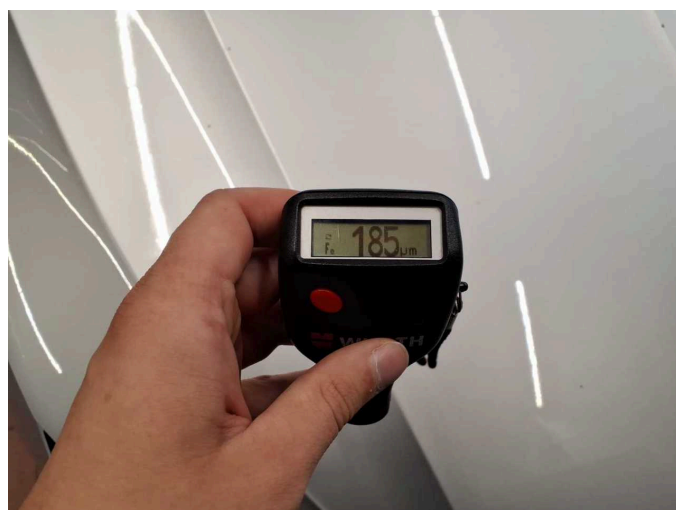
Repainting 6: Bonnet

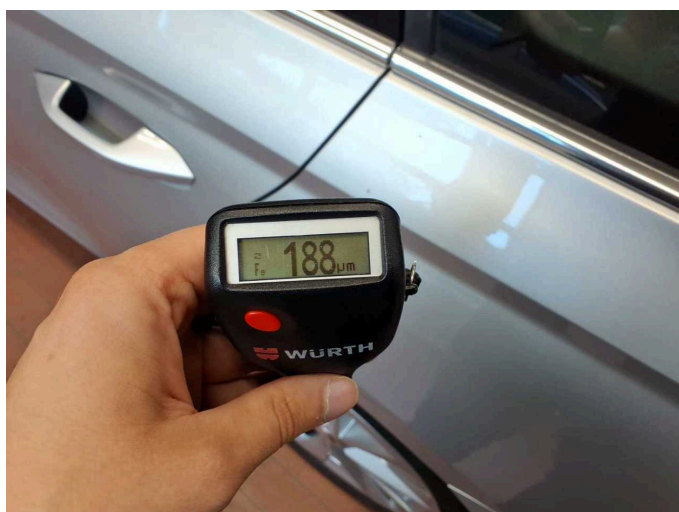
Repainting 7: Side panel - rear left side

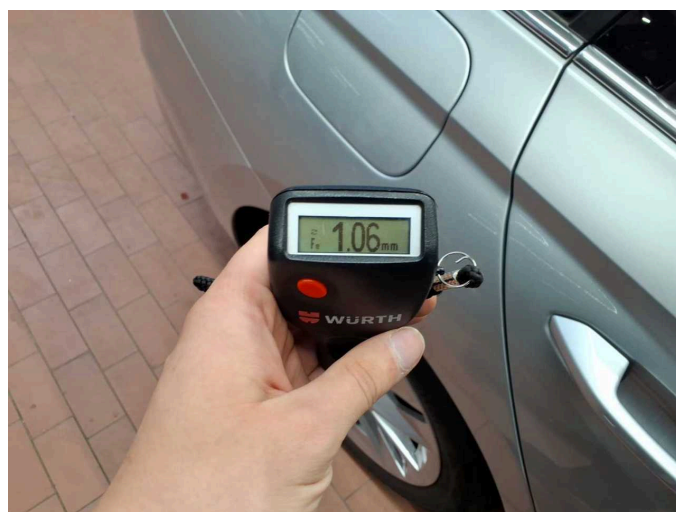
Repainting 8: Side panel - rear right side

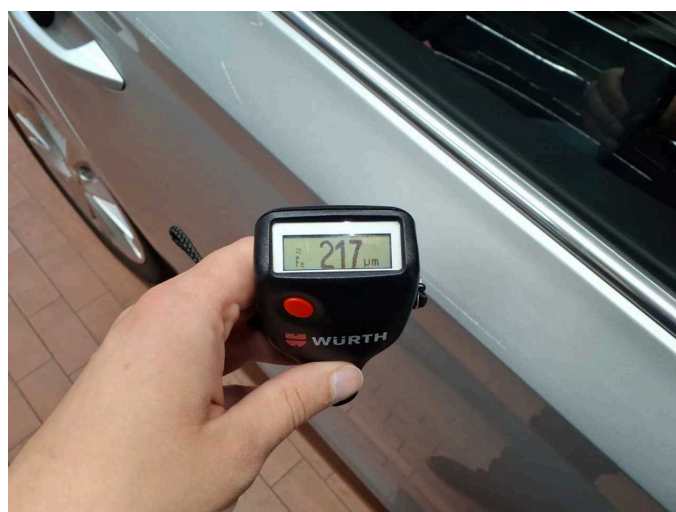
Repainting 9: Door - rear left side

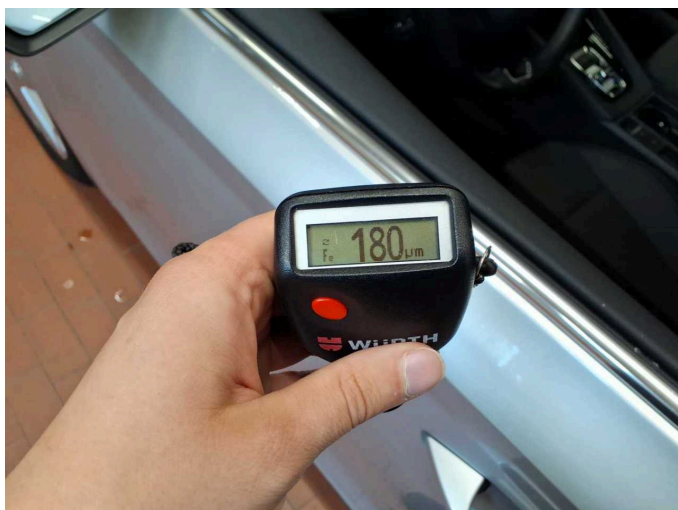
Repainting 10: Door - rear right side

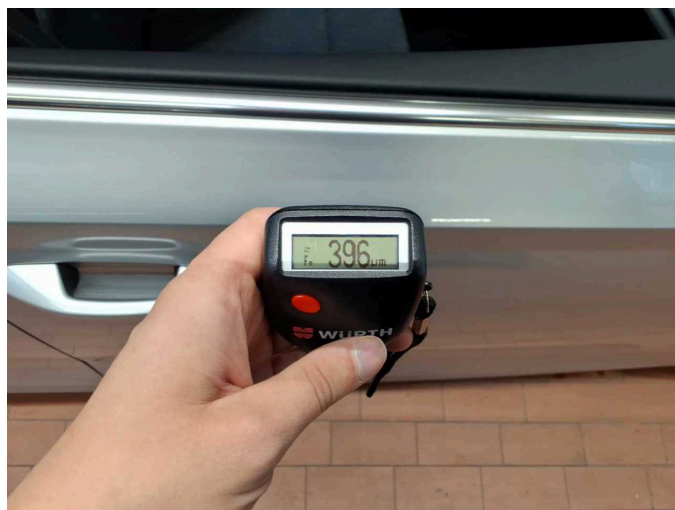
Repainting 11: Door - front left side
