Expertise

Protocol number: 41662080
Order No. / Reference: 25216281
Inspection date: 23 Sept 2025

Manufacturer: Skoda
VIN: TMBJR7NP0N7024709

Model: Superb Combi 2.0 TDI DSG Ambition

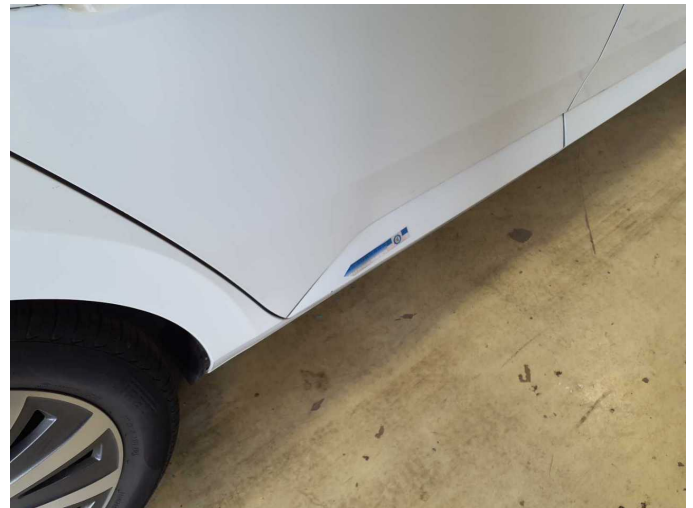
Damage 1: Door - rear right side: Brightware - lower - Scratched - Smart repair

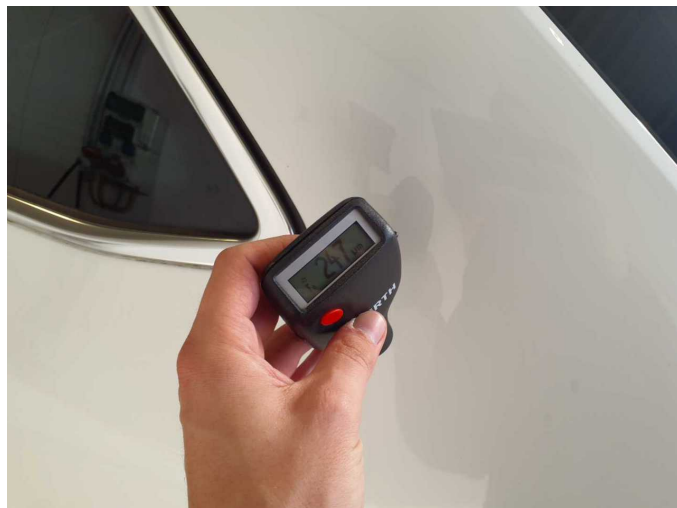
Side panel - rear left side: 247 μm
