Expertise

Protocol number: 41606988  
Order No. / Reference: 25210189  
Inspection date: 17 Sept 2025

| Manufacturer: Skoda | Model: Octavia Combi 1.5 TSI e-TEC DSG Tour |
| VIN: TMBJR8NX6NY105861 | |

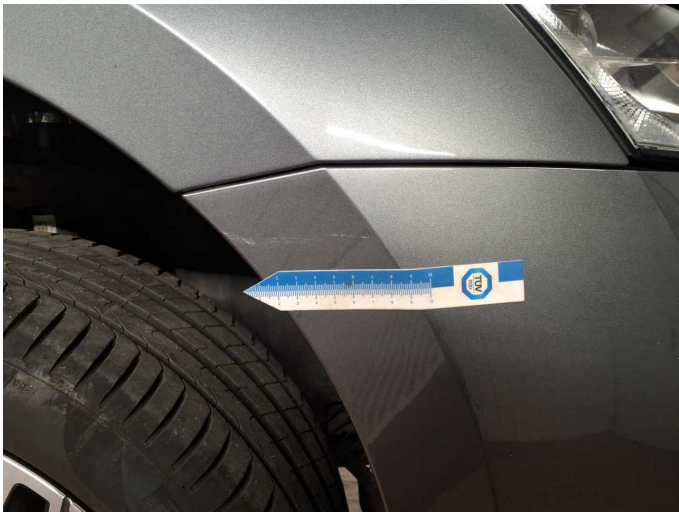
Accident 1: Side right

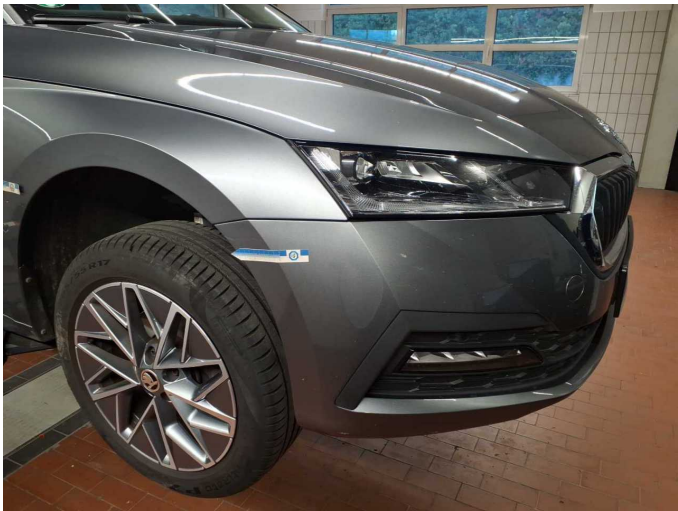
Accident 1: Side right

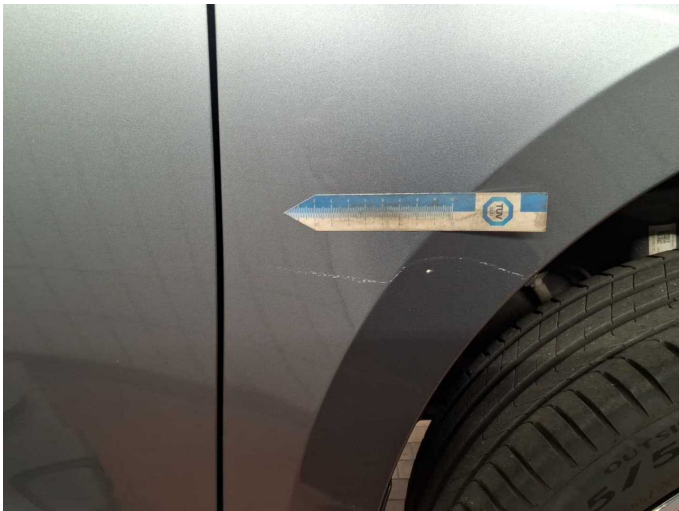
Accident 1: Side right

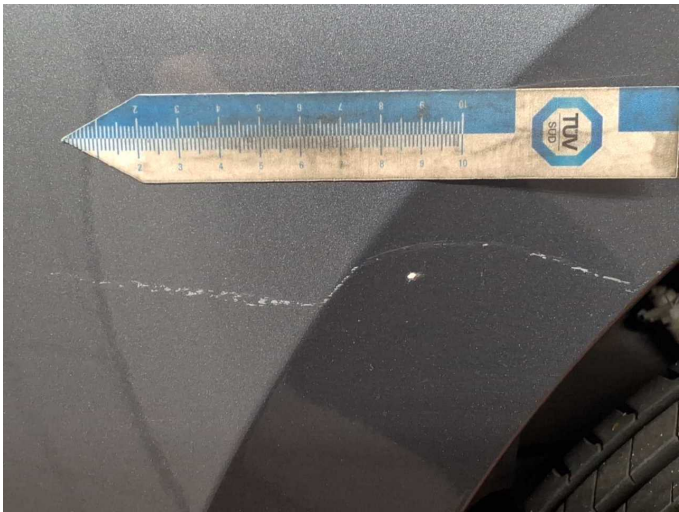
Accident 1: Side right

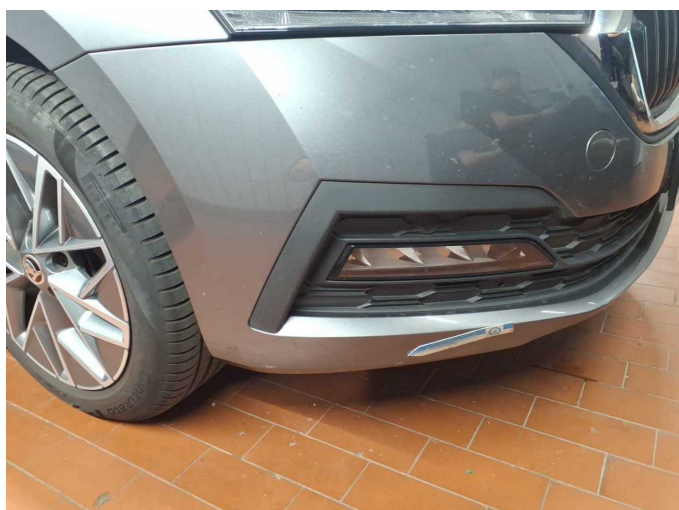
Accident 1: Side right

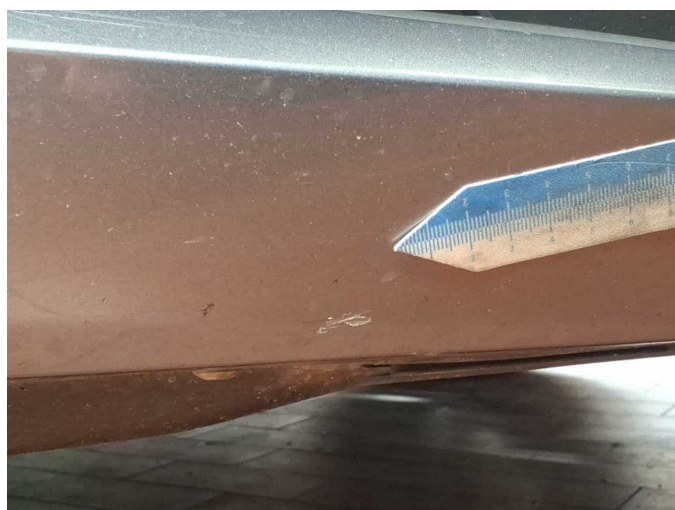
**Accident 1: Side right**
