Expertise

Protocol number: 41165663  
Order No. / Reference: 25093896  
Inspection date: 20 Aug 2025

Manufacturer: Skoda  
VIN: TMBJW7NP0L7073317

Model: Superb Combi 1.4 TSI iV DSG Style

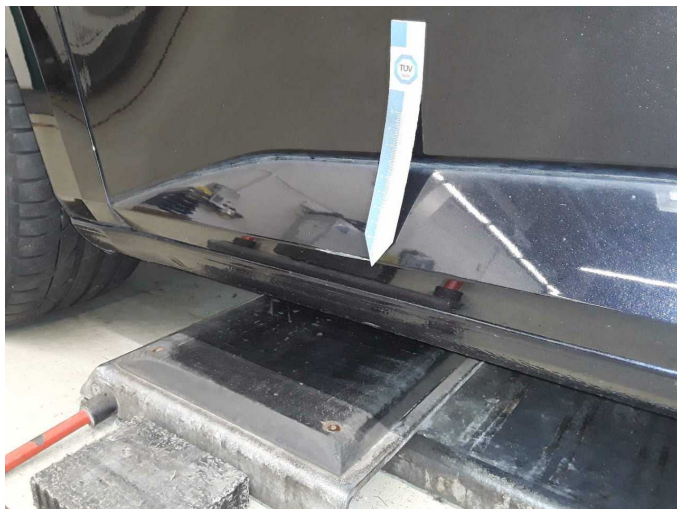
**Accident 1: Side - left**

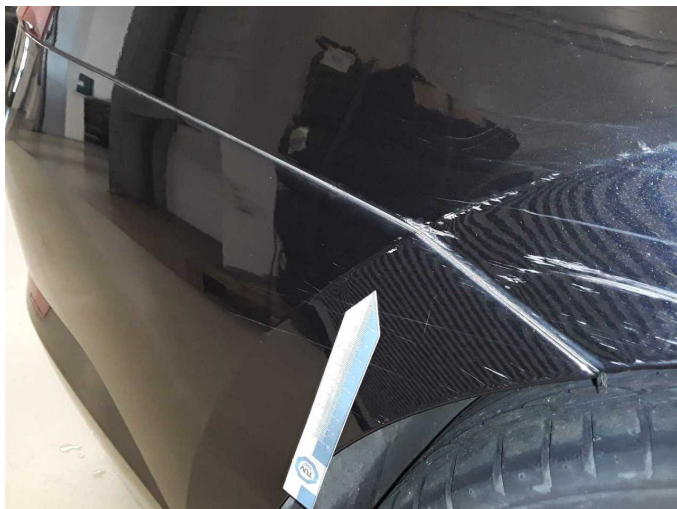
**Accident 2: Side right**

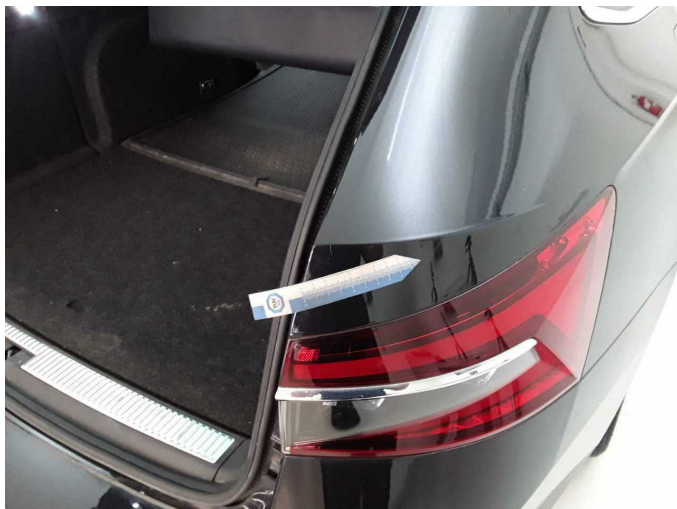
**Accident 2: Side right**

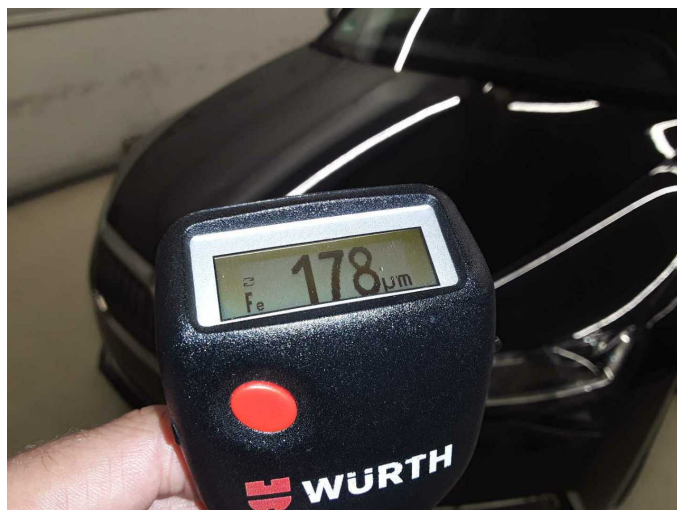
**Bonnet:** 178 µm
