Expertise

Protocol number: 41681451
Order No. / Reference: 25223415
Inspection date: 24 Sept 2025

Manufacturer: Skoda
VIN: TMBLJ7NP3L7026726

Model: Superb Combi 2.0 TDI 4x4 DSG Sportline

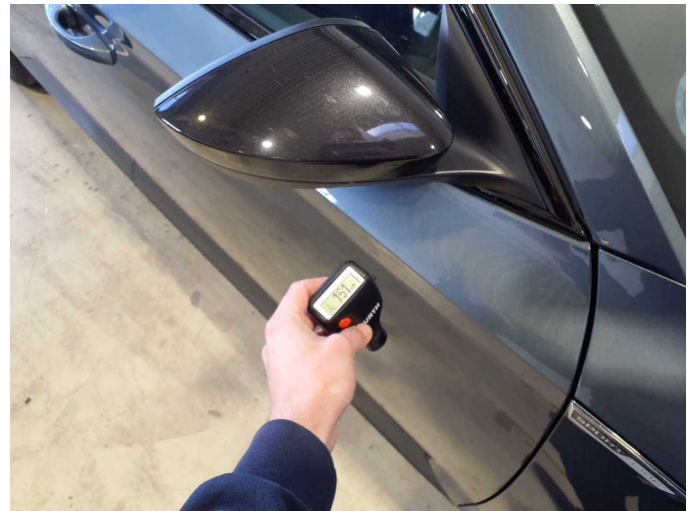
No.	Repainting
1	Door - front right side, Professionally carried out, Invoice of repair done Non-existent
2	Side panel - rear left side, Unprofessionally carried out, Invoice of repair done Non-existent

Repainting 1: Door - front right side

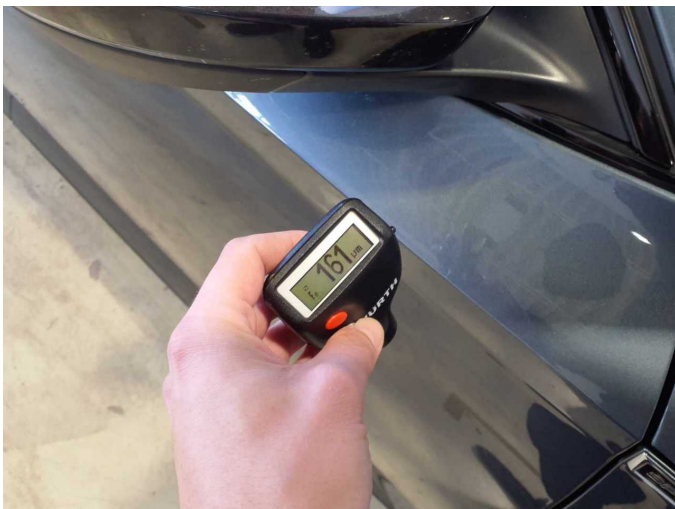
Repainting 1: Door - front right side

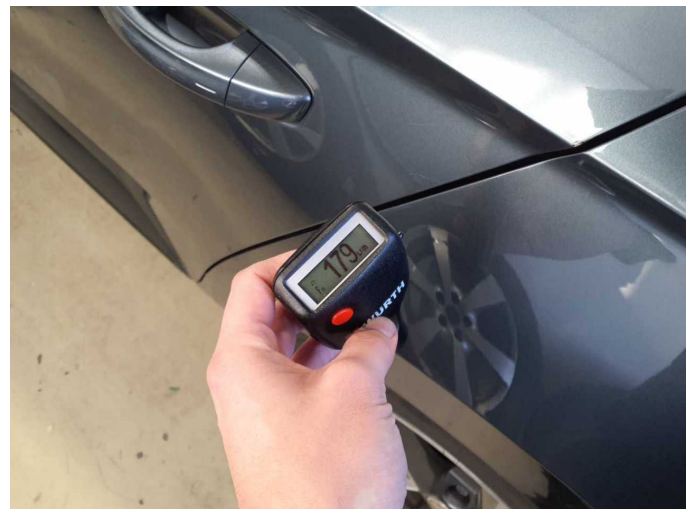
Repainting 2: Side panel - rear left side

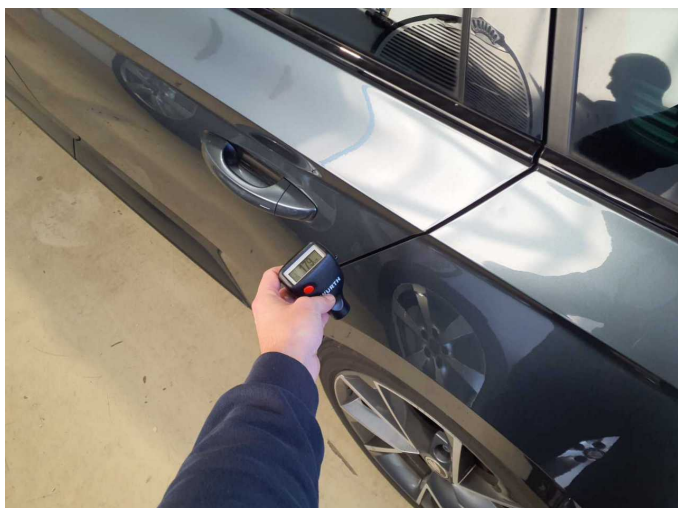
Repainting 2: Side panel - rear left side

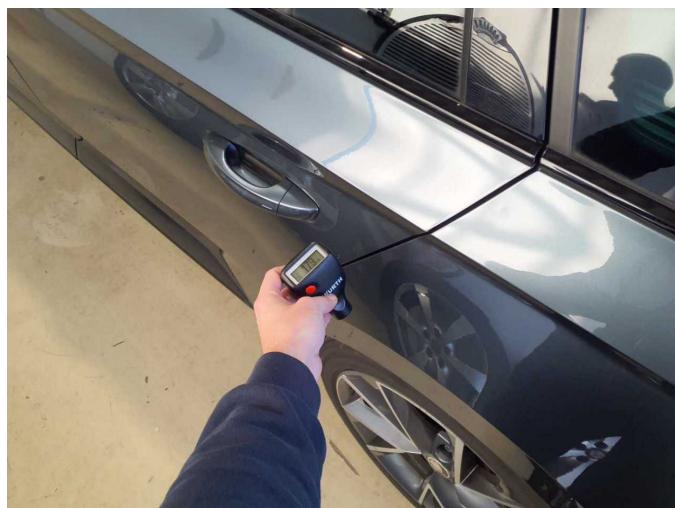
Side panel - rear left side: 179 μ m

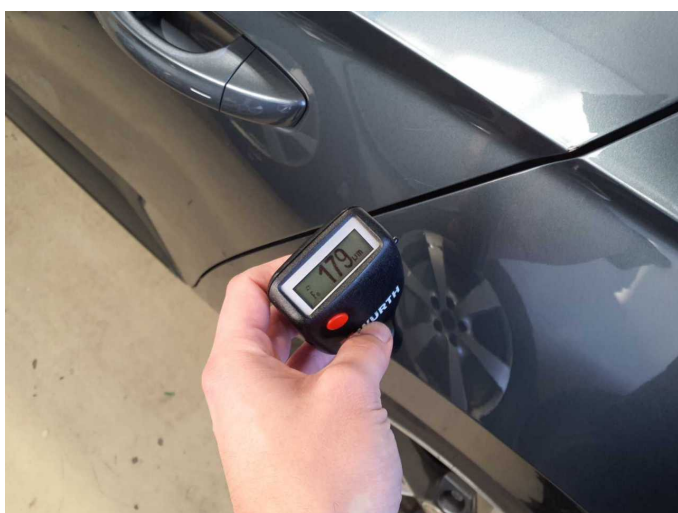
Side panel - rear left side: 179 μ m

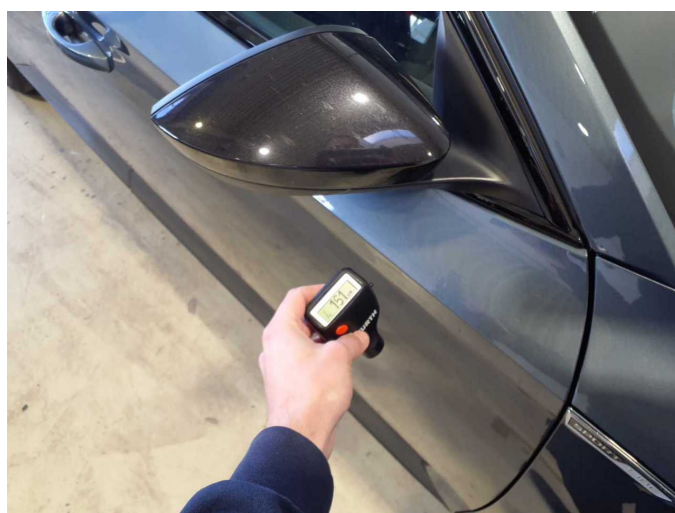
Door - front right side: 161 μ m

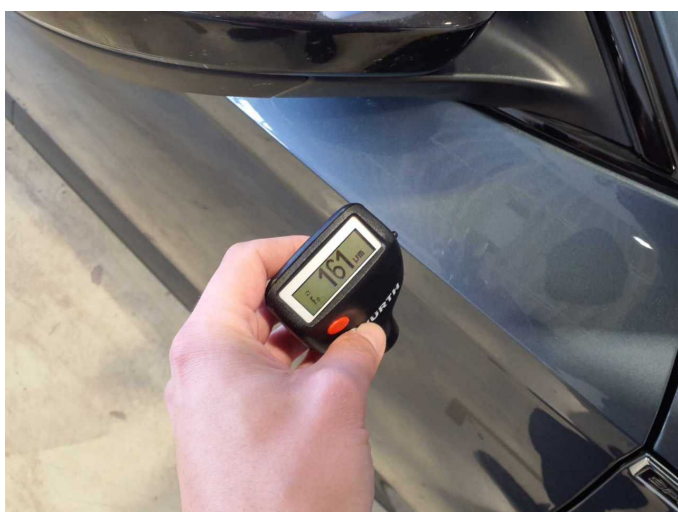
Door - front right side: 161 μ m
