## status report

#### Kia Venga Spirit

| Vehicle identification number | <b>U5YEH812BHL157931</b> | mileage read: | <b>33868 km</b> |

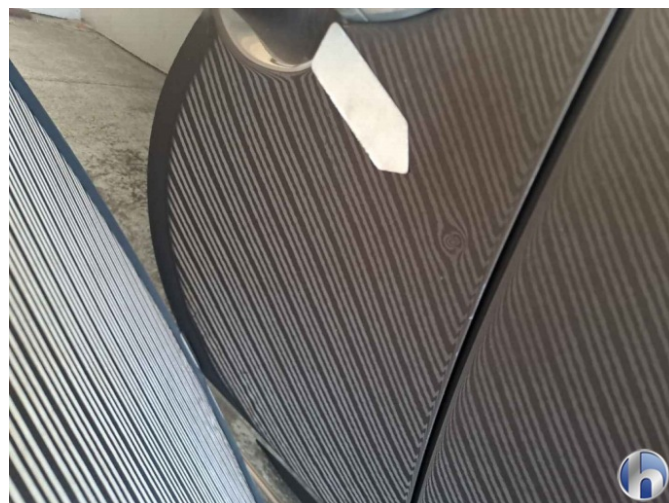
| component | Damage | Rep kind |
|---|---|---|
| 10. Front door - left | Damaged | Refurbish and paint |

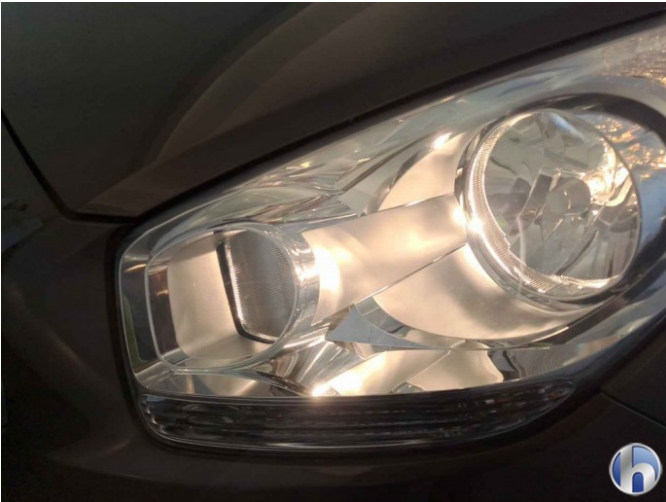
| component | Damage | Rep kind |
|---|---|---|
| 15. Halogen headlights - left | Wear and tear | acceptable |

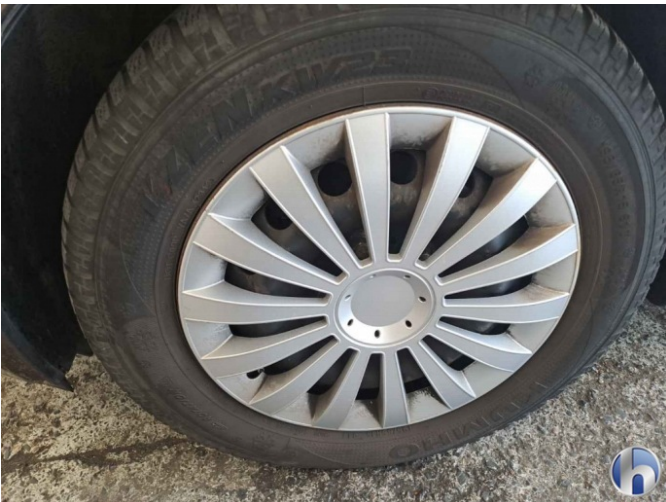
| component | Damage | Rep kind |
|---|---|---|
| 16. Radkappe - Vorne - Links | Scrape | Replace |

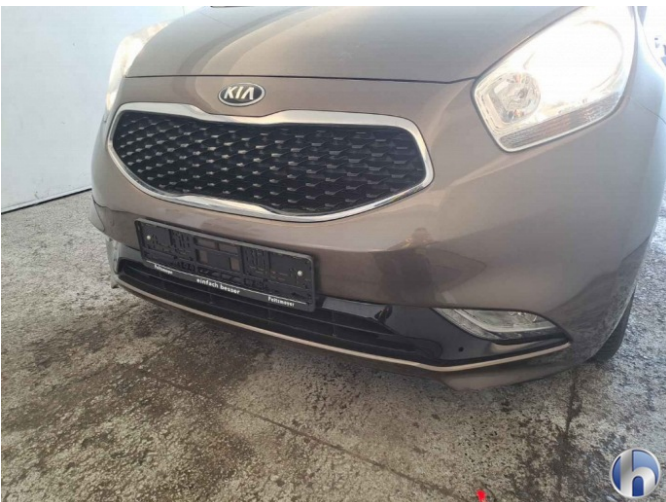
| component | Damage | Rep kind |
|---|---|---|
| 17. Front bumper | Damaged | Replace |

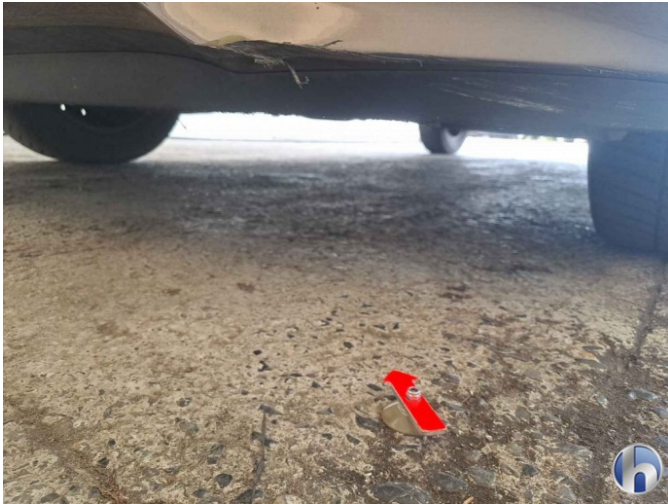
| component | Damage | Rep kind |
|---|---|---|
| 18. spoiler | Scrape | Replace |

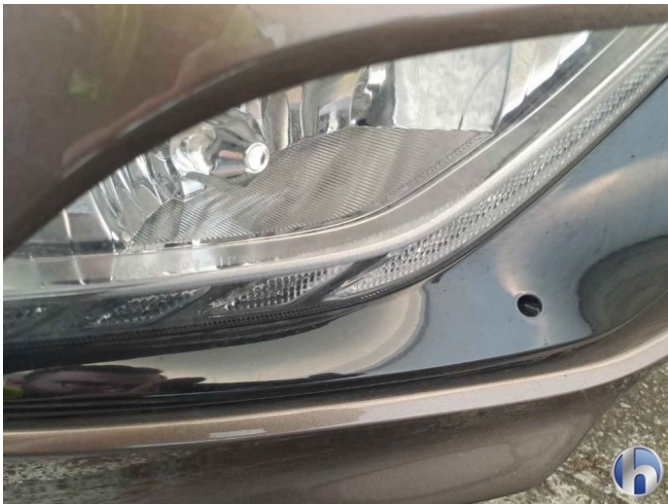
| component | Damage | Rep kind |
|---|---|---|
| 20. | Leaky | Replace |

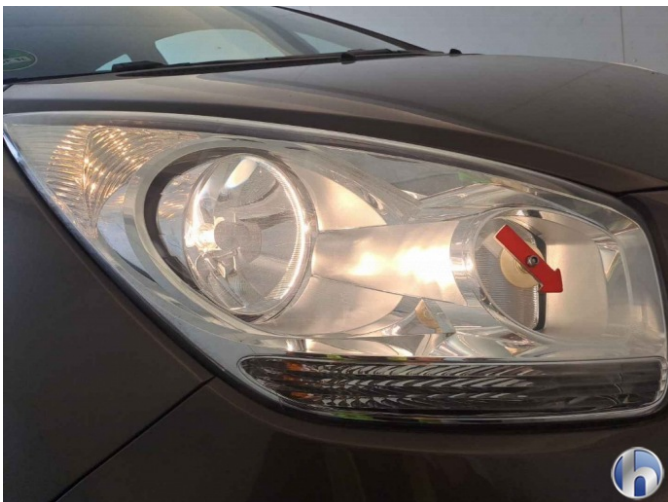
| component | Damage | Rep kind |
|---|---|---|
| 21. Halogen headlights - right | Leaky | Replace |

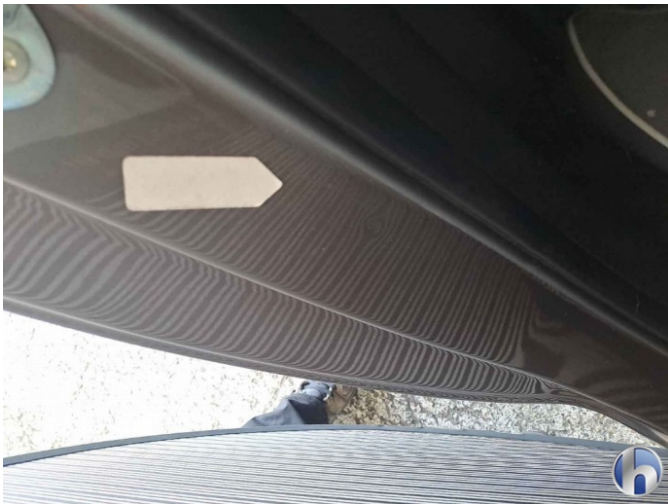
| component | Damage | Rep kind |
|---|---|---|
| 31. Türeinstieg Hinten - Rechts | Damaged | Refurbish and paint |

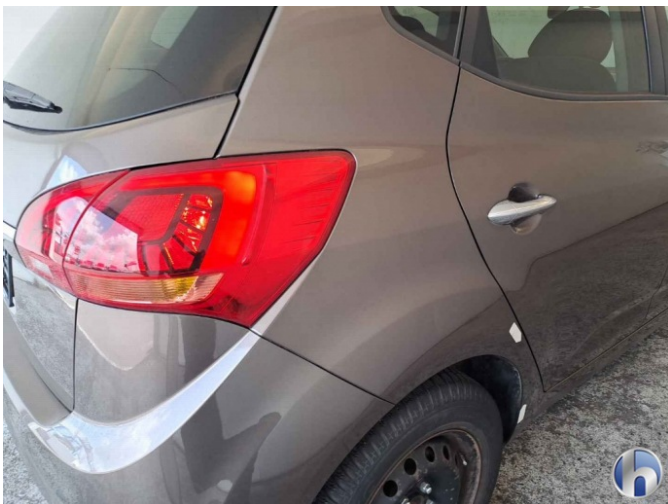
| component | Damage | Rep kind |
|---|---|---|
| 32. Sidewall - Rear - right | Damaged | Refurbish and paint |

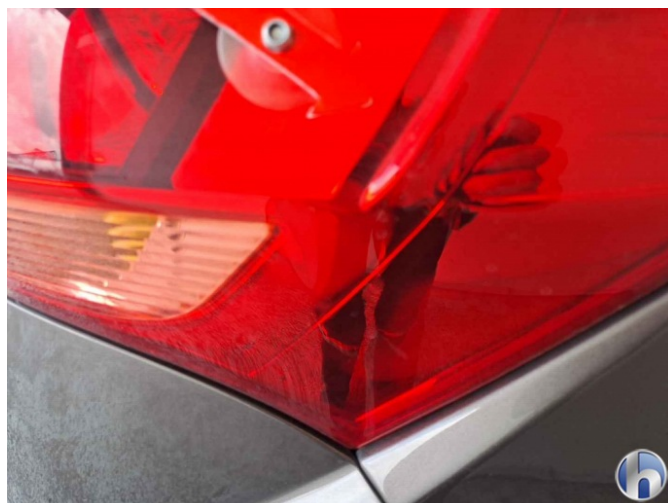
| component | Damage | Rep kind |
|---|---|---|
| 34. Taillight right | Leaky | Replace |
