## status report

**customer:** Bank 11, Neuss  
**contract number:** 1161993730  
**reference:**

#### Kia Sportage Spirit 2WD

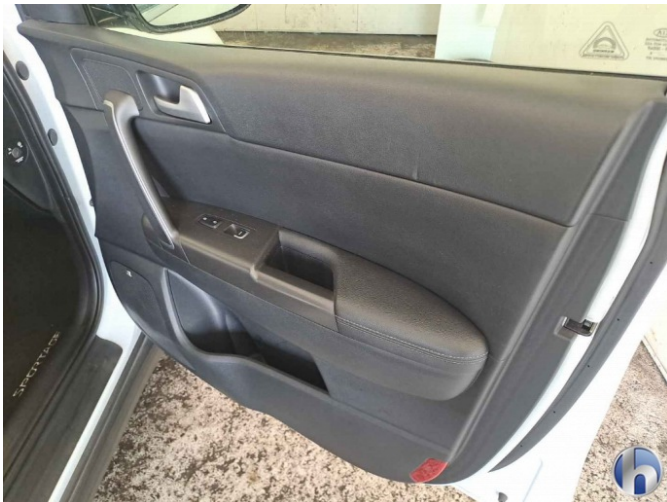
| component | Damage | Rep kind |
|---|---|---|
| 6. Door trim Front - right | Damaged | Replace |

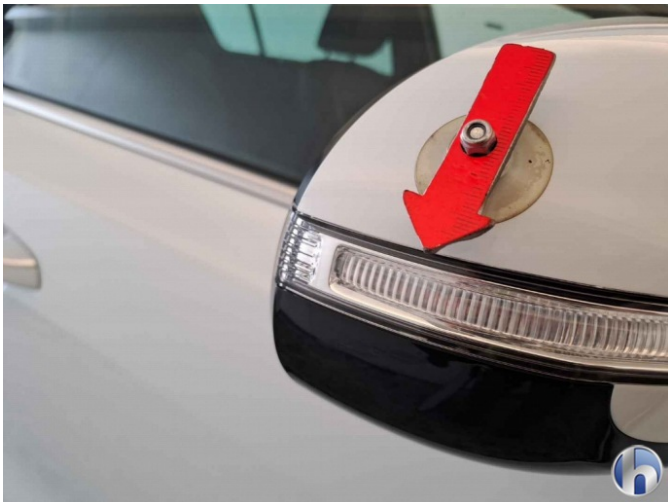
| component | Damage | Rep kind |
|---|---|---|
| 23. | Scrape | Replace |

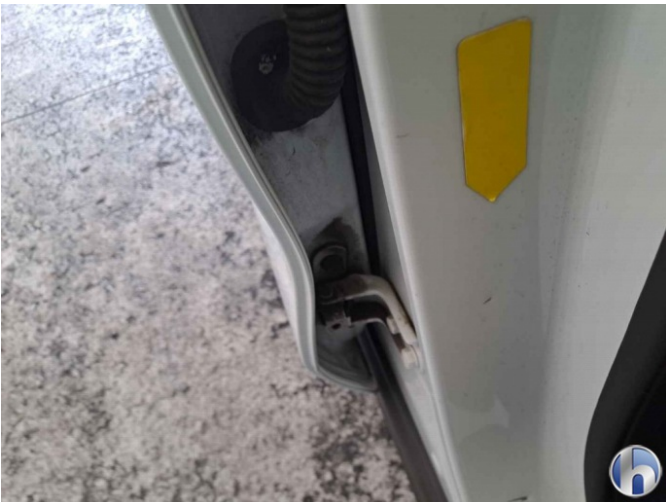
| component | Damage | Rep kind |
|---|---|---|
| 25. Türeinstieg Vorne - Rechts | Damaged | Refurbish and paint |

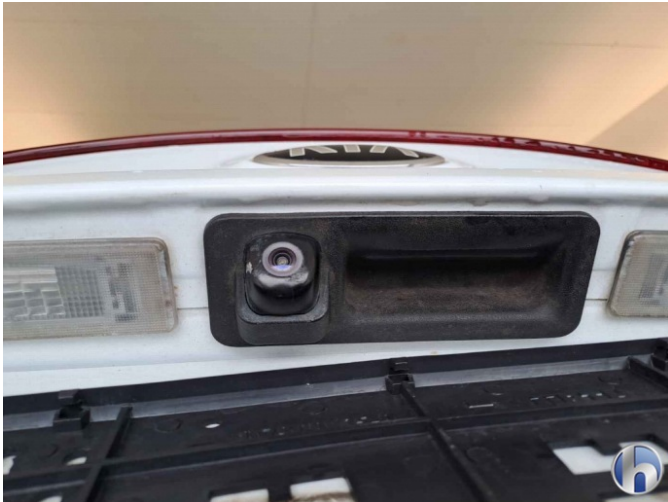
| component | Damage | Rep kind |
|---|---|---|
| 30. Heckklappenschalter | Damaged | Replace |

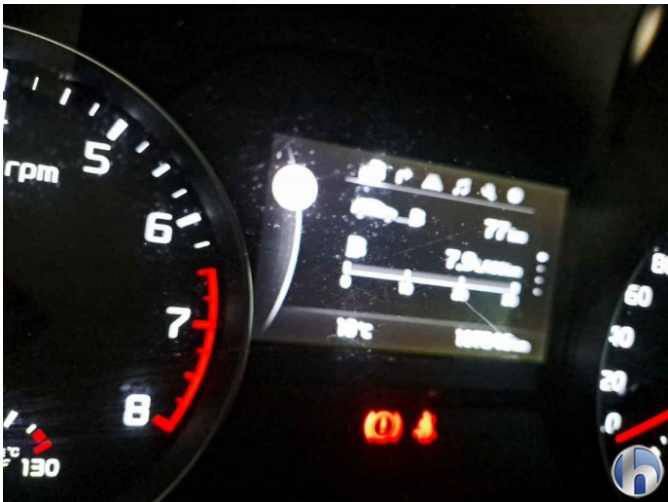
| component | Damage | Rep kind |
|---|---|---|
| 31. instrument cluster | Scratch(es) | Replace |

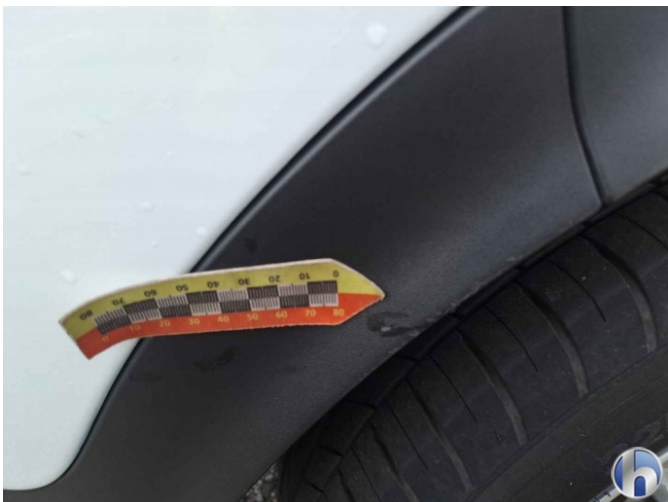
| component | Damage | Rep kind |
|---|---|---|
| 32. Diffusor | Scrape | Replace |

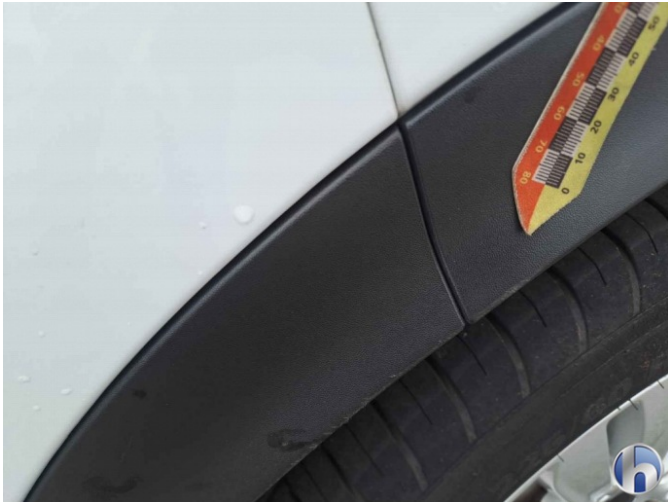
| component | Damage | Rep kind |
|---|---|---|
| 33. | Scrape | Replace |

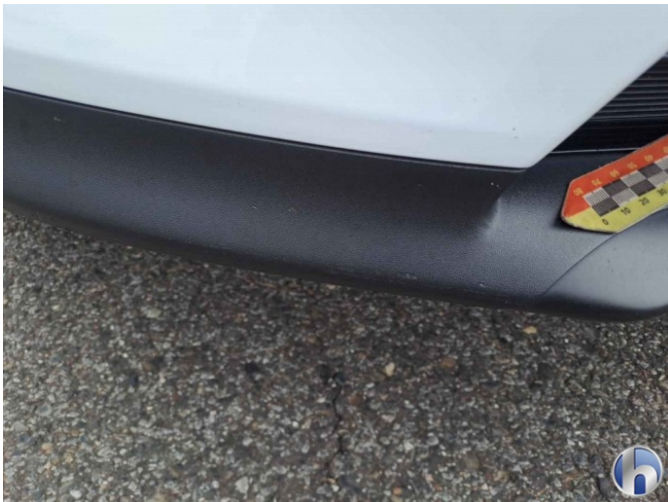
| component | Damage | Rep kind |
|---|---|---|
| 34. spoiler | Scrape | Replace |

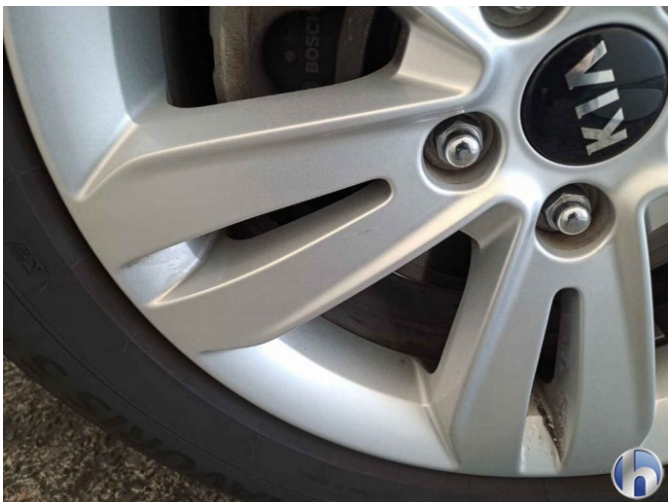
| component | Damage | Rep kind |
|---|---|---|
| 35. | Scratch(es) | Smart repair |
