## status report

**customer:** Bank 11, Neuss  
**contract number:**  
**reference:**

#### Dacia Duster Prestige 4x4

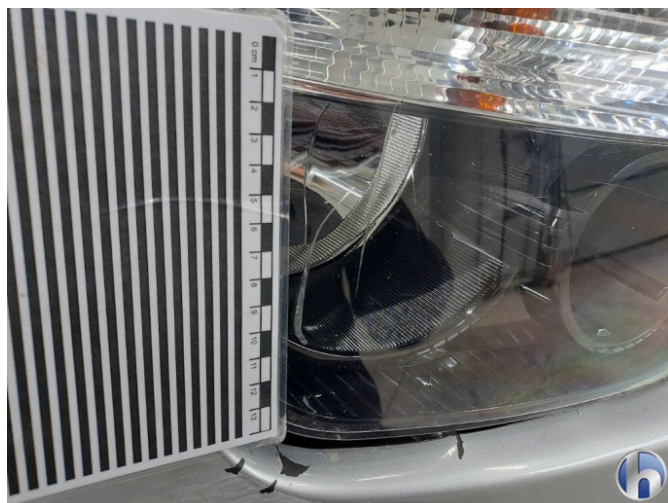
| component | Damage | Rep kind |
|---|---|---|
| 35. Halogen headlights - right | Scratch(es) | Replace |
