Expertise

Protocol number: 41657258  
Order No. / Reference: 25241643  
Inspection date: 23 Sept 2025

Manufacturer: Renault

Model: Trafic ENERGY dCi 120 L1H1 3,0t Komfort

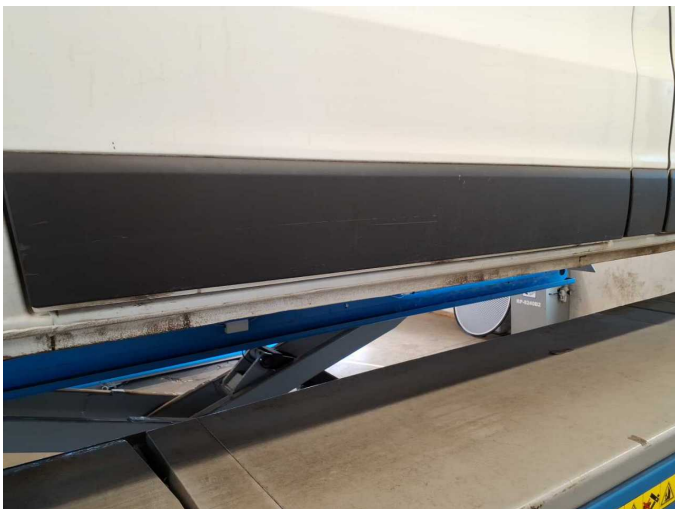
**Damage 3:** Trim / covers: Brightware / decorative strip (Schiebetür rechts)  
- Scratch(es) - Loss in value

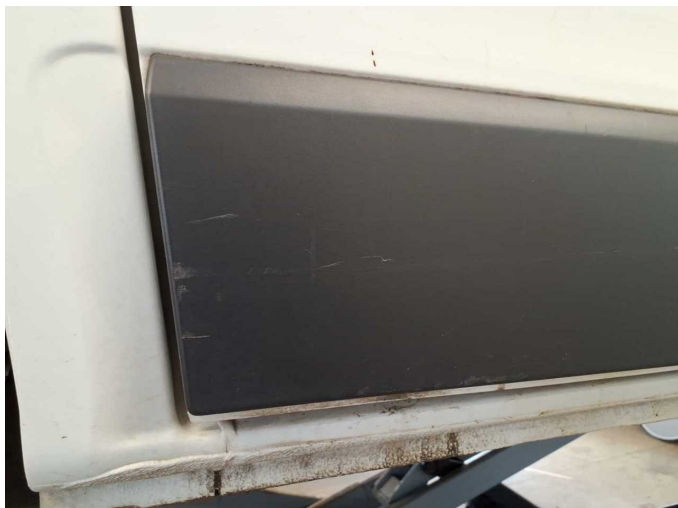
**Damage 3:** Trim / covers: Brightware / decorative strip (Schiebetür rechts) - Scratch(es) - Loss in value

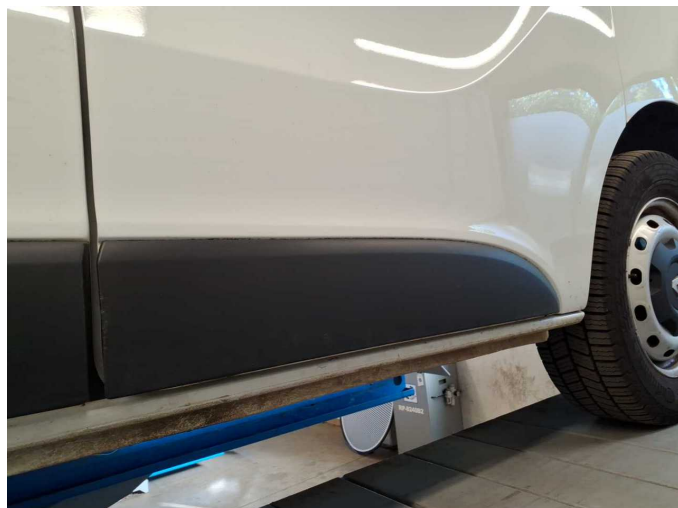
**Damage 4:** Trim / covers: Brightware / decorative strip (Tür Vorne rechts) - Scratch(es) - Loss in value

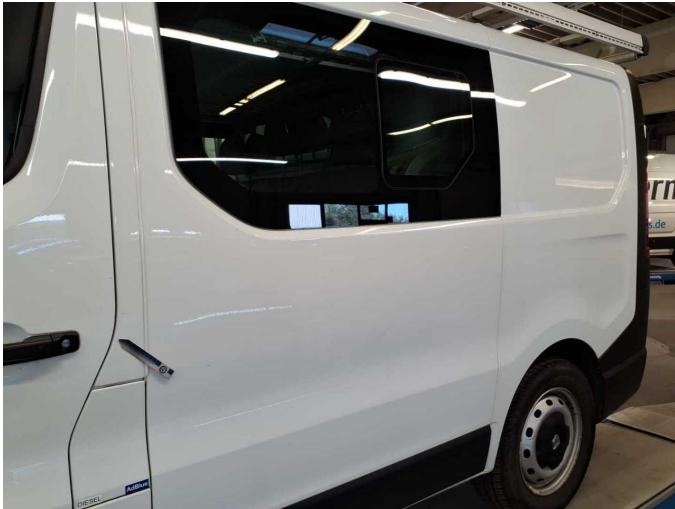
| No. | Component group | Description |
|---|---|---|
| 7 | Side panel - rear left side | Side panel - Scratch(es) - Smart repair |

**Damage 7:** Side panel - rear left side: Side panel - Scratch(es) - Smart repair

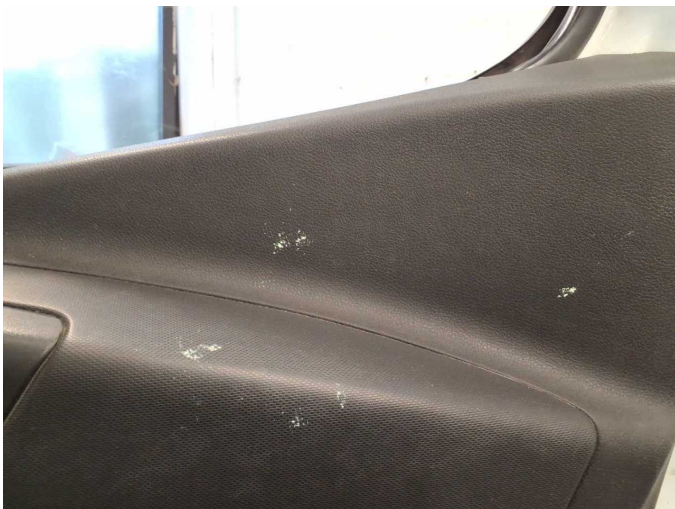
**Damage 8:** Trim / covers: Door trim - front right side - Scratched - Loss in value

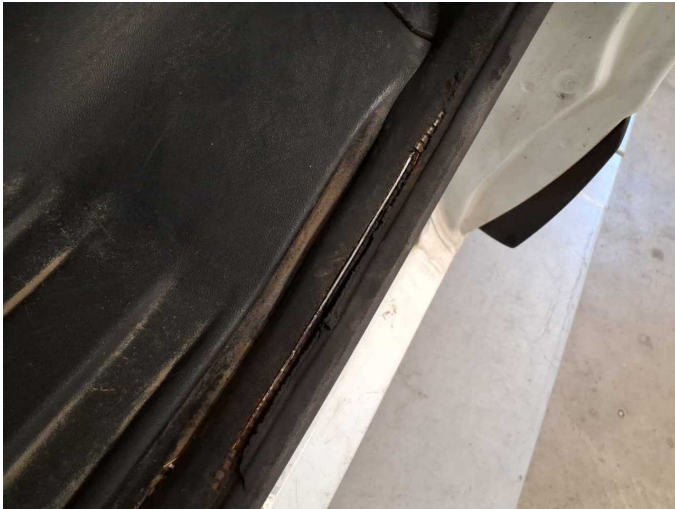
| No. | Component group | Description |
|---|---|---|
| 9 | Body | Seal - sliding door - right side - Broken / torn - Replace |

**Damage 9:** Body: Seal - sliding door - right side - Broken / torn - Replace

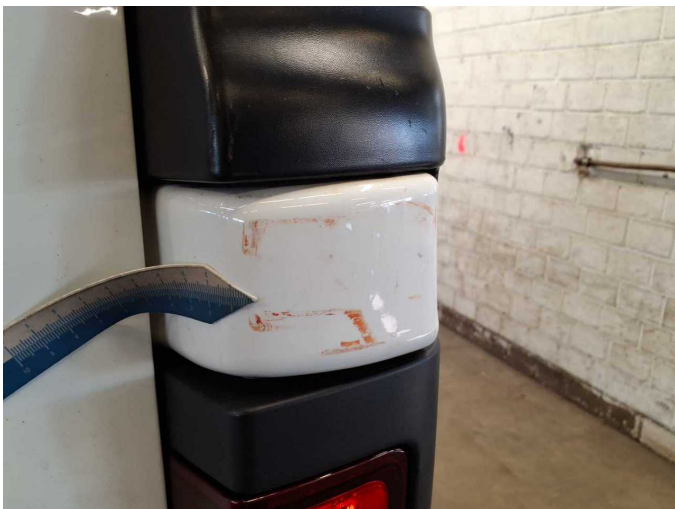
| No. | Component group | Description |
|---|---|---|
| 10 | Boot lid / rear door | Rear door - right side - Scratch(es) - Smart repair |

**Damage 10:** Boot lid / rear door: Rear door - right side - Scratch(es) - Smart repair

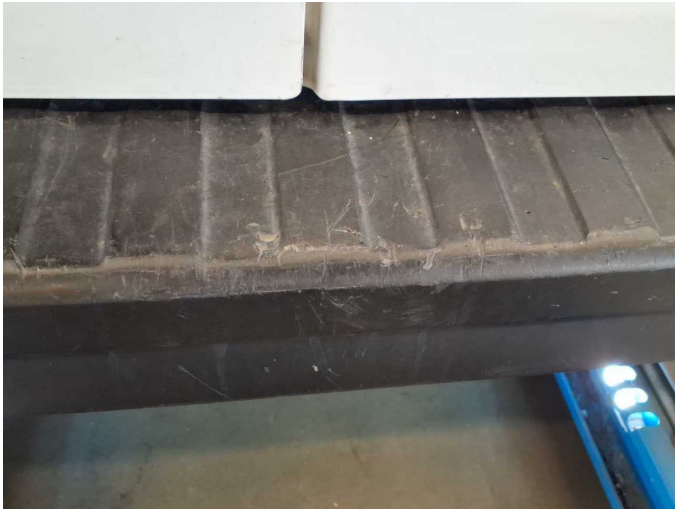
**Damage 12:** Rear bumper: Rear bumper - Scratch(es) - Loss in value

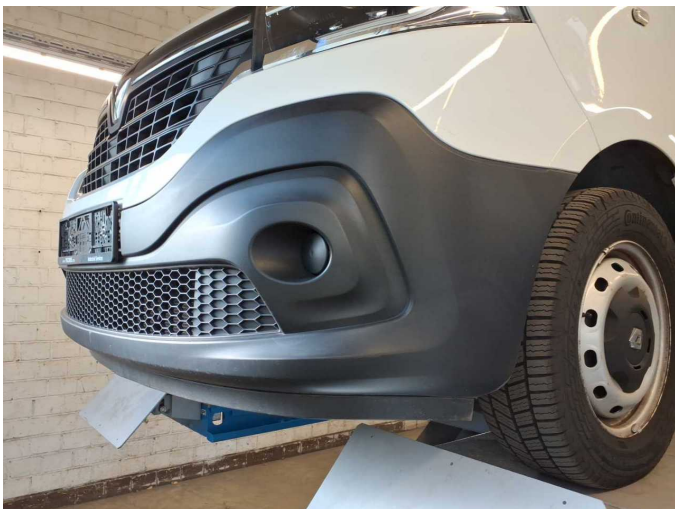
**Damage 13:** Front bumper: Front bumper - Scratch(es) - Loss in value

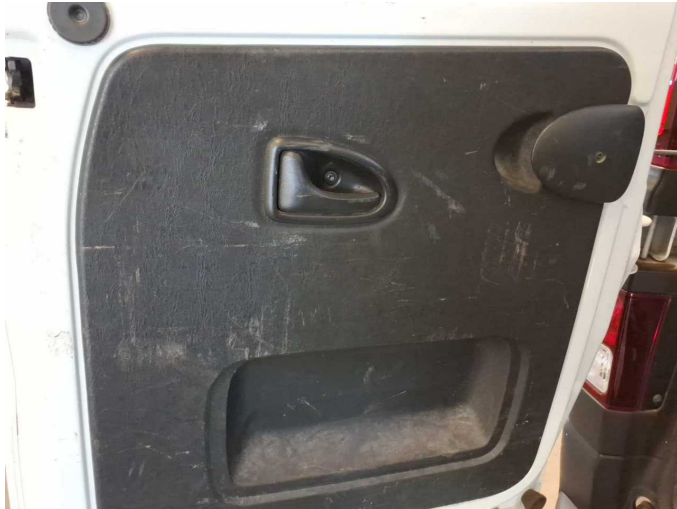
**Damage 14:** Interior: Cargo space division - Dent / paintcoat damage - Loss in value

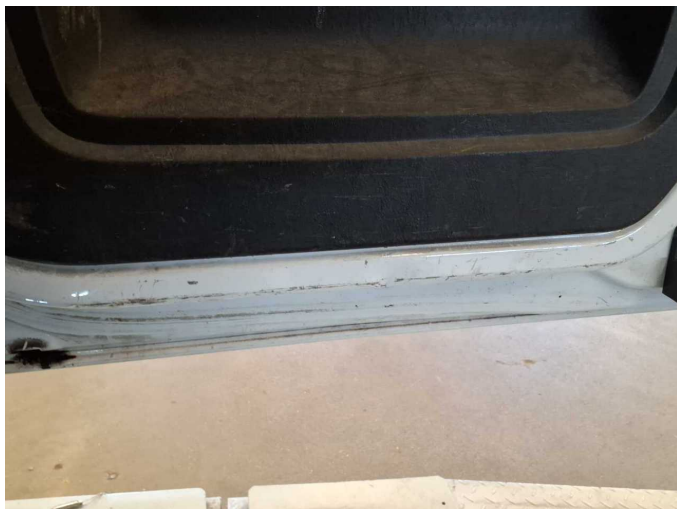
**Damage 14:** Interior: Cargo space division - Dent / paintcoat damage - Loss in value

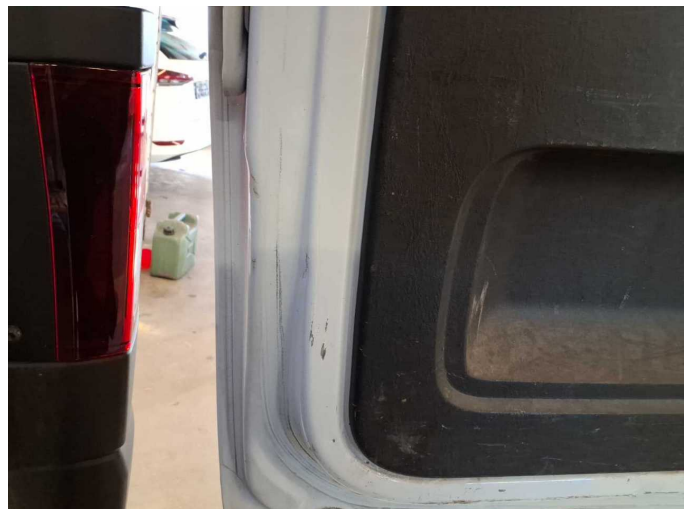
**Damage 14:** Interior: Cargo space division - Dent / paintcoat damage - Loss in value

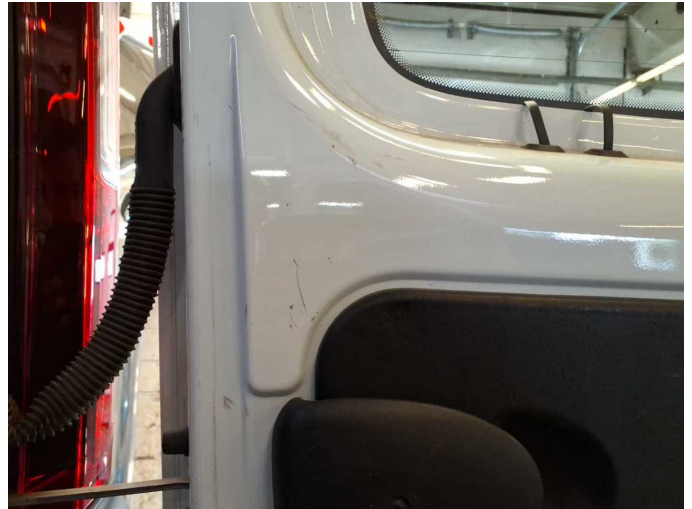
**Damage 14:** Interior: Cargo space division - Dent / paintcoat damage - Loss in value

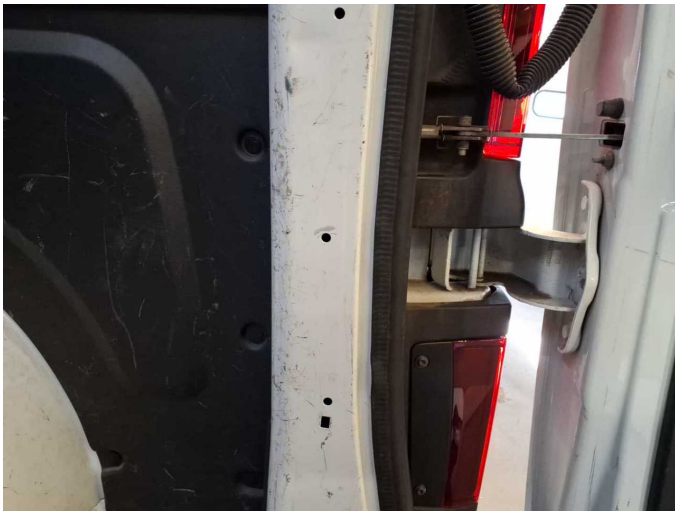
**Damage 14:** Interior: Cargo space division - Dent / paintcoat damage - Loss in value

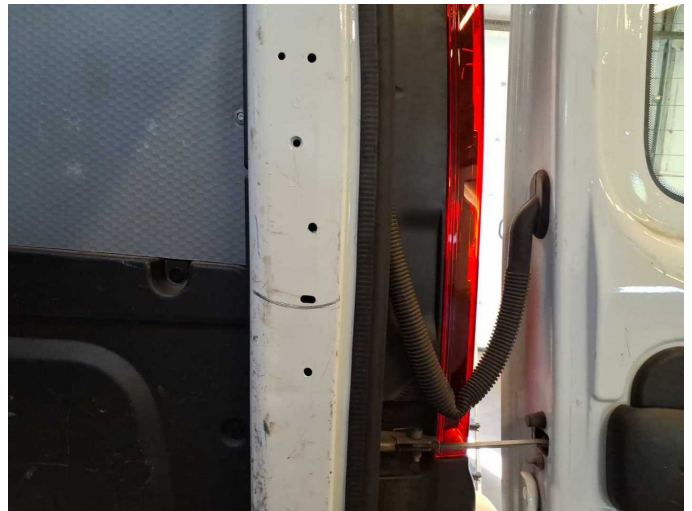
**Damage 14:** Interior: Cargo space division - Dent / paintcoat damage - Loss in value

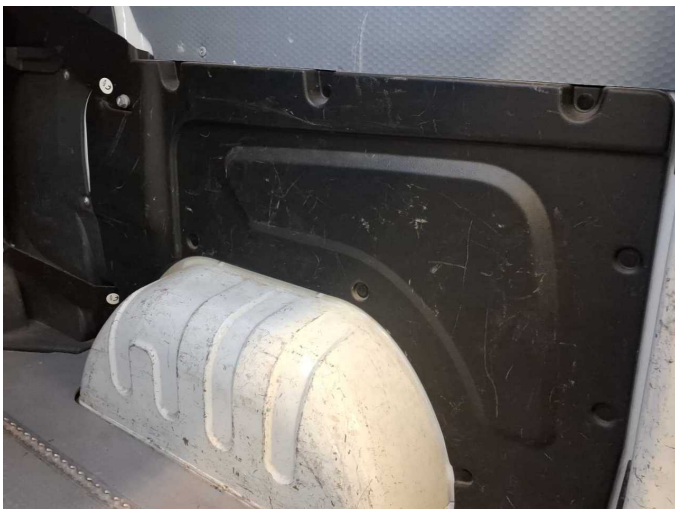
**Damage 14:** Interior: Cargo space division - Dent / paintcoat damage - Loss in value

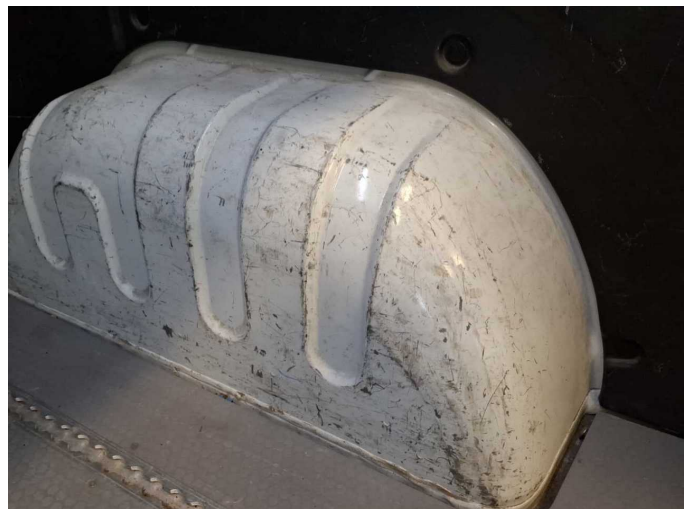
**Damage 14:** Interior: Cargo space division - Dent / paintcoat damage - Loss in value

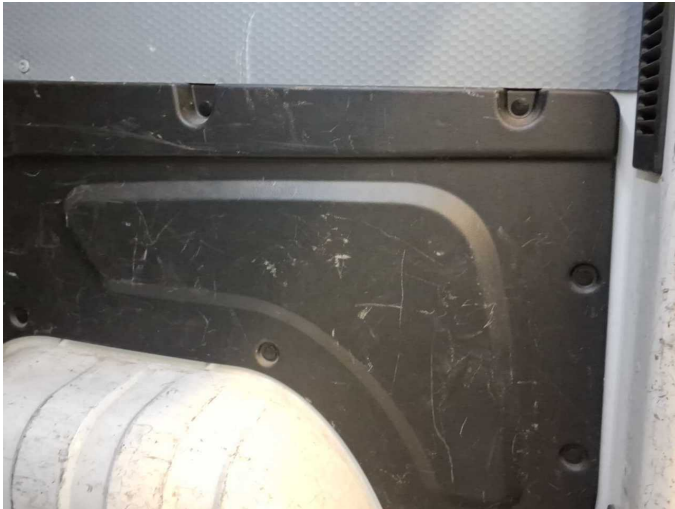
**Damage 14:** Interior: Cargo space division - Dent / paintcoat damage - Loss in value

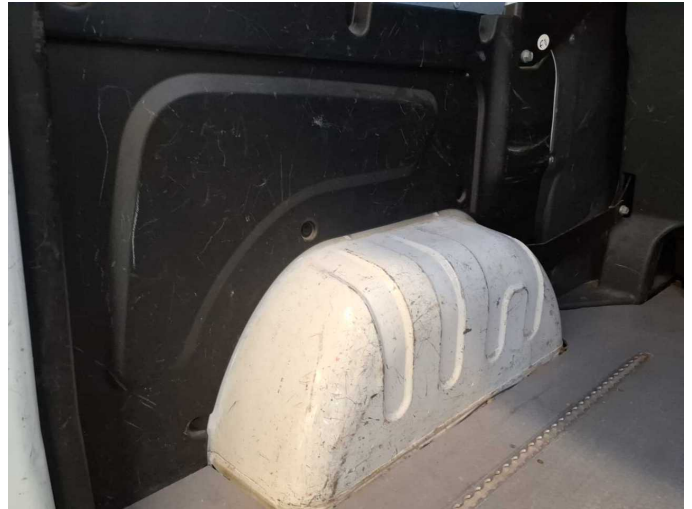
**Damage 14:** Interior: Cargo space division - Dent / paintcoat damage - Loss in value

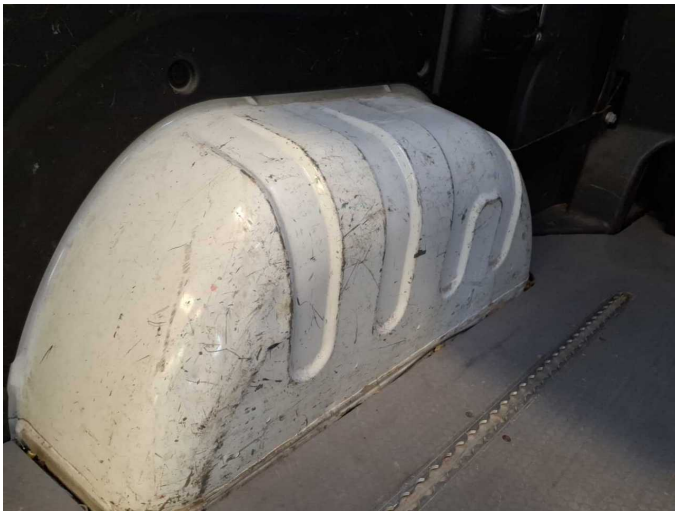
**Damage 14:** Interior: Cargo space division - Dent / paintcoat damage - Loss in value

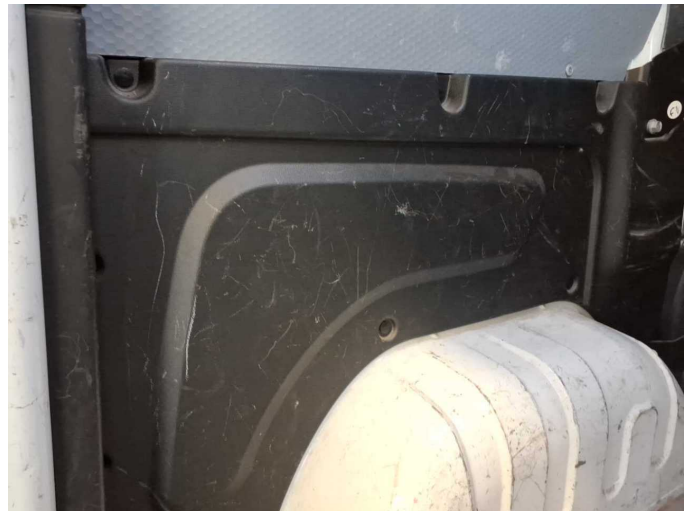
**Damage 14:** Interior: Cargo space division - Dent / paintcoat damage - Loss in value

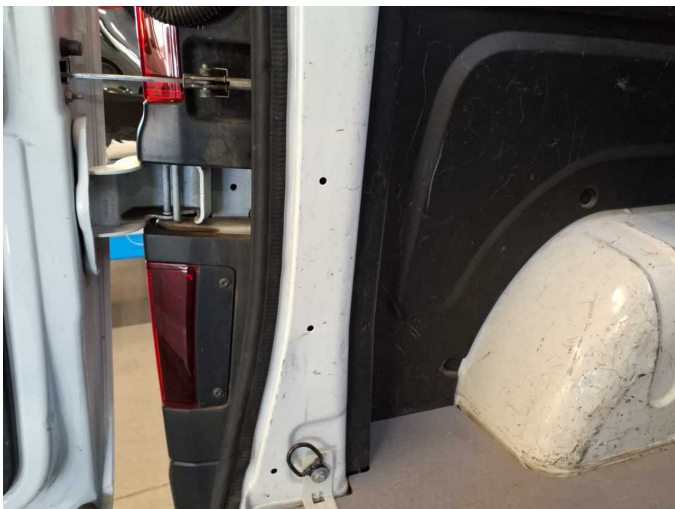
**Damage 14:** Interior: Cargo space division - Dent / paintcoat damage - Loss in value

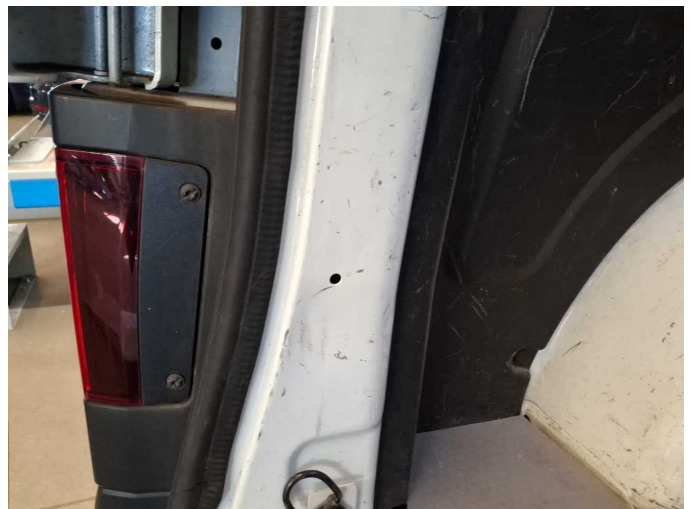
**Damage 14:** Interior: Cargo space division - Dent / paintcoat damage - Loss in value

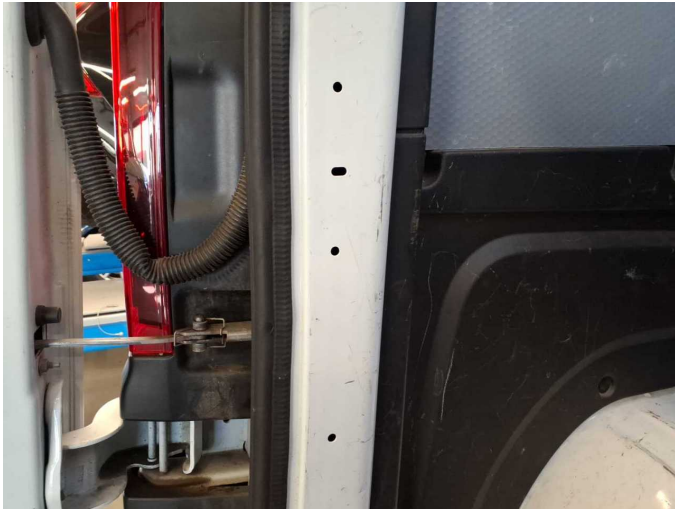
**Damage 14:** Interior: Cargo space division - Dent / paintcoat damage - Loss in value

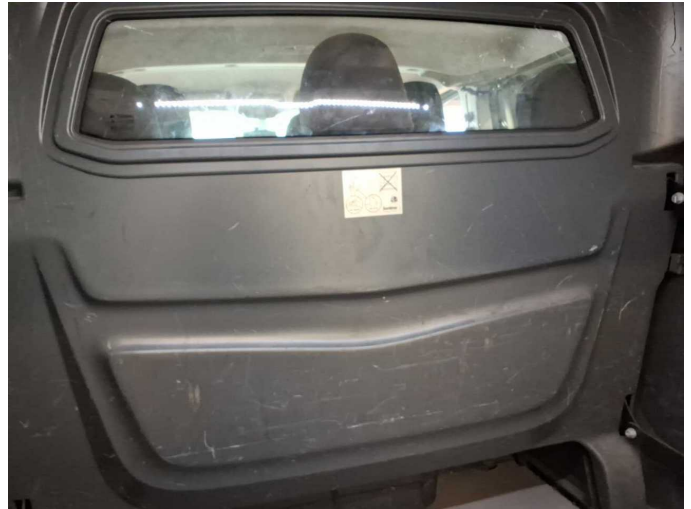
**Damage 14:** Interior: Cargo space division - Dent / paintcoat damage - Loss in value

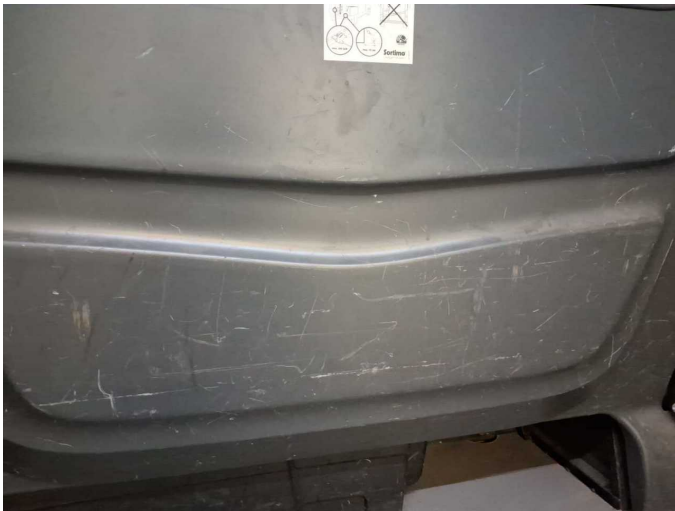
**Damage 14:** Interior: Cargo space division - Dent / paintcoat damage - Loss in value

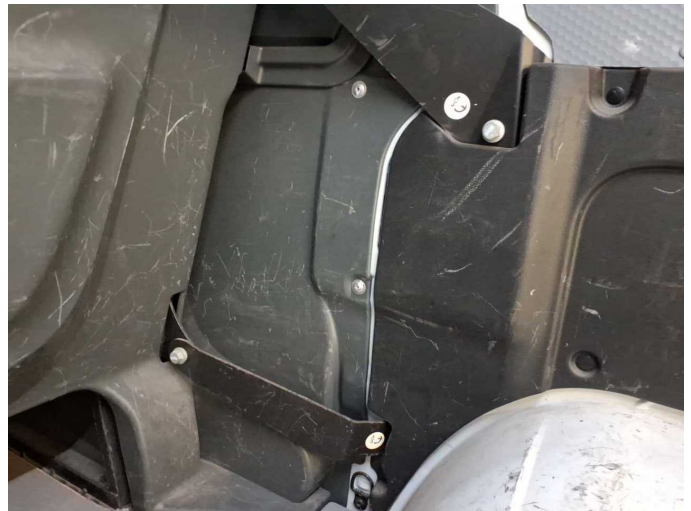
**Damage 14:** Interior: Cargo space division - Dent / paintcoat damage - Loss in value

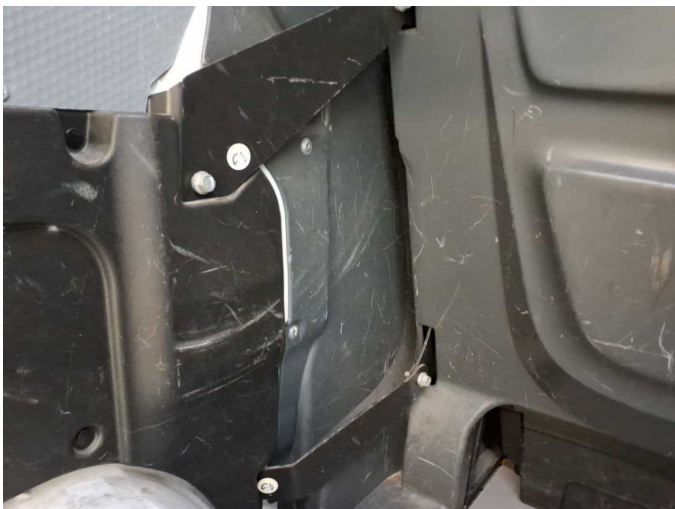
**Damage 14:** Interior: Cargo space division - Dent / paintcoat damage - Loss in value

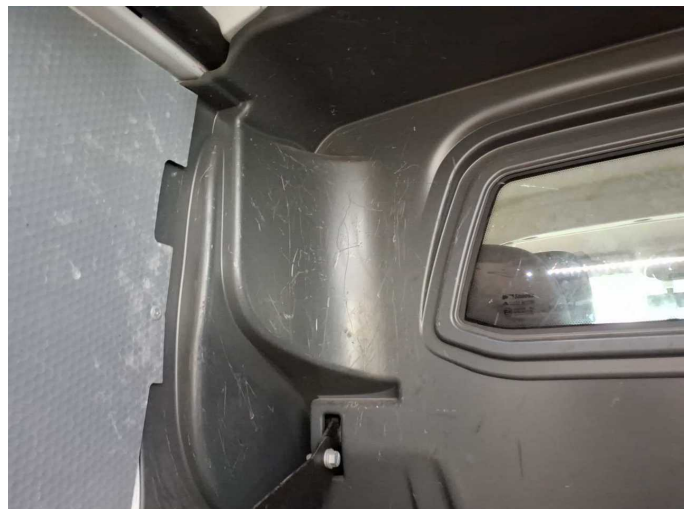
**Damage 14:** Interior: Cargo space division - Dent / paintcoat damage - Loss in value

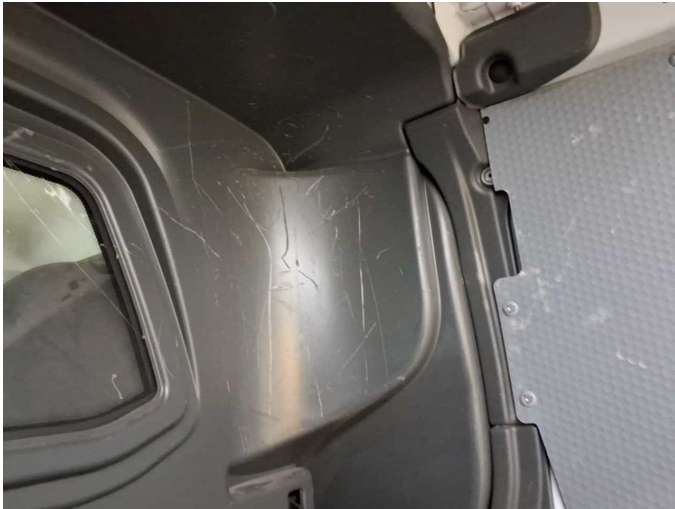
**Damage 14:** Interior: Cargo space division - Dent / paintcoat damage - Loss in value

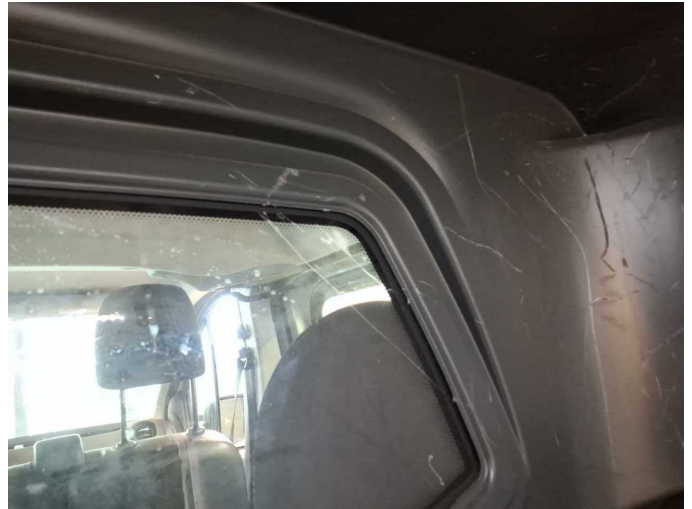
**Damage 14:** Interior: Cargo space division - Dent / paintcoat damage - Loss in value

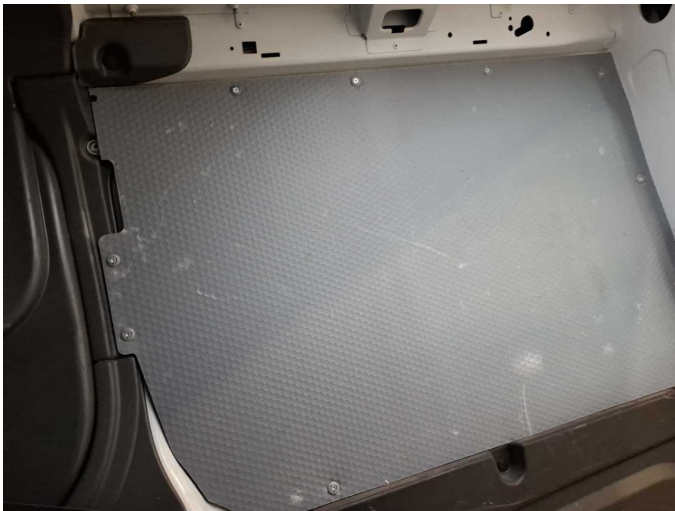
**Damage 14:** Interior: Cargo space division - Dent / paintcoat damage - Loss in value

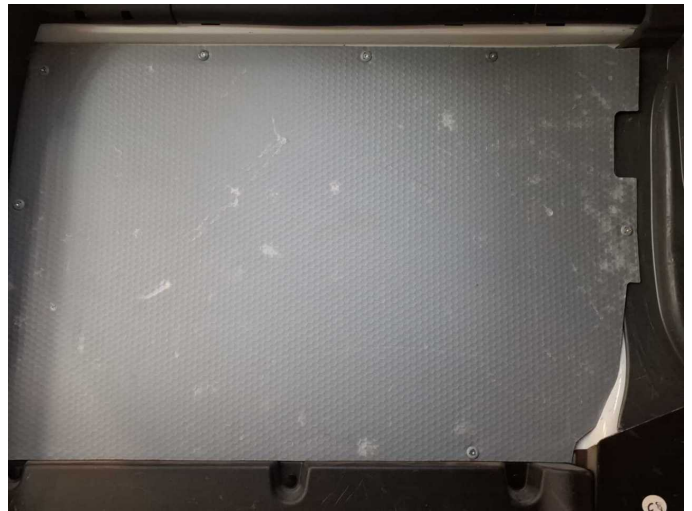
**Damage 14:** Interior: Cargo space division - Dent / paintcoat damage - Loss in value

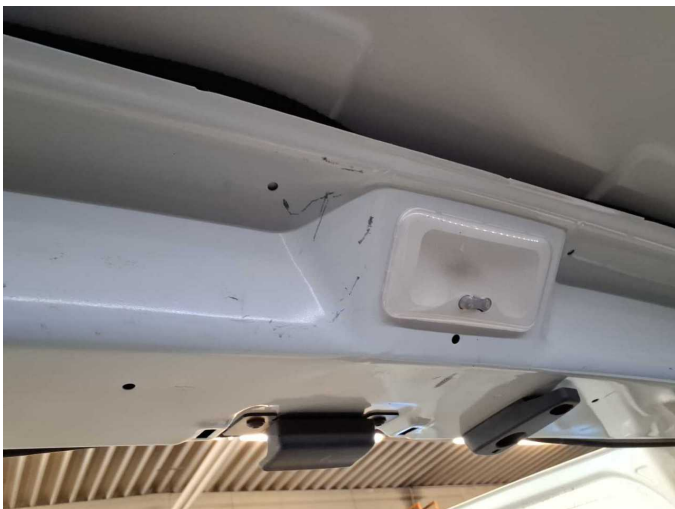
**Damage 14:** Interior: Cargo space division - Dent / paintcoat damage - Loss in value

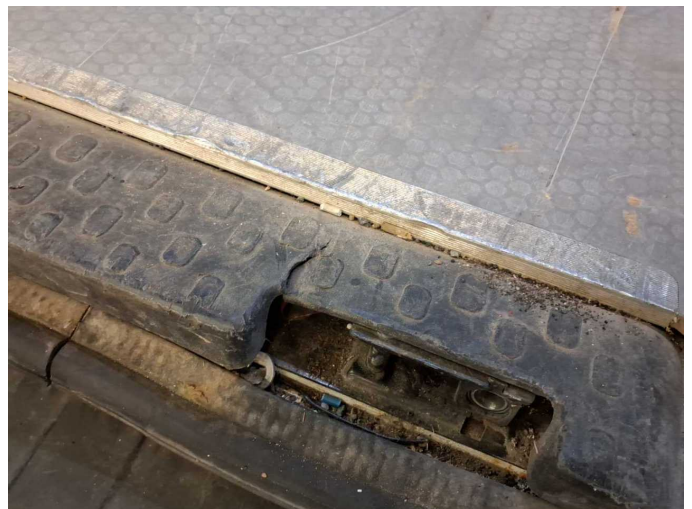
**Damage 14:** Interior: Cargo space division - Dent / paintcoat damage - Loss in value

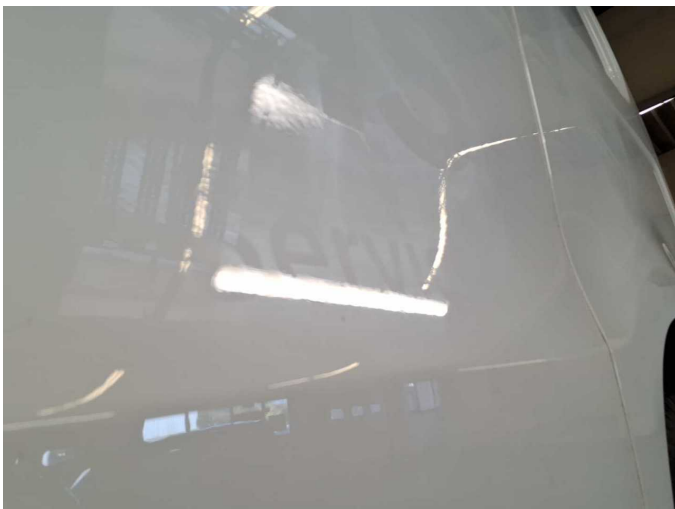
**Damage 15:** Body: Body (Klebereste) - Glued / labelled - De-glue / neutralise

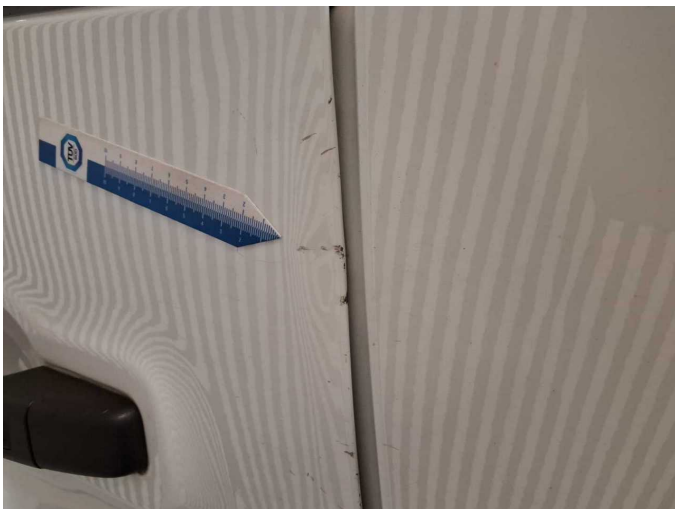
**Damage 20:** Boot lid / rear door: Rear door - left side (+ Kratzer) - Deformed - Repair and paint

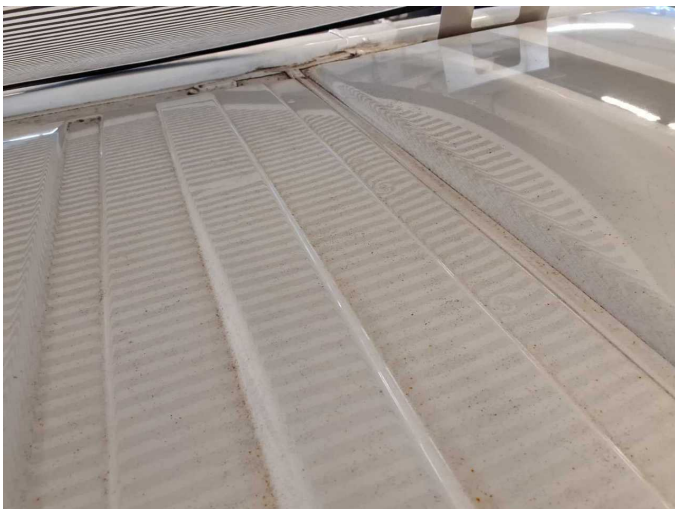
**Damage 21:** Roof: Roof (+ Delle) - Deformed - Repair and paint

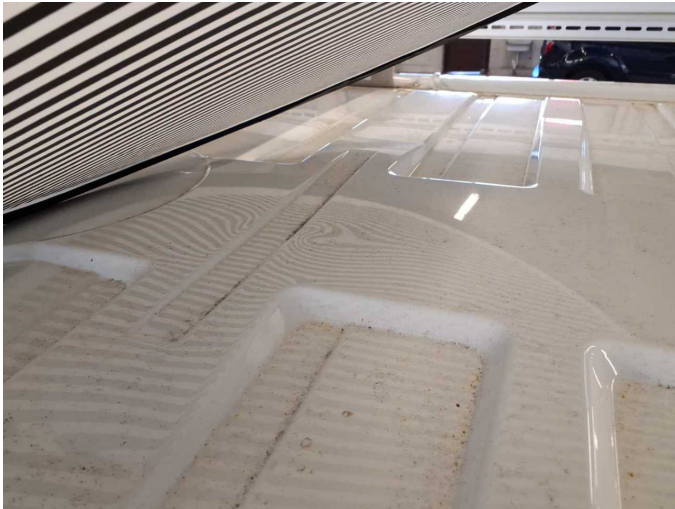
**Damage 21:** Roof: Roof (+ Delle) - Deformed - Repair and paint

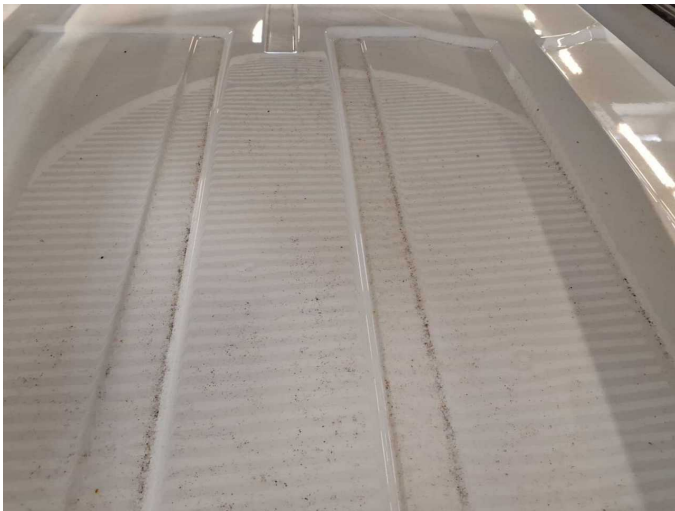
**Damage 21:** Roof: Roof (+ Delle) - Deformed - Repair and paint
