## status report

**customer:** Bank 11, Neuss  
**contract number:** 934788730-INSO  
**reference:**

#### Renault Trafic Kasten L1H1 2,8t Komfort

| Vehicle identification number | <b>VF1FL000869403681</b> | mileage read: | <b>30652 km</b> |

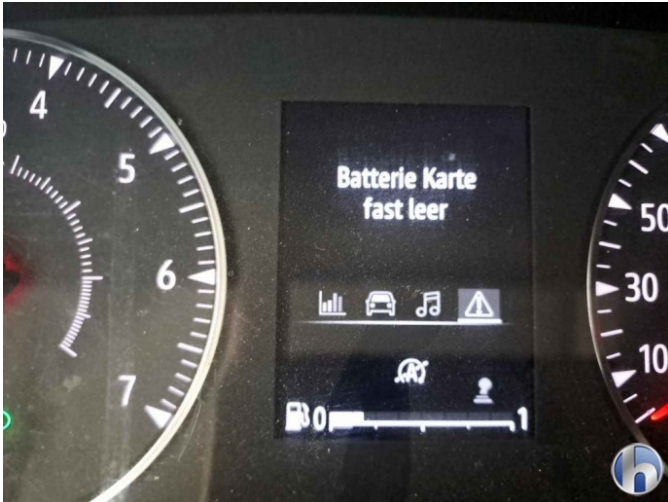
| component | Damage | Rep kind |
|---|---|---|
| 2. Key with remote control | Empty battery | Replace |

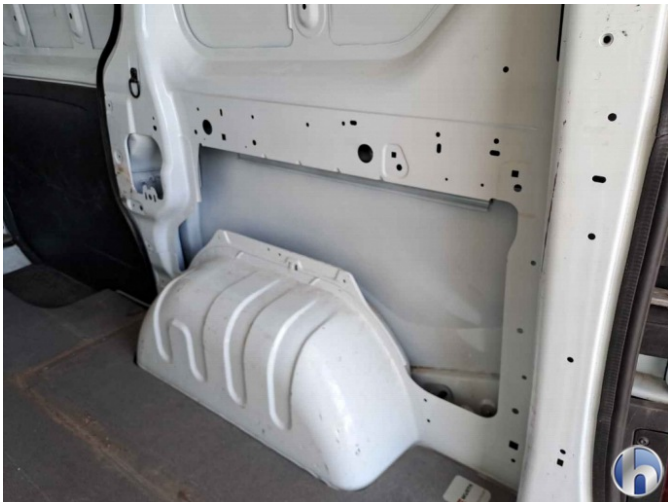
| component | Damage | Rep kind |
|---|---|---|
| 7. Laderaum Verkleidungen | Missing | Replace |

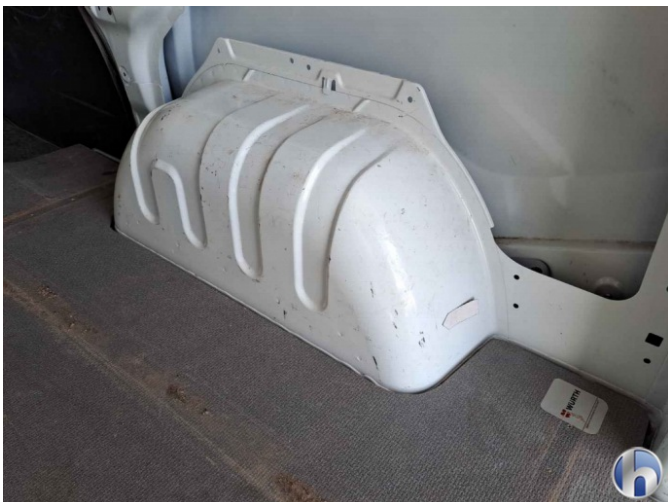
| component | Damage | Rep kind |
|---|---|---|
| 8. | Damaged | Refurbish and paint |

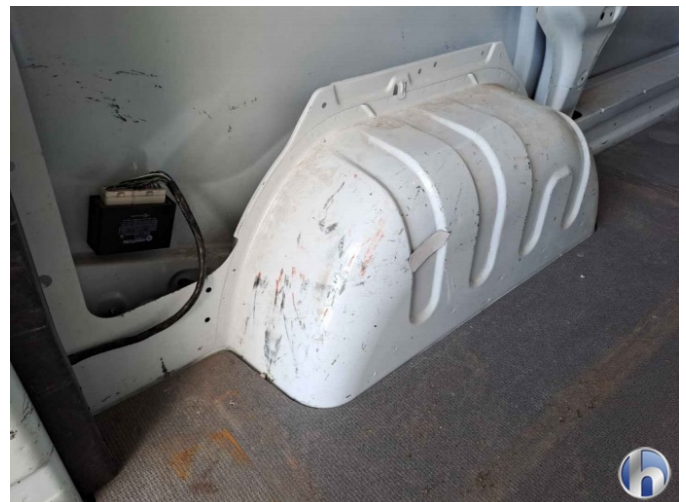
| component | Damage | Rep kind |
|---|---|---|
| 9. | Damaged | Refurbish and paint |

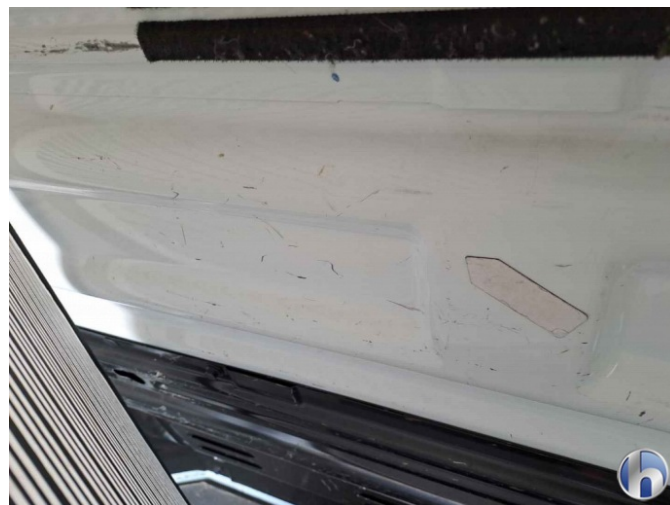
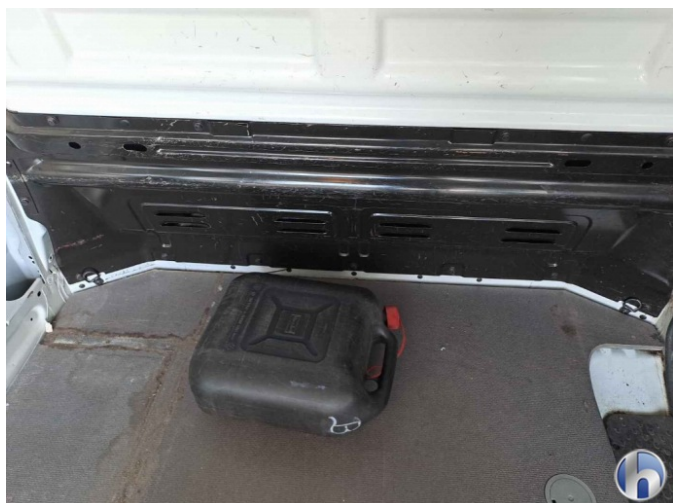
| component | Damage | Rep kind |
|---|---|---|
| 10. Partition load space | Damaged | Refurbish and paint |

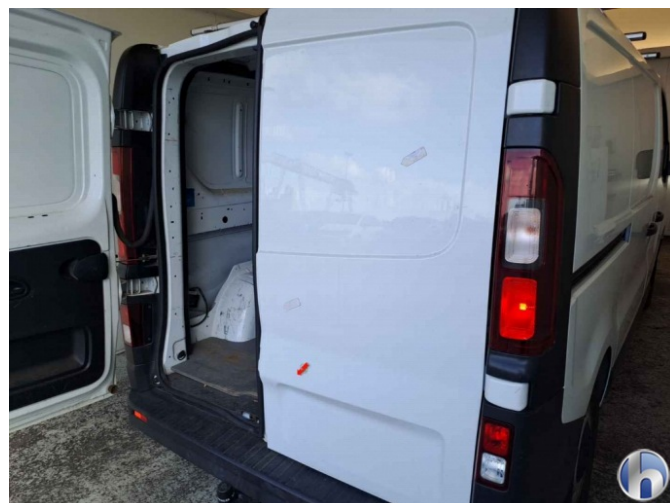
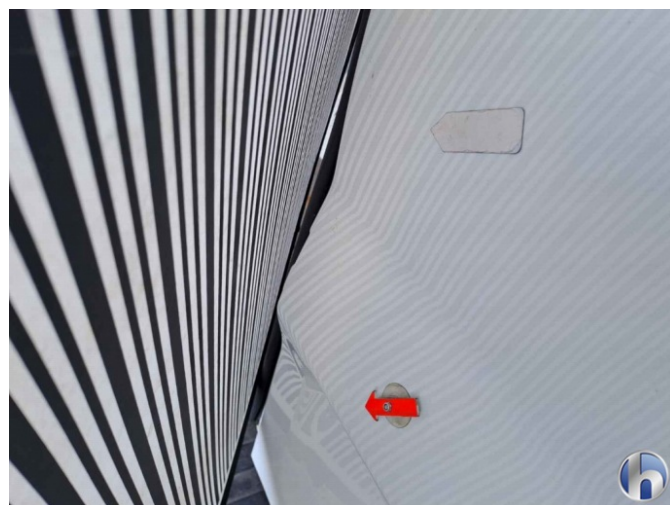
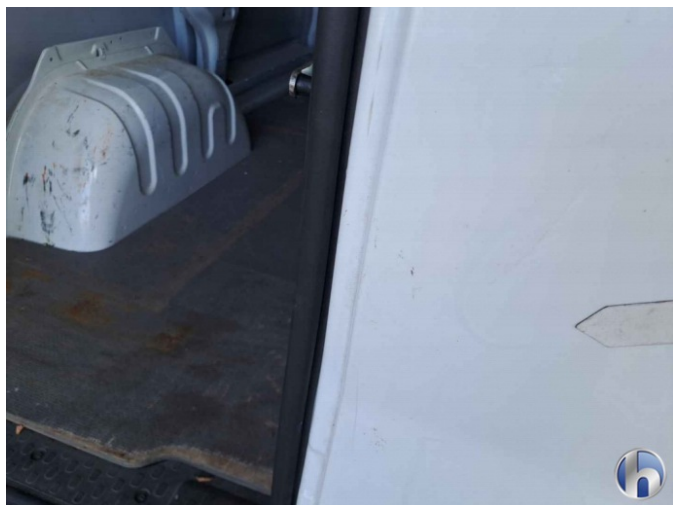
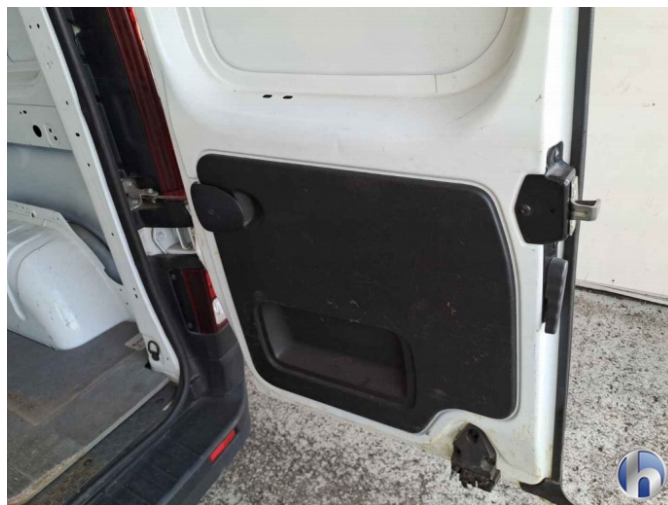
| component | Damage | Rep kind |
|---|---|---|
| 11. Tailgate right | Damaged | Refurbish and paint |

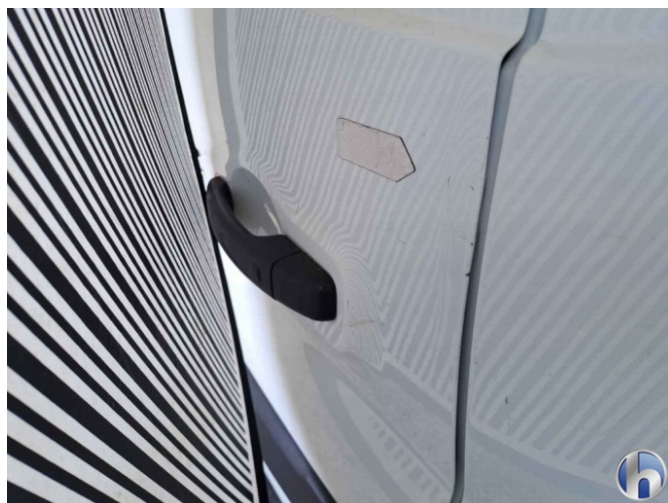
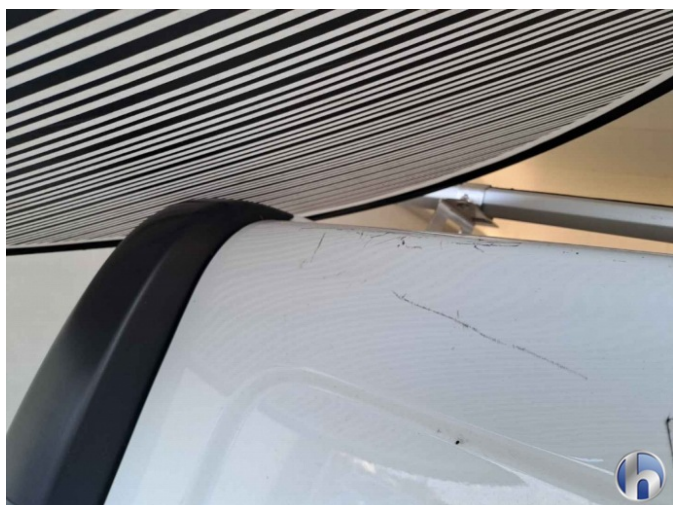
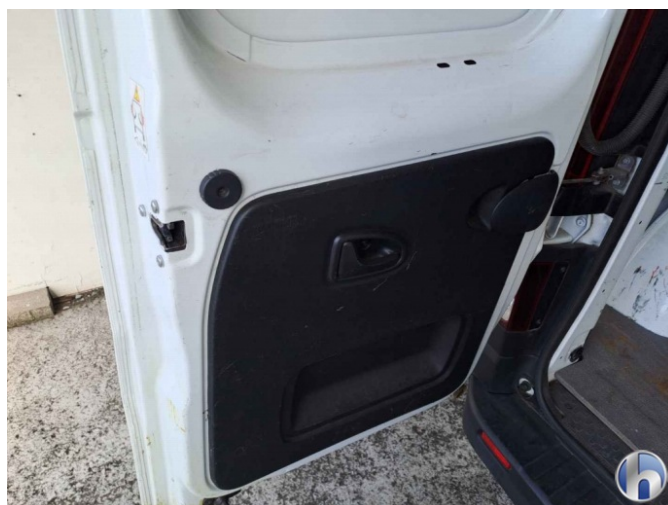
| component | Damage | Rep kind |
|---|---|---|
| 12. Tailgate left | Damaged | Refurbish and paint |

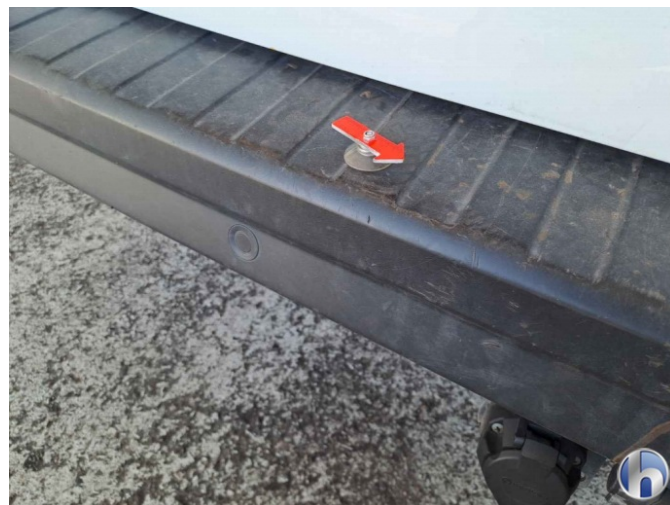
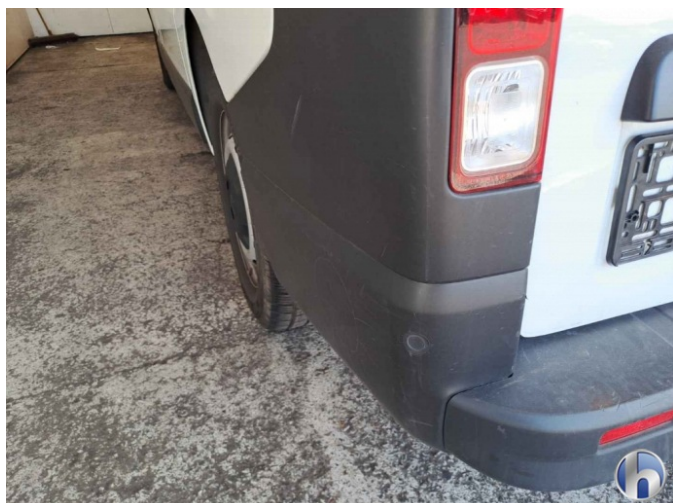
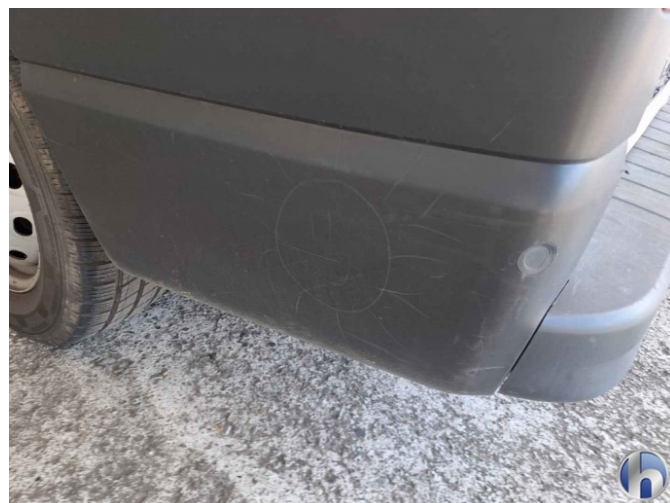
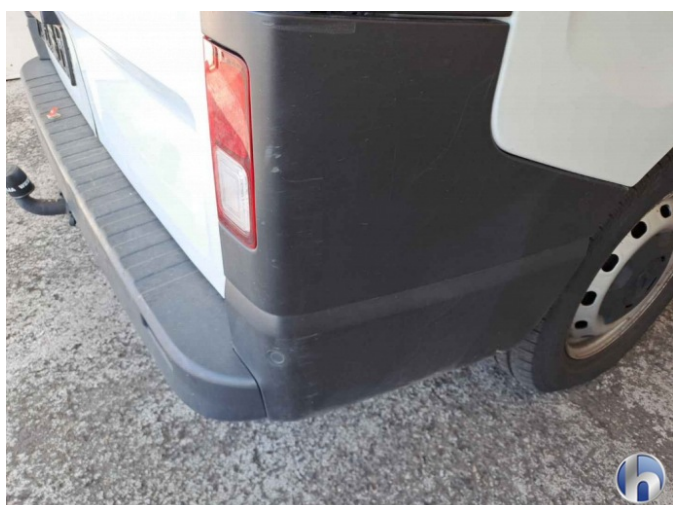
| component | Damage | Rep kind |
|---|---|---|
| 13. Rear bumper | Damaged | Replace |

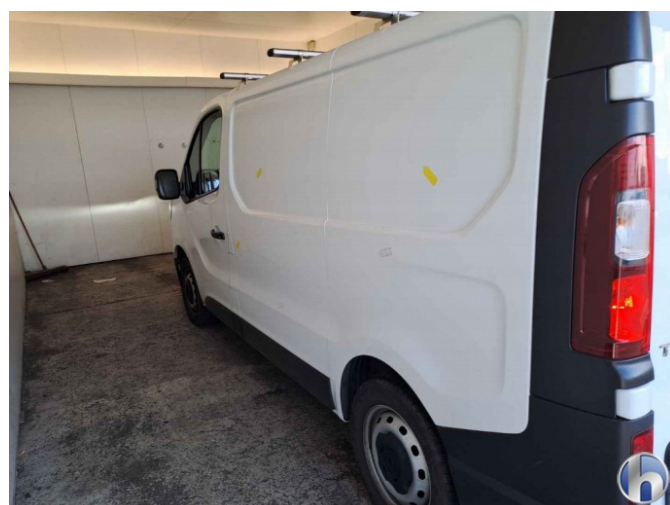
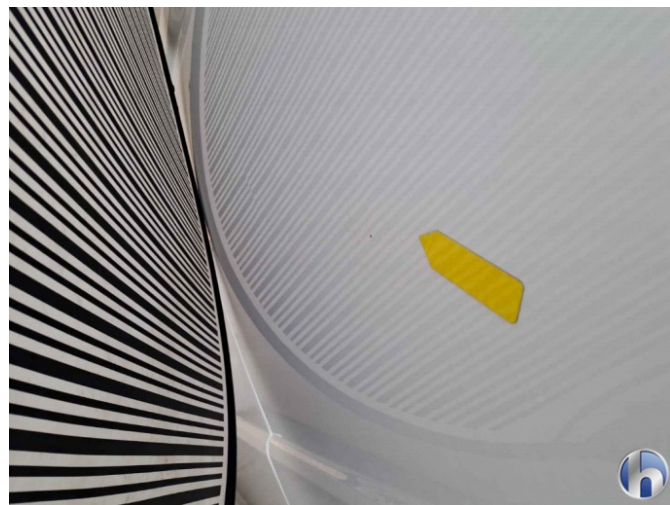
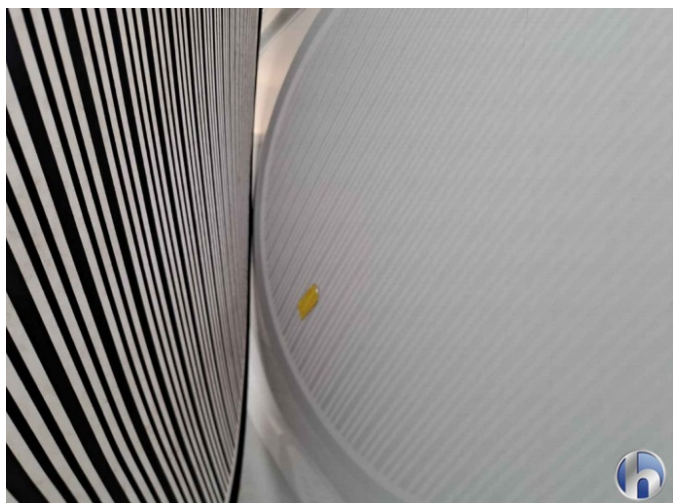
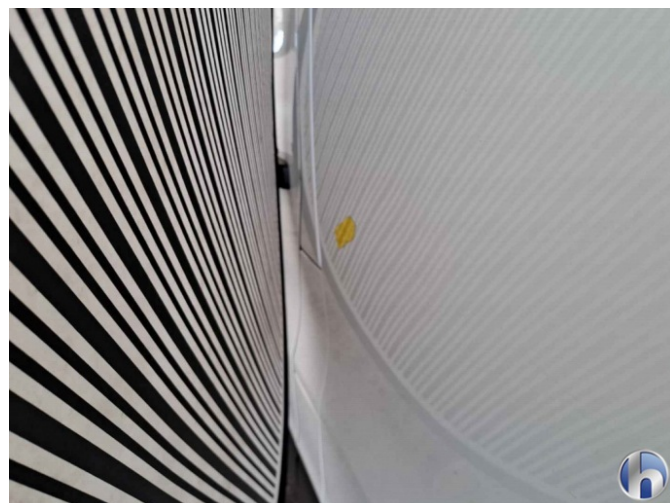
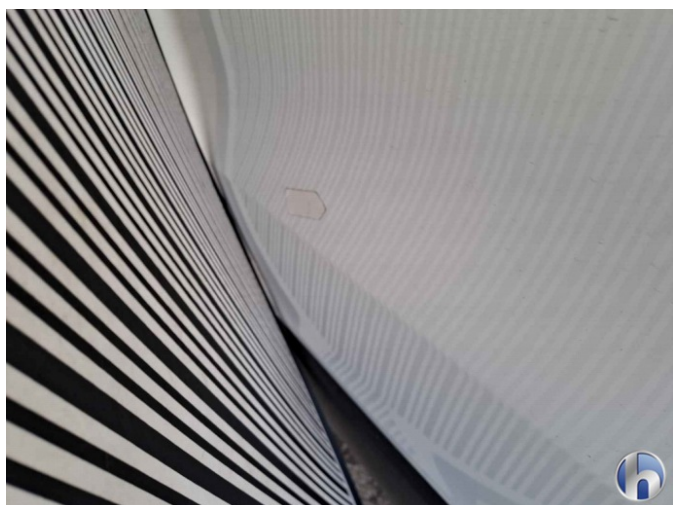
| component | Damage | Rep kind |
|---|---|---|
| 14. Seitenwand - Links | Damaged | Refurbish and paint |

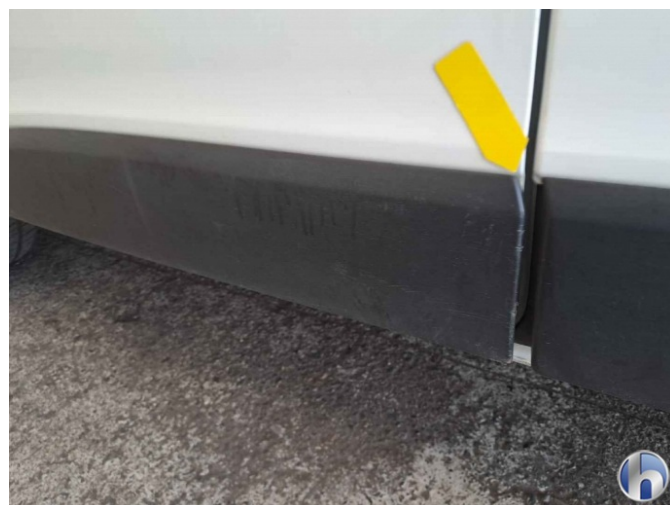
| component | Damage | Rep kind |
|---|---|---|
| 15. Tür Vorne - Links Beplankung | Scrape | Replace |

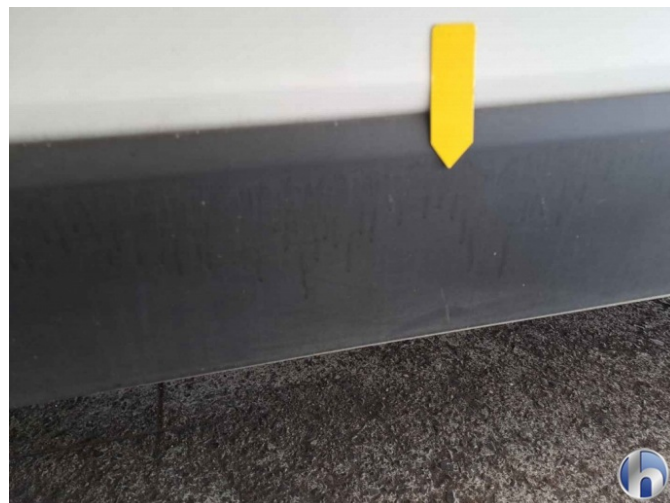
| component | Damage | Rep kind |
|---|---|---|
| 16. Seitenwand - Beplankung- Links | Scratch(es) | Replace |

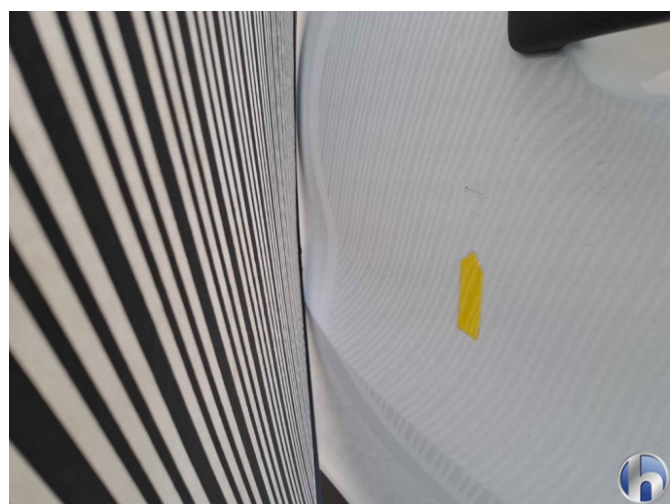
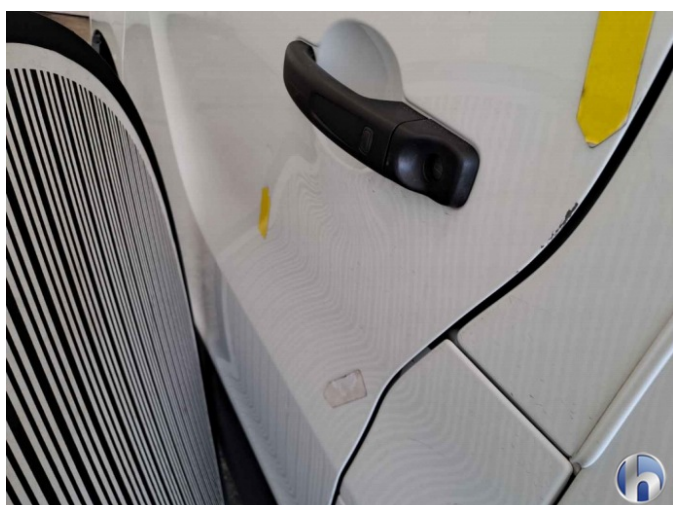
| component | Damage | Rep kind |
|---|---|---|
| 17. Front door - left | Damaged | Refurbish and paint |

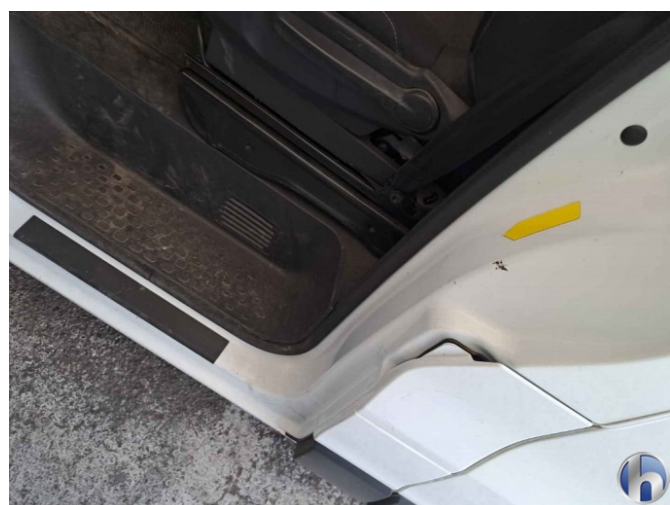
| component | Damage | Rep kind |
|---|---|---|
| 18. Türeinstieg Vorne - Links | Damaged | Refurbish and paint |

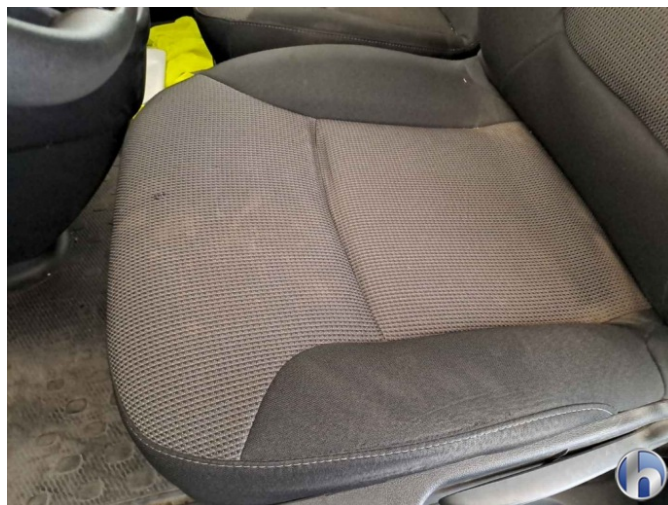
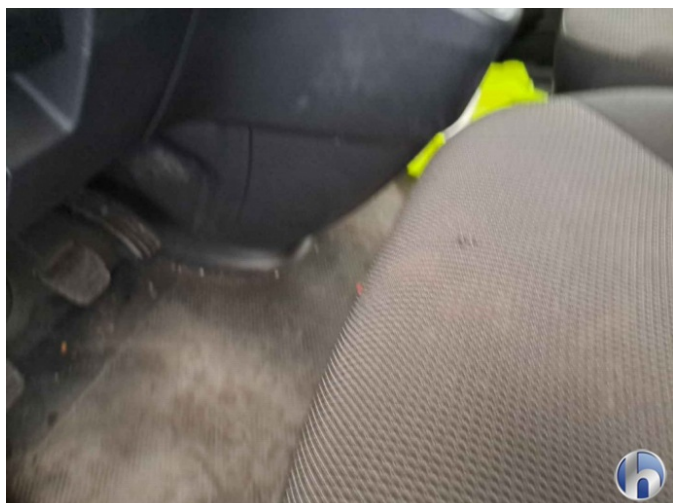
| component | Damage | Rep kind |
|---|---|---|
| 19. | Damaged | Replace |

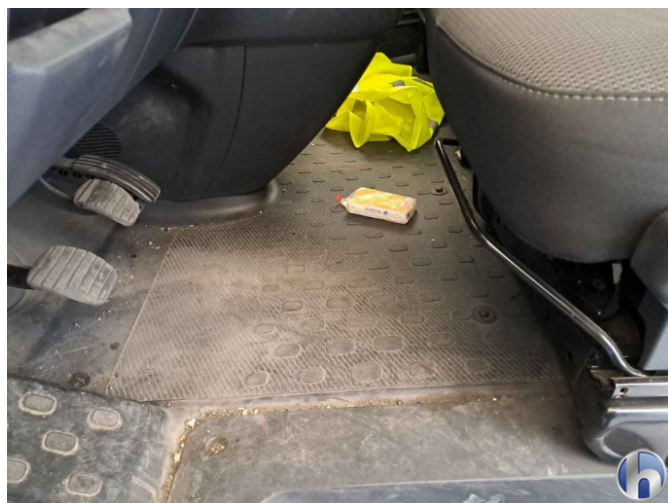
| component | Damage | Rep kind |
|---|---|---|
| 20. | Missing | Replace |

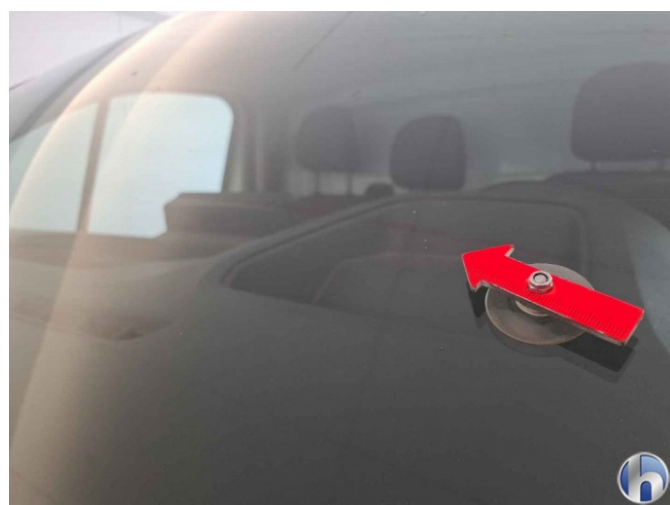
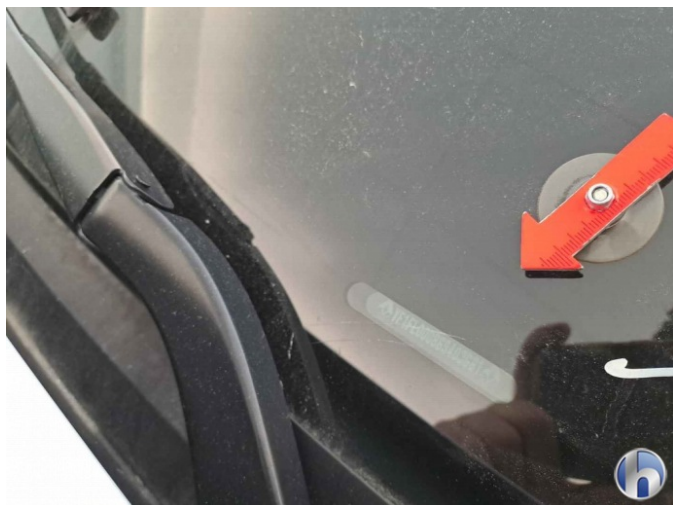
| component | Damage | Rep kind |
|---|---|---|
| 24. Windshield | Damaged | Replace |

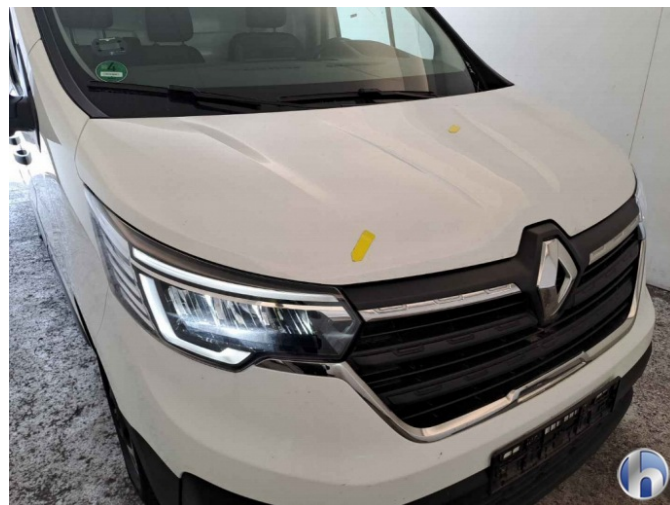
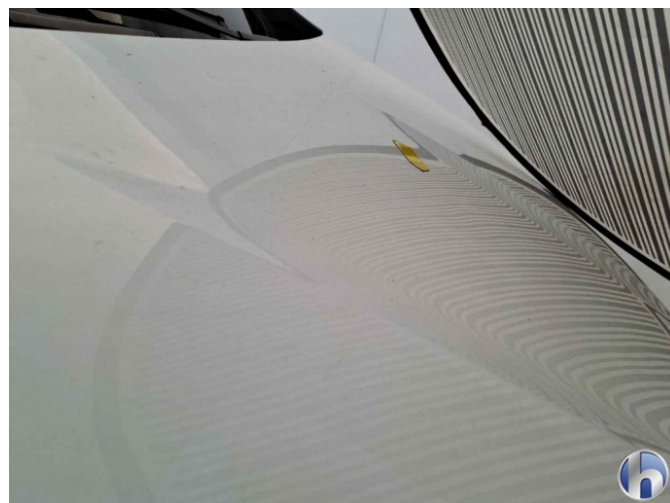
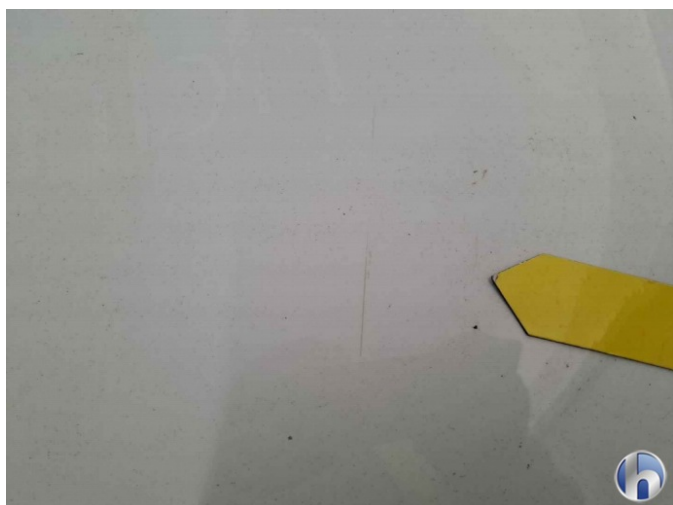
| component | Damage | Rep kind |
|---|---|---|
| 25. hood | Damaged | Refurbish and paint |

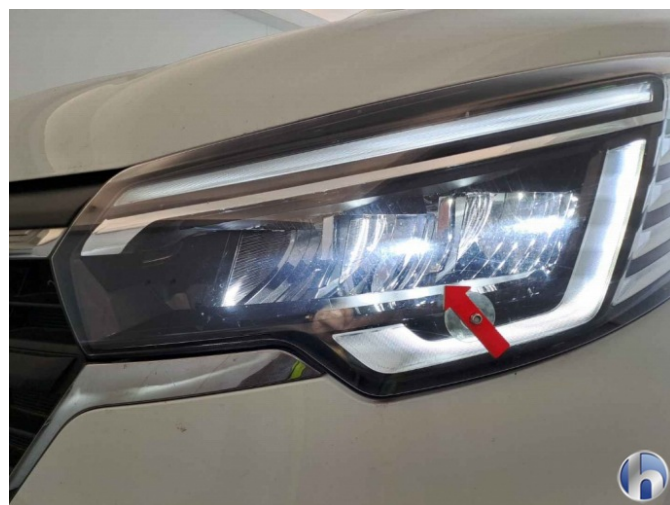
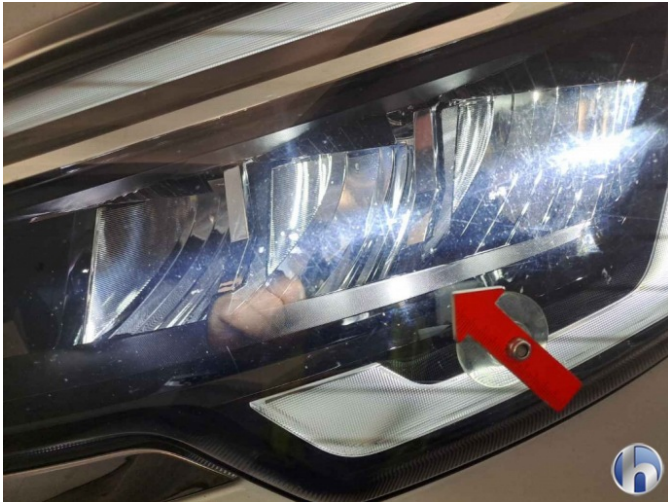
| component | Damage | Rep kind |
|---|---|---|
| 26. | Scratch(es) | Replace |

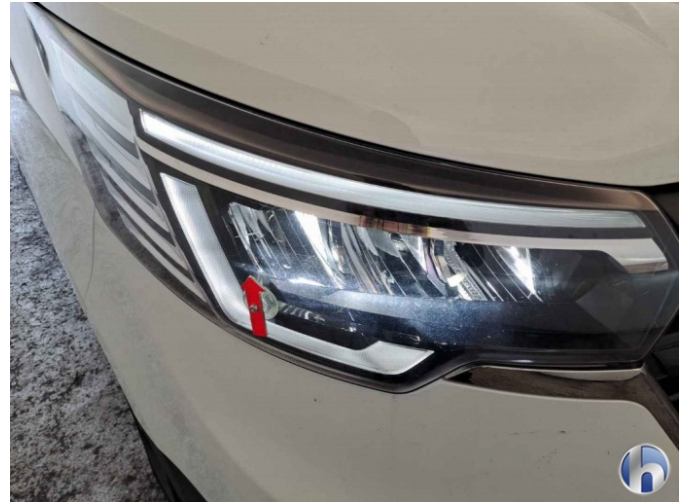
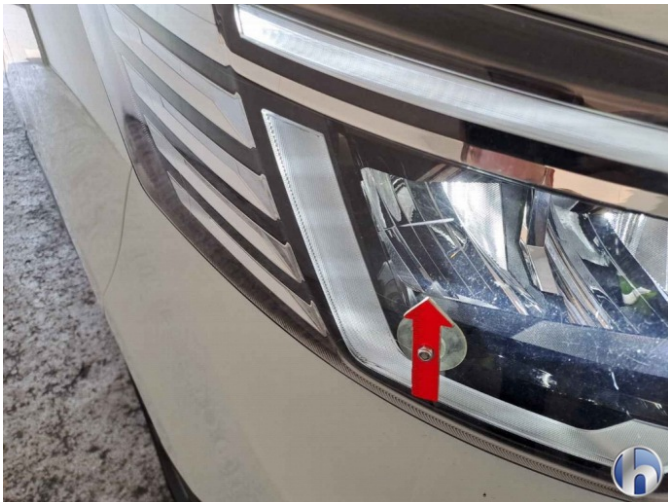
| component | Damage | Rep kind |
|---|---|---|
| 27. | Scratch(es) | Replace |

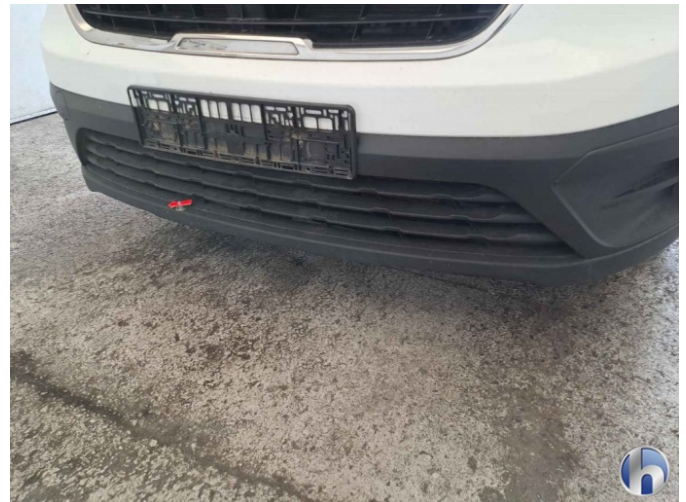
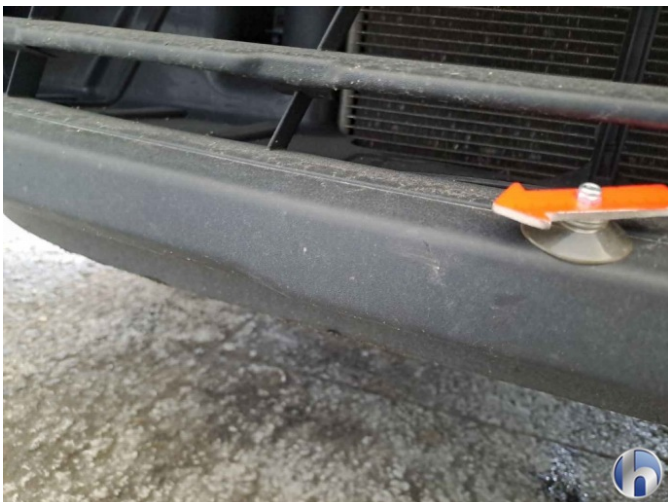
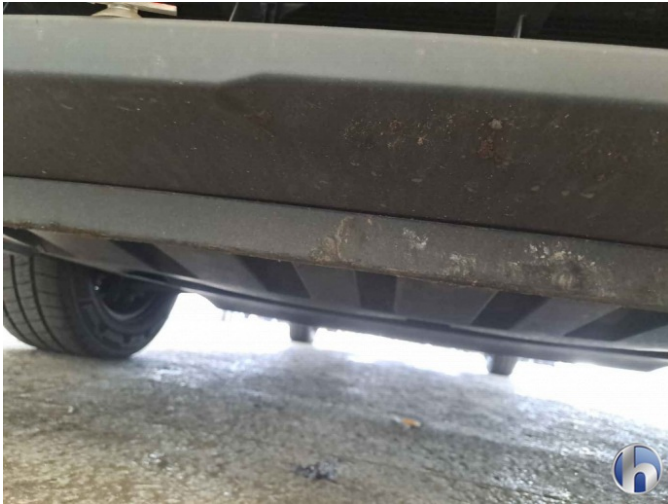
| component | Damage | Rep kind |
|---|---|---|
| 28. spoiler | Scrape | Replace |

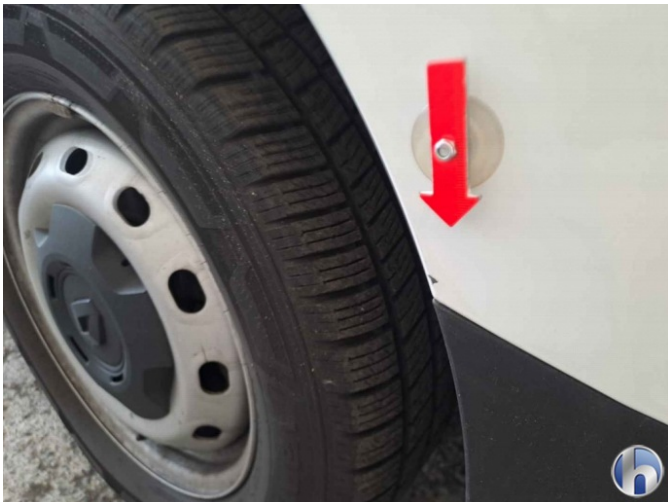
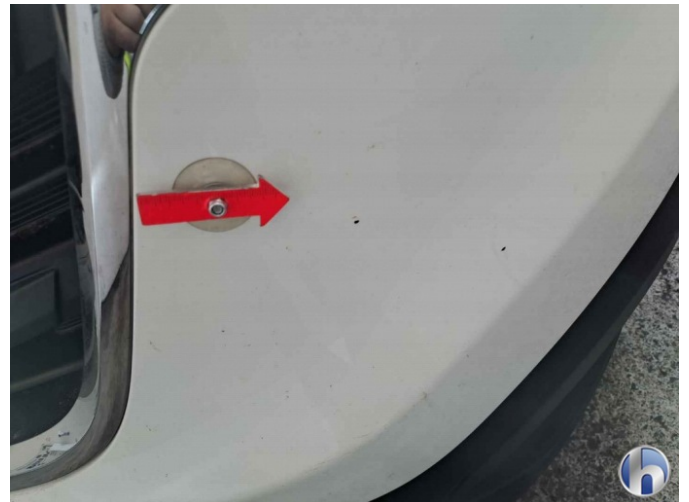
| component | Damage | Rep kind |
|---|---|---|
| 29. Front bumper | Scratch(es) | Replace |

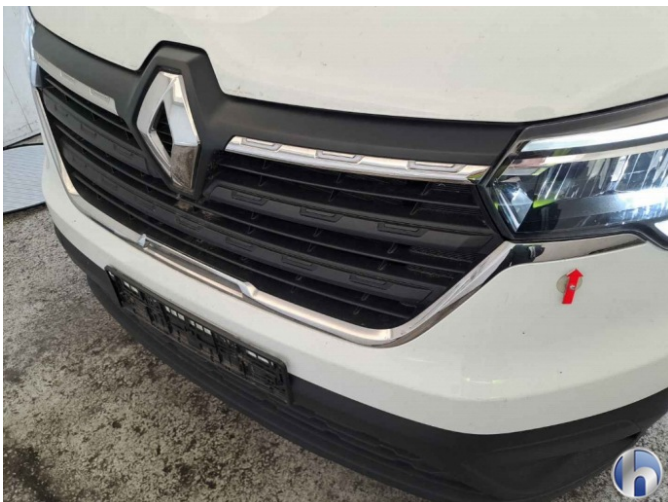
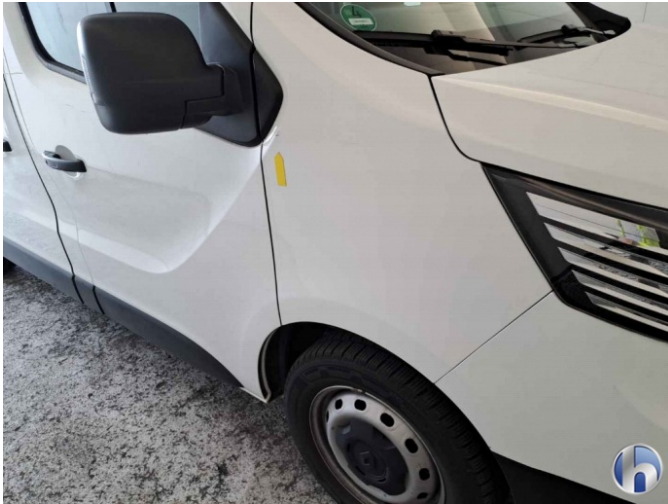
| component | Damage | Rep kind |
|---|---|---|
| 30. Front grille top | Scratch(es) | Replace |

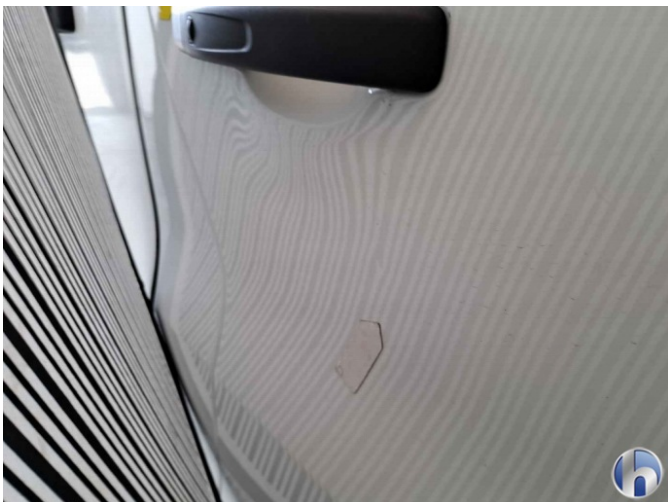
| component | Damage | Rep kind |
|---|---|---|
| 32. Front door - right | Damaged | Refurbish and paint |

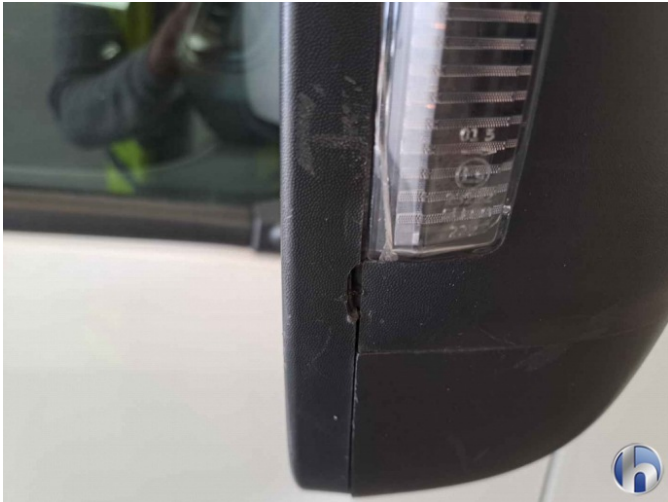
| component | Damage | Rep kind |
|---|---|---|
| 33. Outside mirror - right | Damaged | Replace |

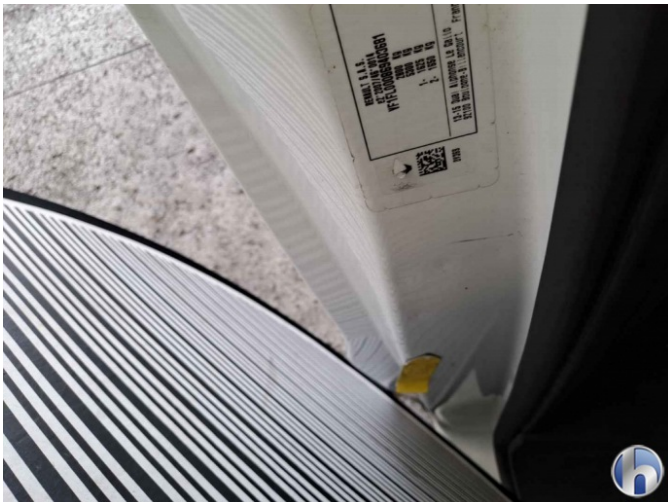
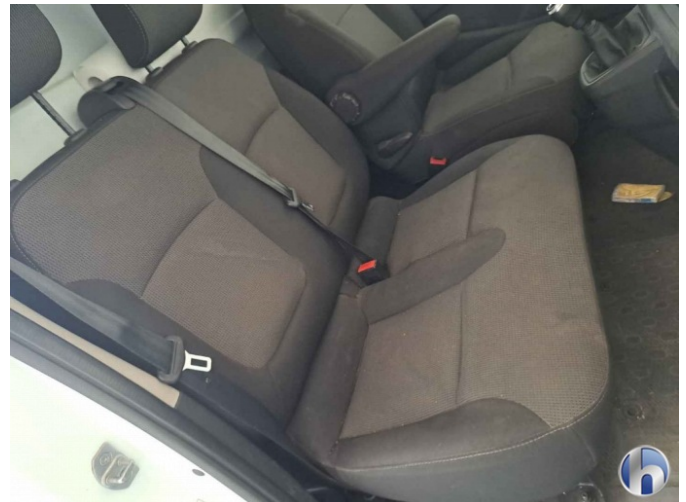
| component | Damage | Rep kind |
|---|---|---|
| 34. Türeinstieg Vorne - Rechts | Damaged | Refurbish and paint |

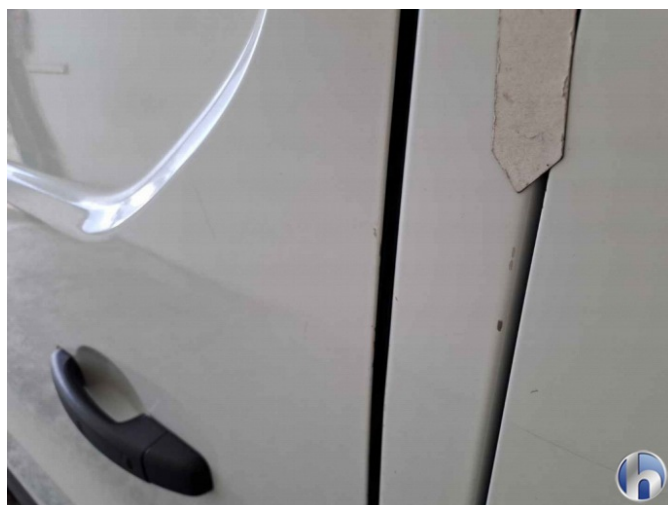
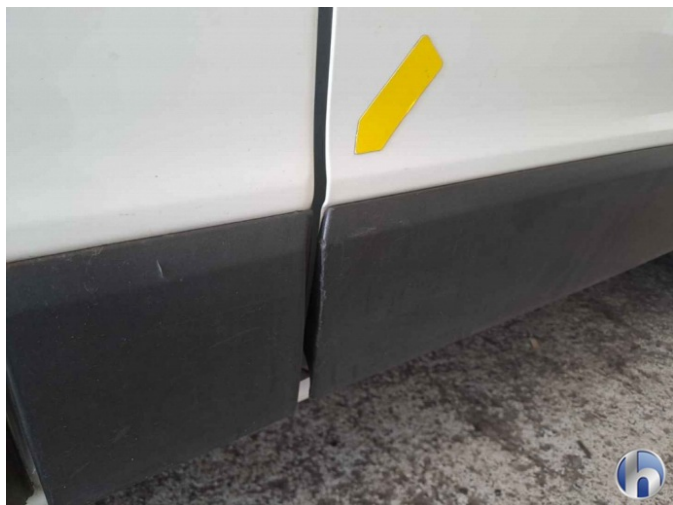
| component | Damage | Rep kind |
|---|---|---|
| 37. B-pillar center - right | Damaged | Refurbish and paint |

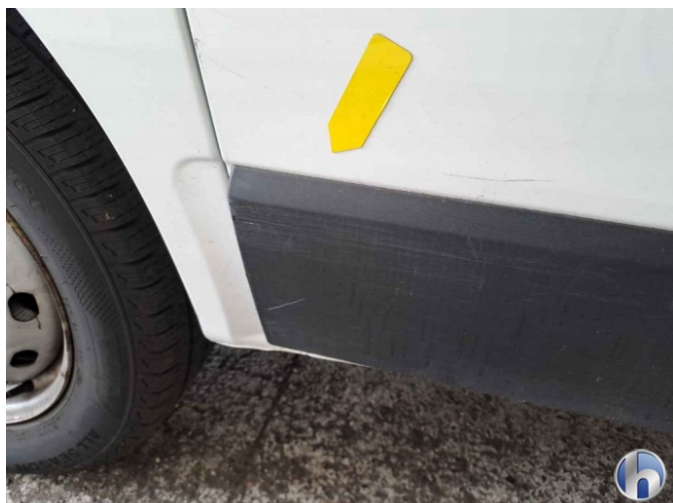
| component | Damage | Rep kind |
|---|---|---|
| 39. B-säule Mitte - Rechts Beplankung | Scratch(es) | Replace |

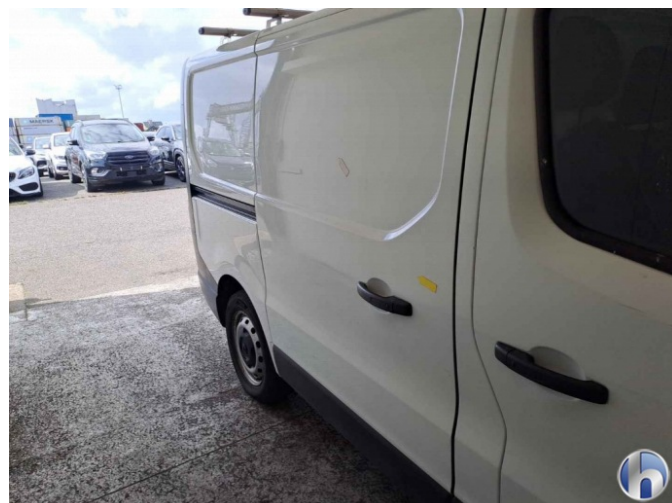
40. Schiebetür - Rechts Beplankung

| 40. | Schiebetür - Rechts Beplankung | Scrape | Replace |

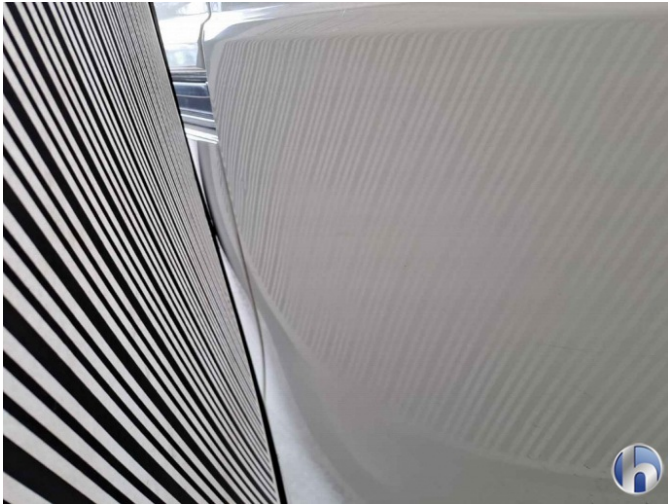
41. Sliding door - right

| 41. | Sliding door - right | Execution defect | Refurbish and paint |

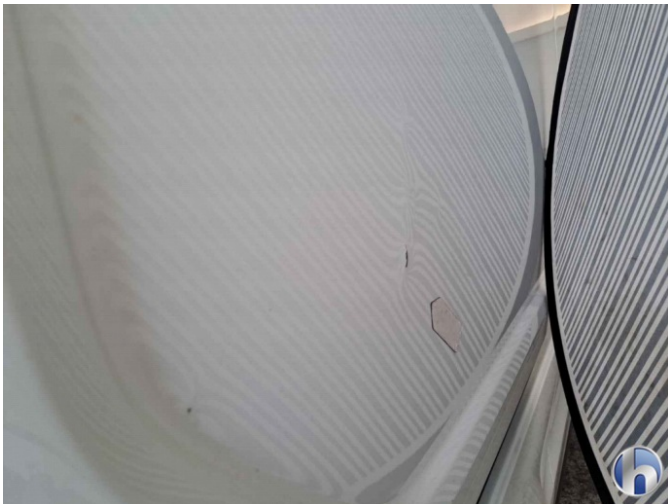
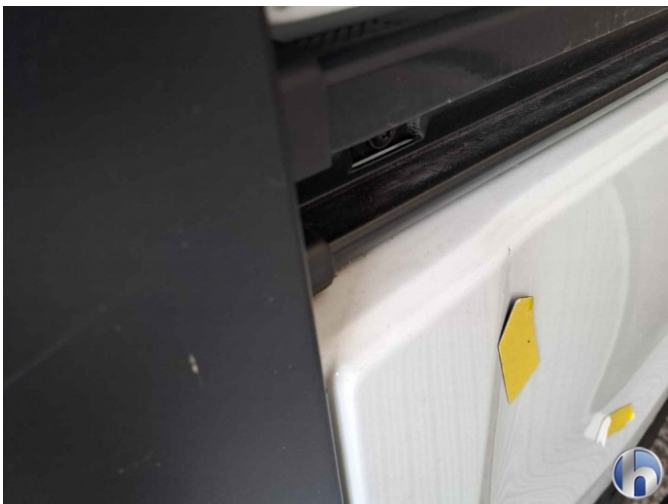
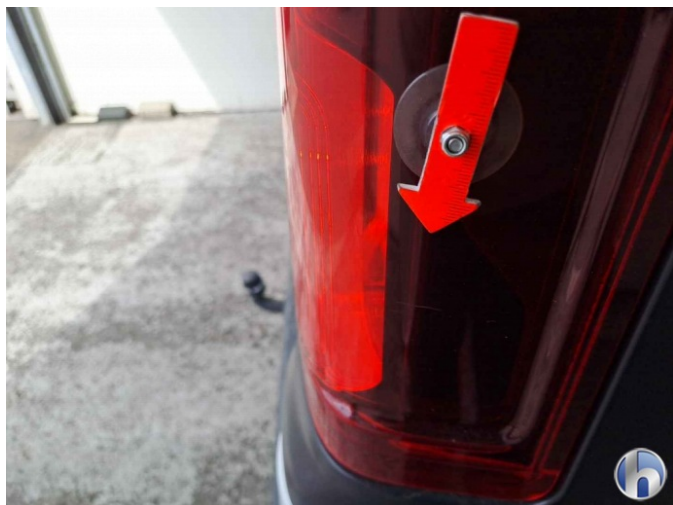
42. Sidewall - Rear - right

| 42. | Sidewall - Rear - right | Damaged | Refurbish and paint |

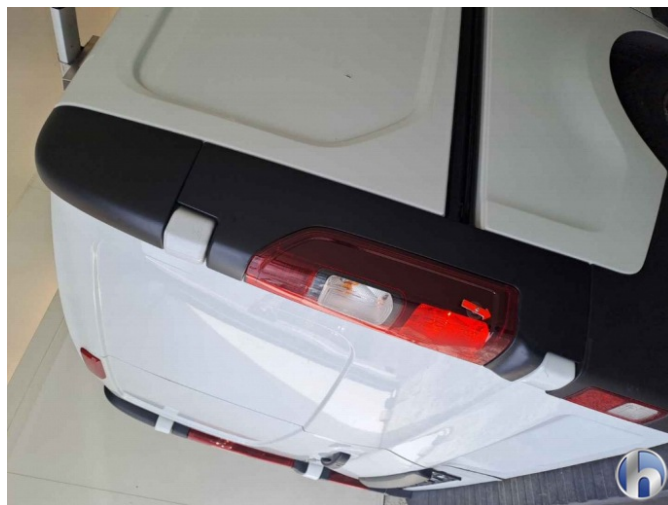
43. Taillight right

| 43. | Taillight right | Scratch(es) | Replace |

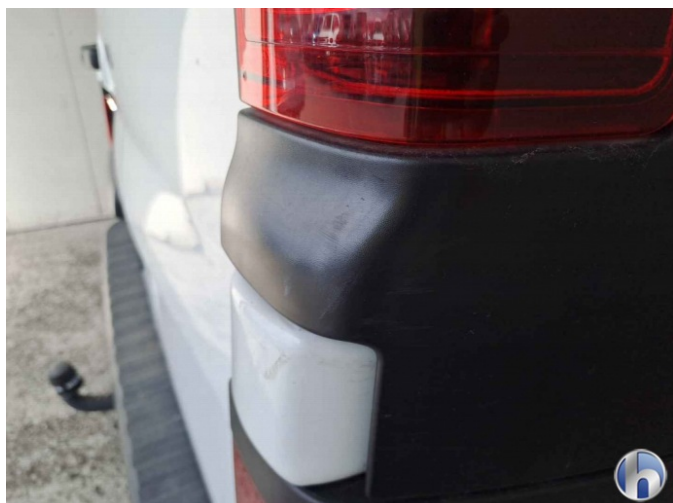
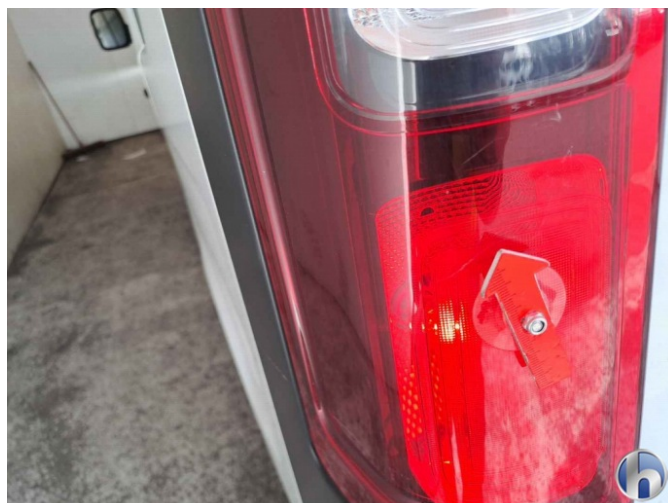
| 44. | | Scrape | Replace |
