## status report

**customer:** Bank 11, Neuss  
**contract number:** 934788730-INSO  
**reference:**

#### Renault Trafic Kasten L1H1 2,8t Komfort

| Vehicle identification number | <b>VF1FL000869403681</b> | mileage read: | <b>30652 km</b> |

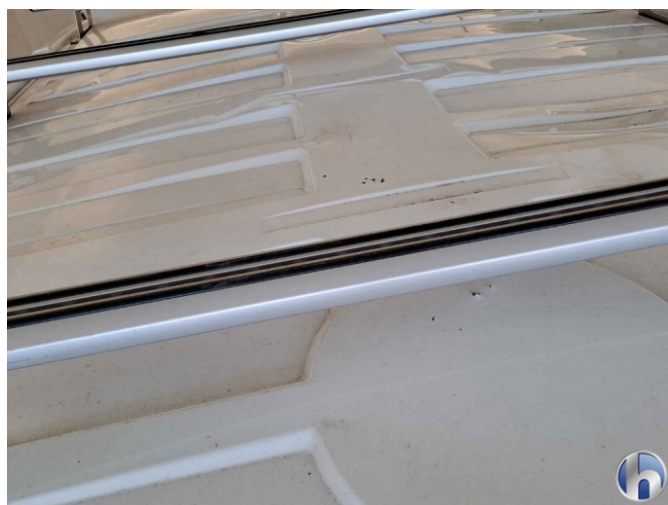
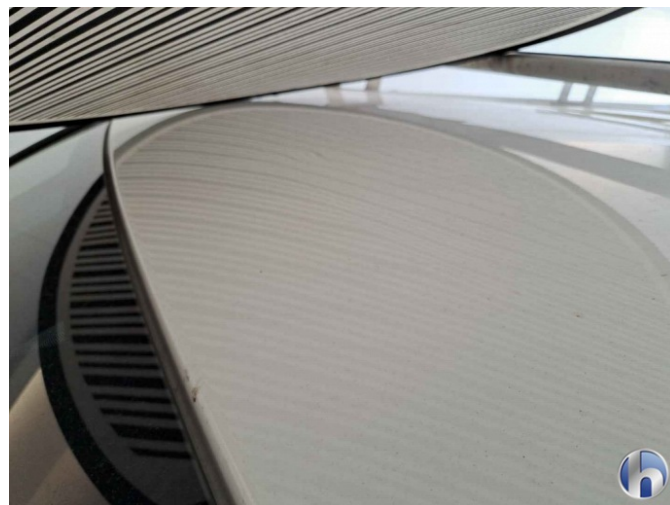
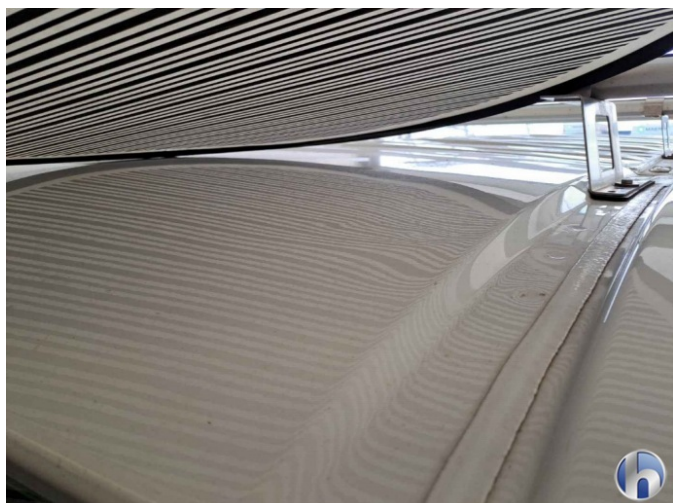
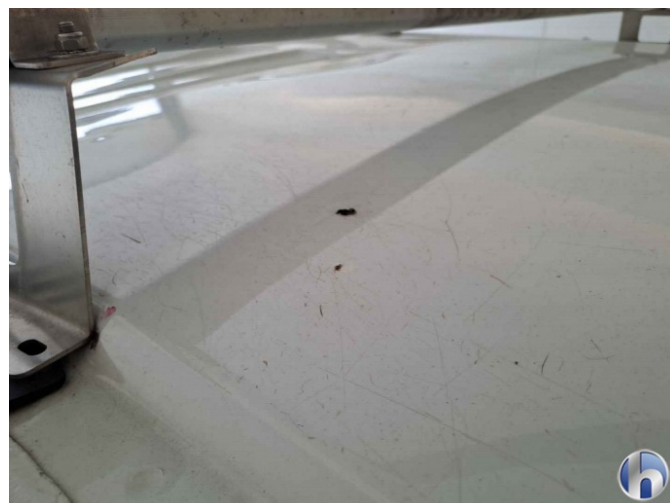
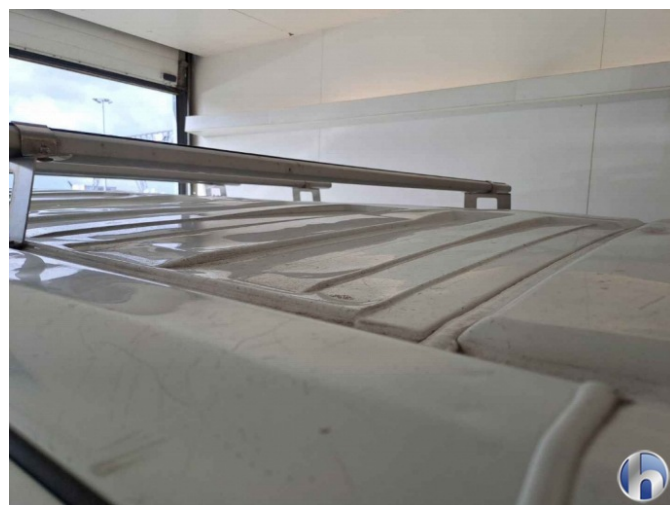
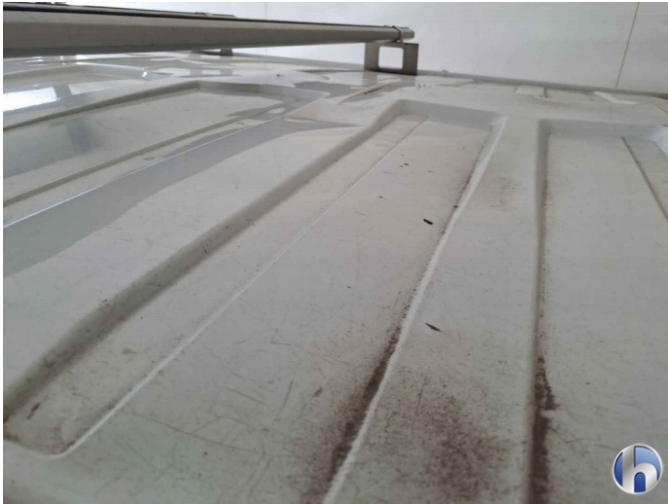
56. roof

| 56. | roof | Damaged | Replace |
