## status report

| vehicle data | | | |
|---|---|---|---|
| <b>Renault Trafic Kasten L1H1 2,7t Komfort</b> | | | |
| Vehicle identification number | <b>VF1FL000963546139</b> | mileage estimated: | <b>999999 km</b> |
| First Registration / construction year: | <b>01.07.2019 / 2019</b> | Visit Date / place of birth: | <b>17.07.2025 Neuss</b> |

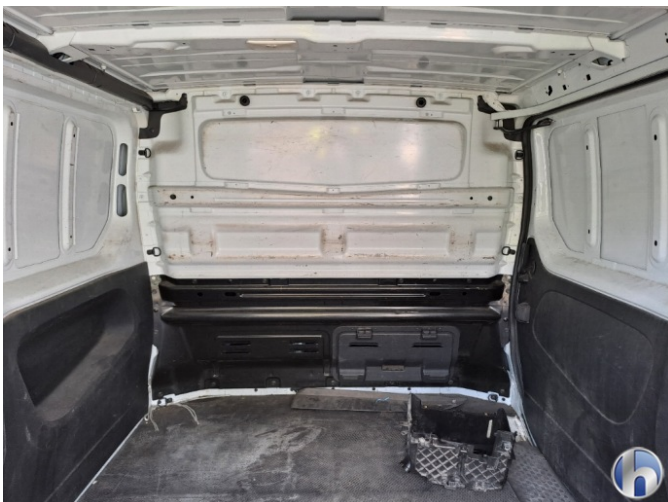
| component | Damage | Rep kind |
|---|---|---|
| 8. | Wear and tear | acceptable |

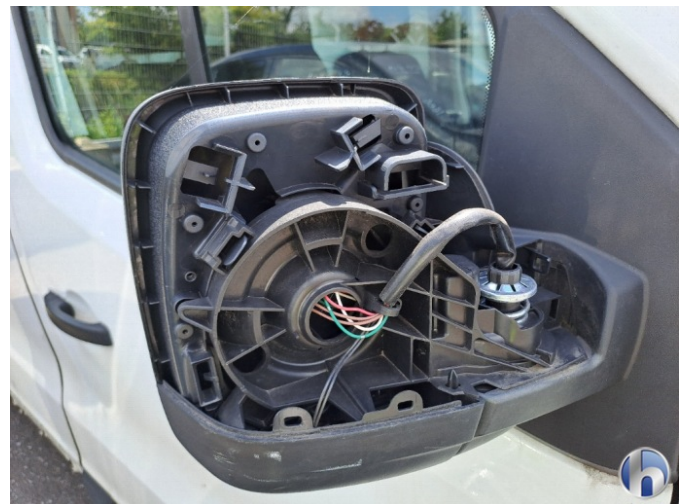
| component | Damage | Rep kind |
|---|---|---|
| 19. | Missing | Replace |

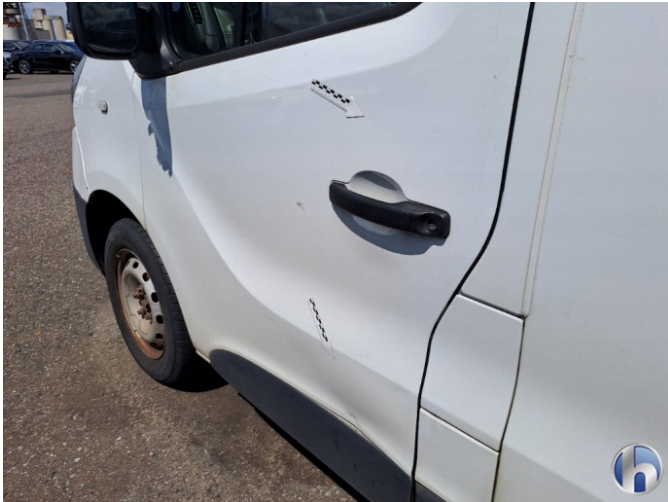
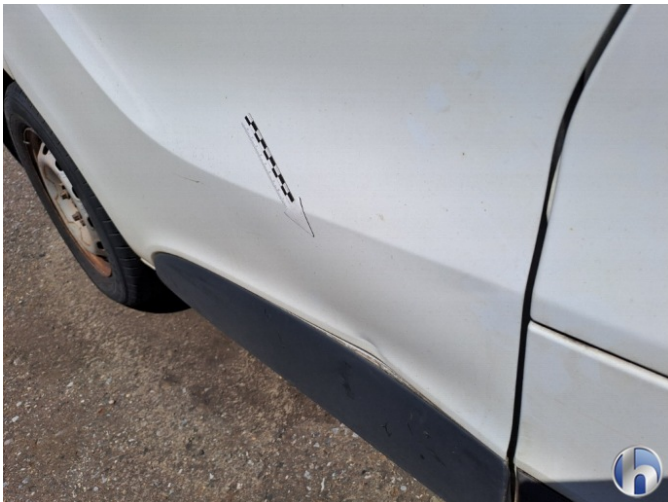
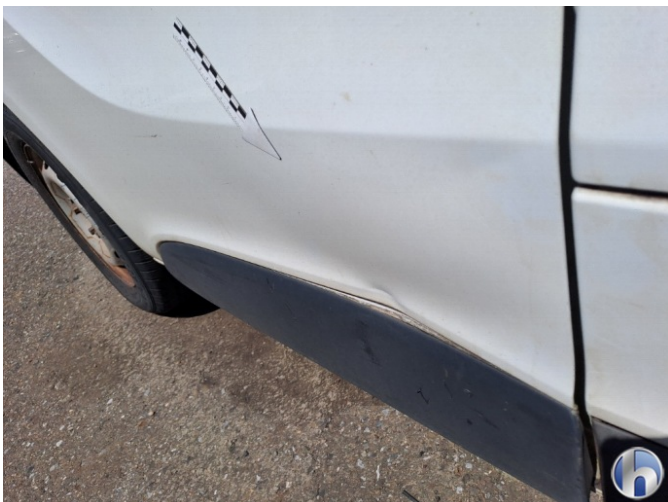
| component | Damage | Rep kind |
|---|---|---|
| 20. Front door - left | Damaged | Refurbish and paint |

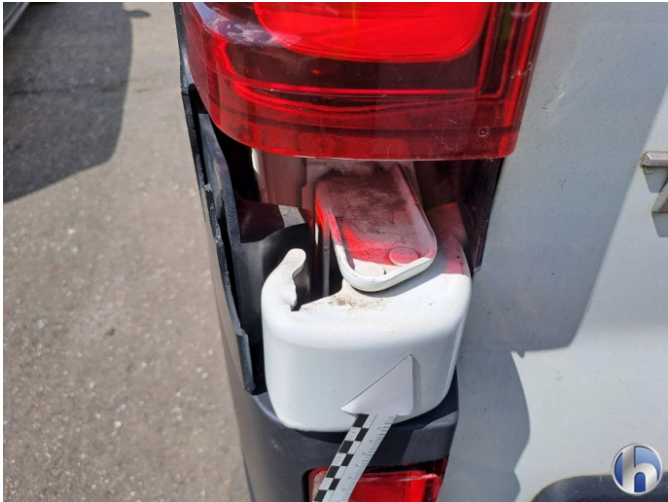
| component | Damage | Rep kind |
|---|---|---|
| 23. Verkleidung Rücklicht links | Damaged | Replace |

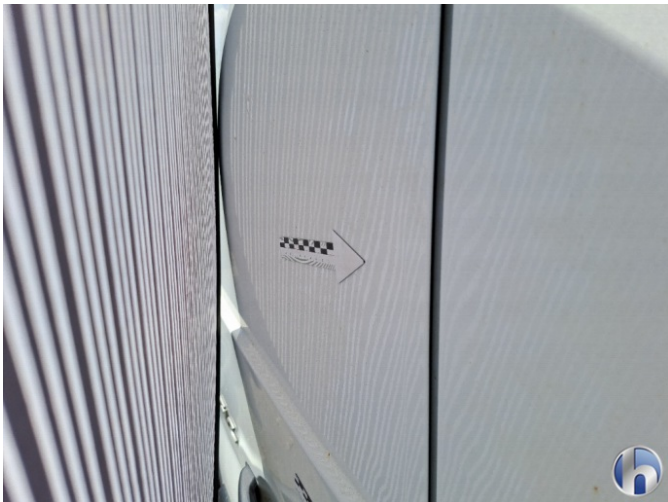
| component | Damage | Rep kind |
|---|---|---|
| 24. Tailgate left | Damaged | Refurbish and paint |

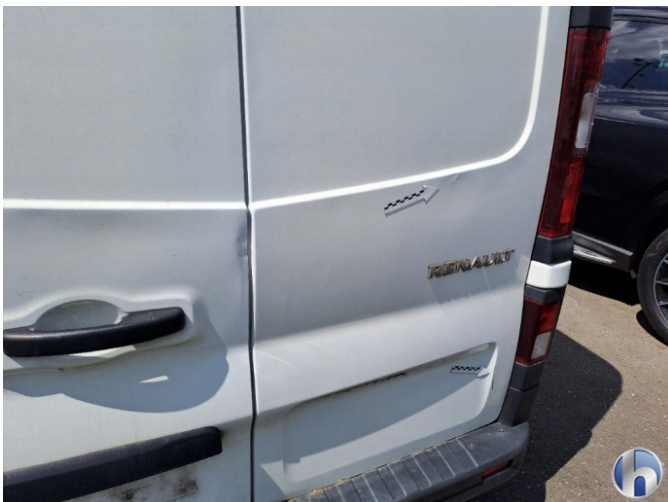
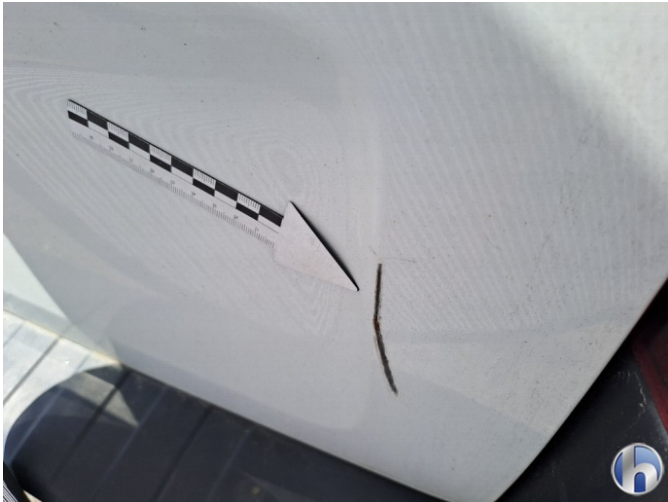
| component | Damage | Rep kind |
|---|---|---|
| 25. Tailgate right | Damaged | Refurbish and paint |

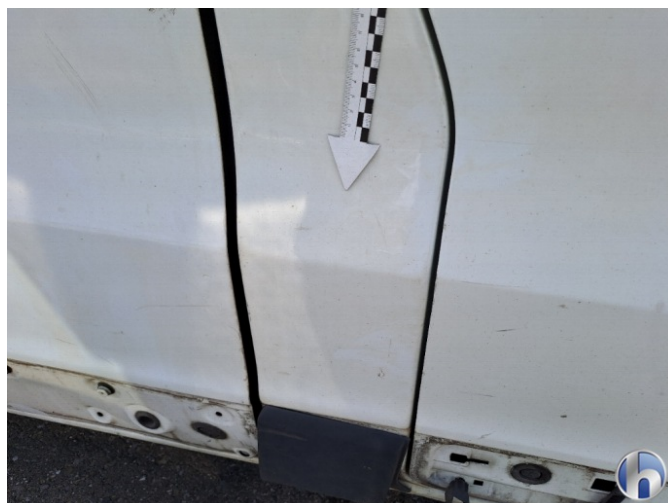
| component | Damage | Rep kind |
|---|---|---|
| 28. B-pillar center - right | Execution defect | Refurbish and paint |

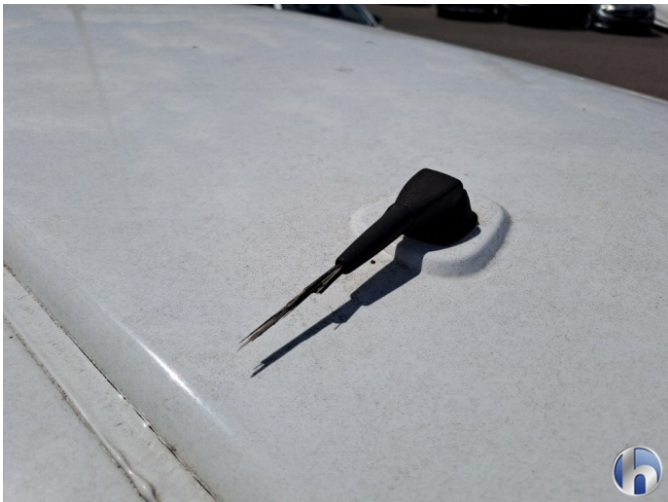
| component | Damage | Rep kind |
|---|---|---|
| 31. antenna Gps | Damaged | Replace |

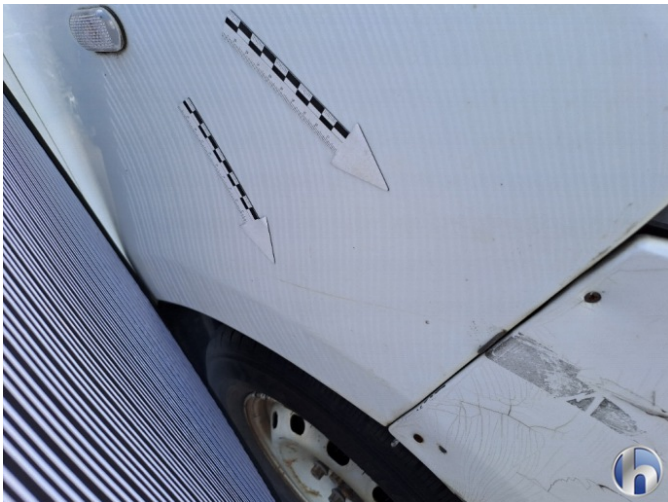
| component | Damage | Rep kind |
|---|---|---|
| 33. Front fender - right | Damaged | Refurbish and paint |

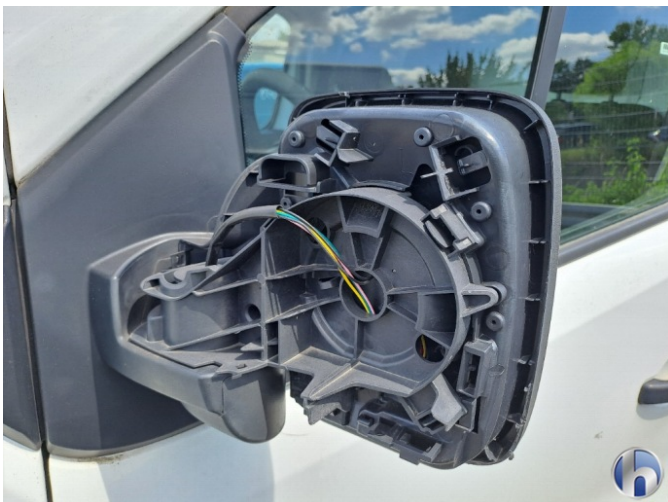
| component | Damage | Rep kind |
|---|---|---|
| 34. | Missing | Replace |
