## status report

#### Renault Trafic Kasten L1H1 2,8t Komfort

| Vehicle identification number | <b>VF1FL000969403673</b> | mileage read: | <b>26357 km</b> |

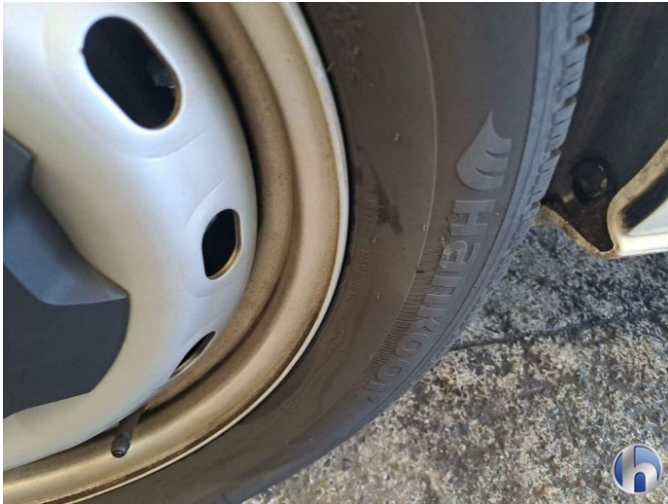
| component | Damage | Rep kind |
|---|---|---|
| 1. tire front - left | Damaged | Replace |

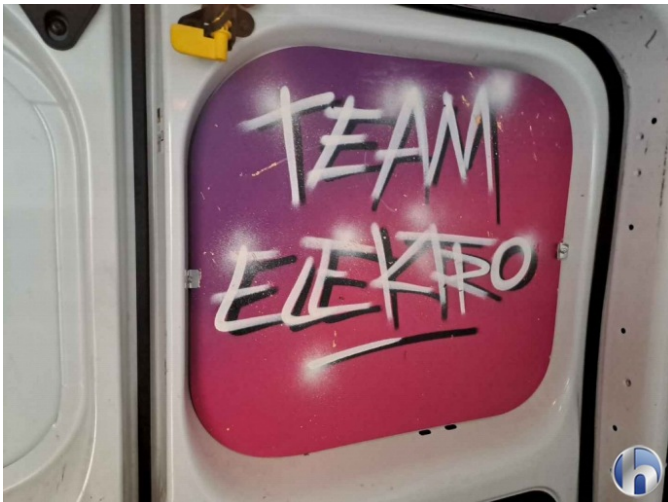
| component | Damage | Rep kind |
|---|---|---|
| 7. Hecktür Links Verkleidung | Damaged | Replace |

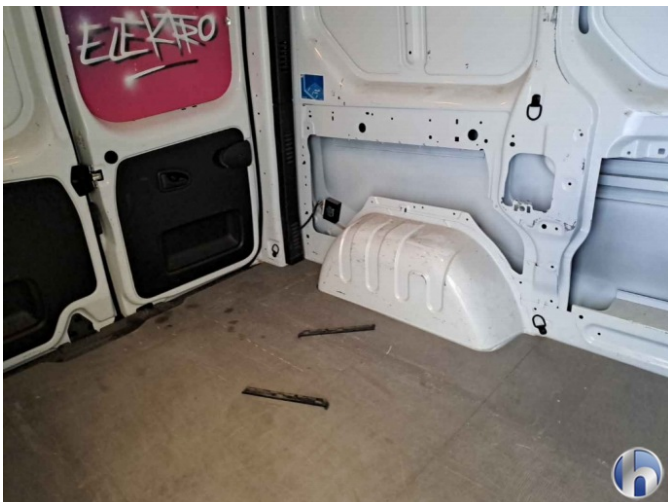
| component | Damage | Rep kind |
|---|---|---|
| 8. Laderaum Verkleidungen | Missing | Replace |

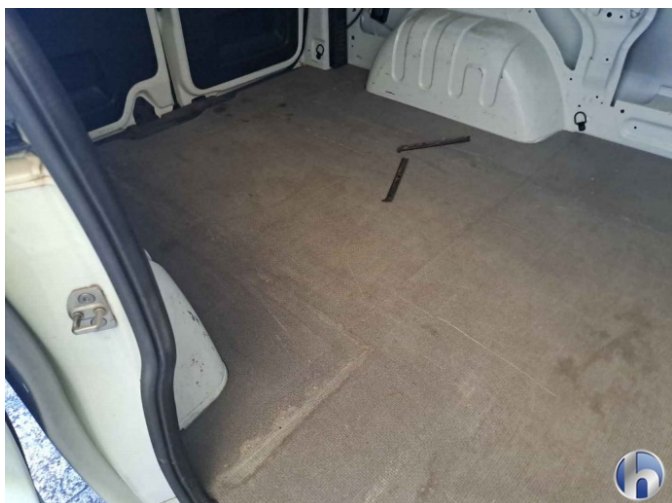
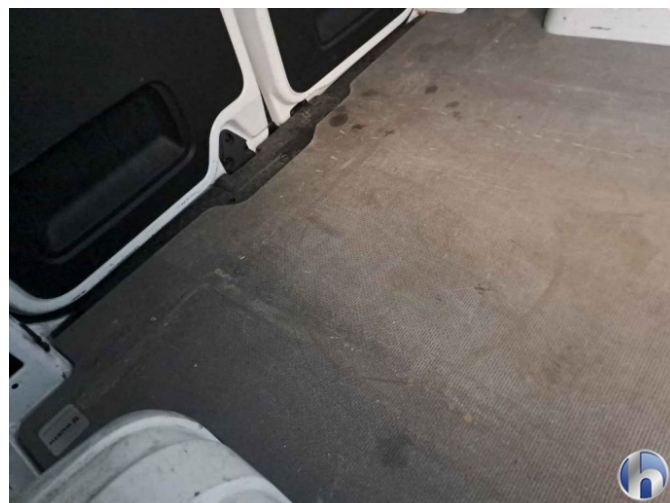
| component | Damage | Rep kind |
|---|---|---|
| 10. flooring | Damaged | Replace |

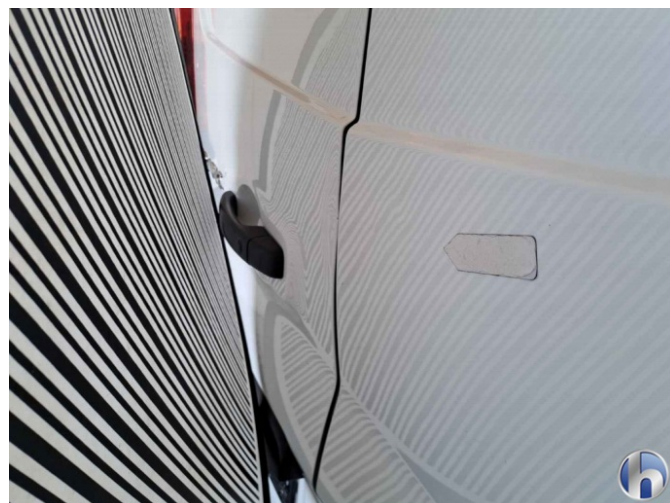
| component | Damage | Rep kind |
|---|---|---|
| 13. Tailgate right | Damaged | Refurbish and paint |

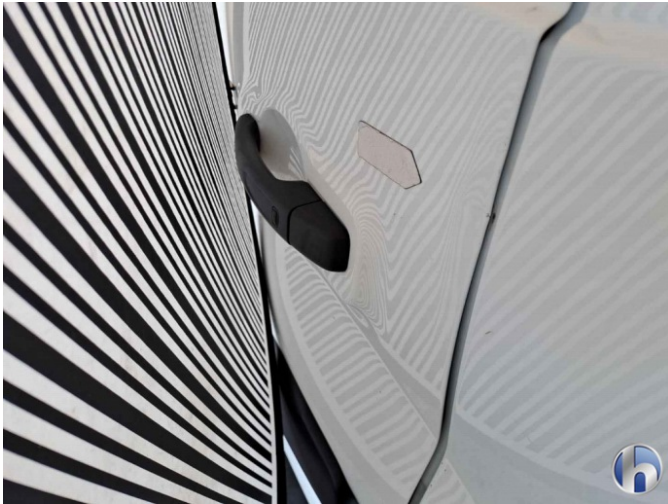
| component | Damage | Rep kind |
|---|---|---|
| 14. Tailgate left | Damaged | Refurbish and paint |

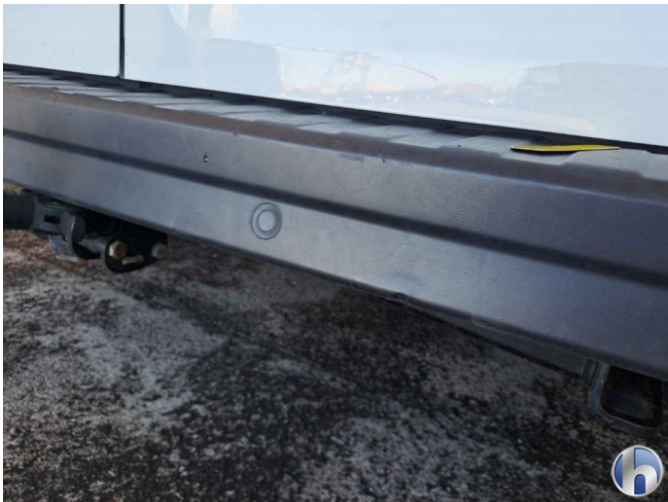
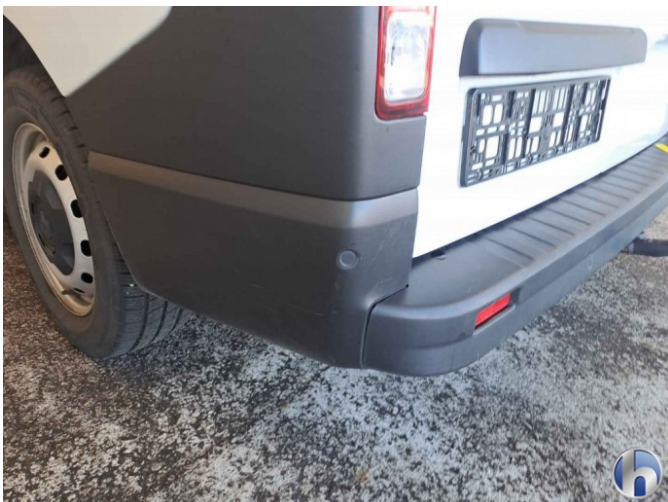
| component | Damage | Rep kind |
|---|---|---|
| 15. Rear bumper | Damaged | Replace |

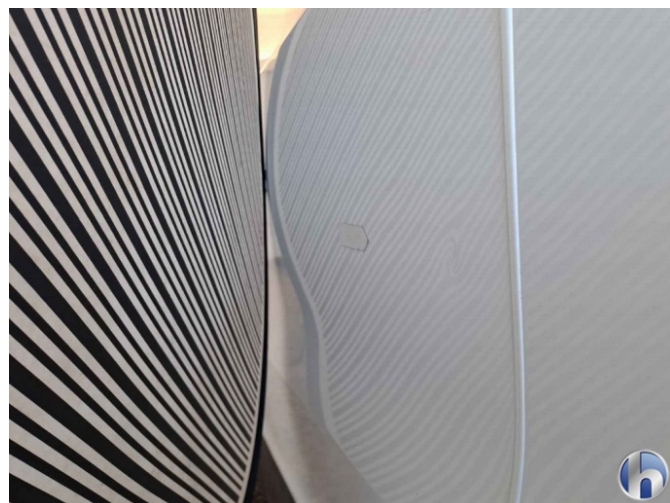
| component | Damage | Rep kind |
|---|---|---|
| 17. Seitenwand - Links | Damaged | Refurbish and paint |

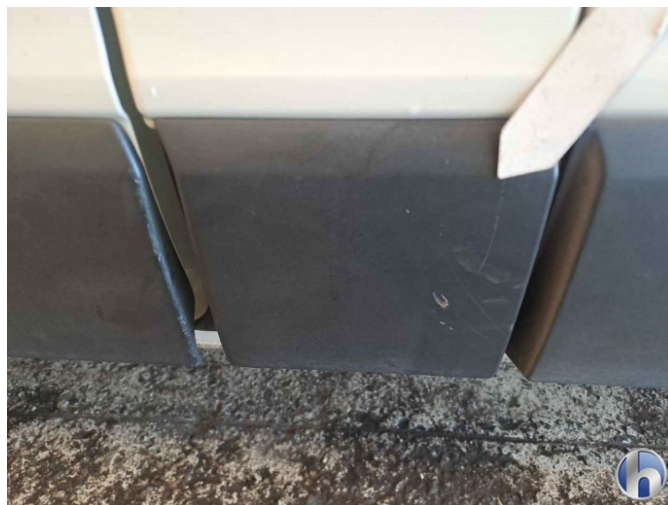
| component | Damage | Rep kind |
|---|---|---|
| 18. B-säule Mitte - Links Beplankung | Scrape | Replace |

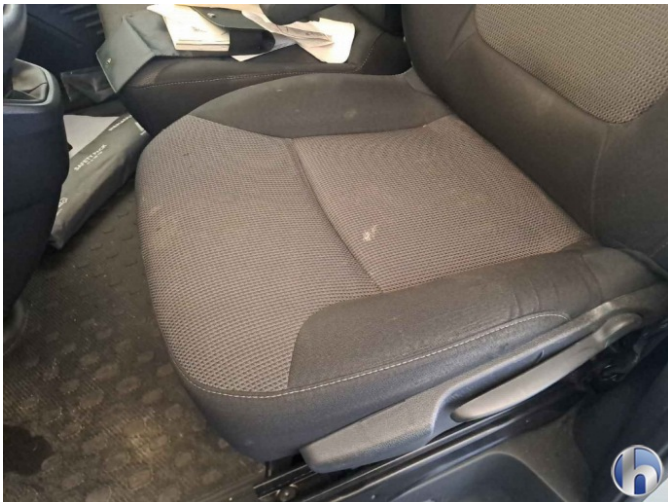
| component | Damage | Rep kind |
|---|---|---|
| 22. | Damaged | Replace |

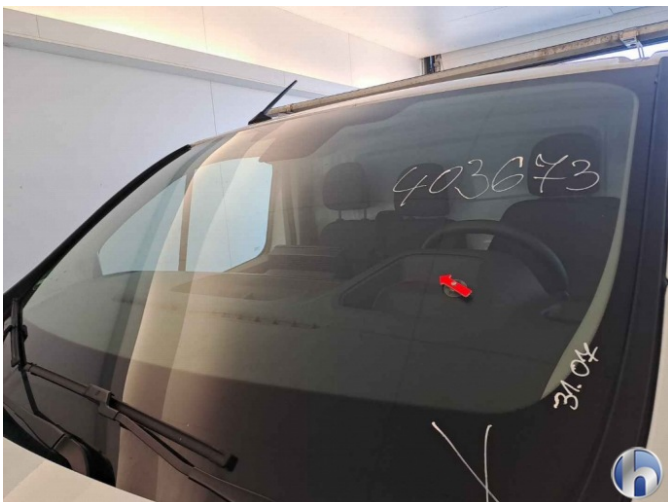
| component | Damage | Rep kind |
|---|---|---|
| 23. Windshield | Chipping from stones in field of view | Replace |

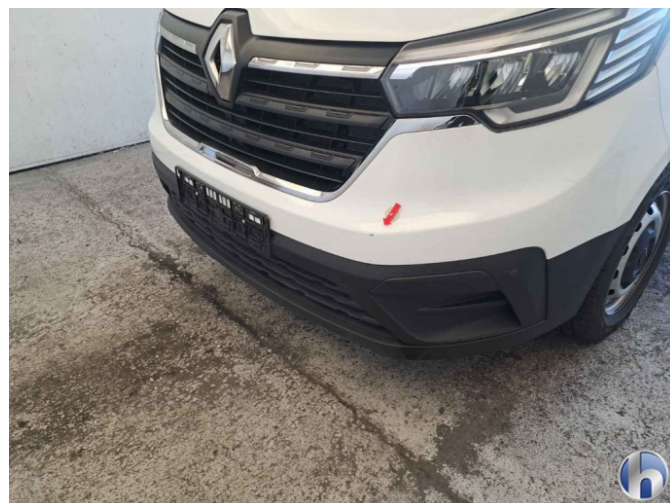
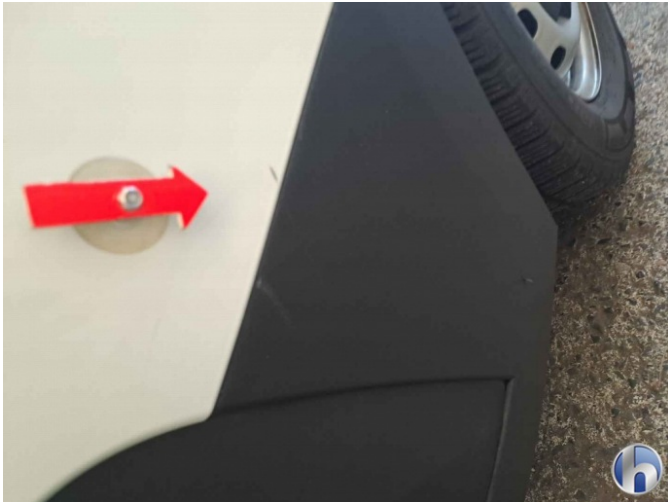
| component | Damage | Rep kind |
|---|---|---|
| 25. Front bumper | Scrape | Replace |

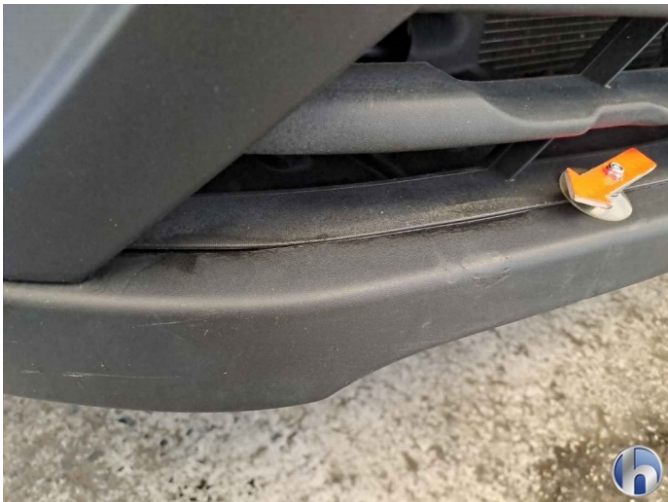
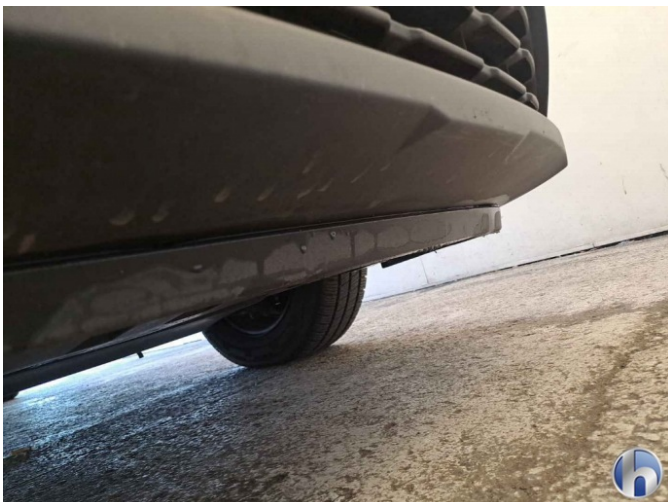
| component | Damage | Rep kind |
|---|---|---|
| 26. spoiler | Scrape | Replace |

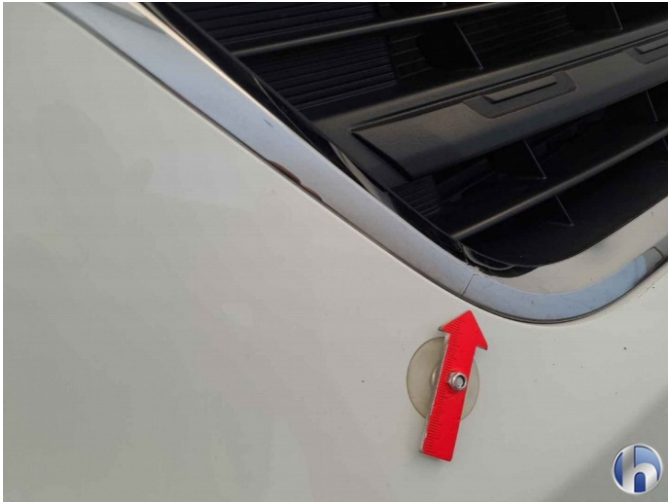
| component | Damage | Rep kind |
|---|---|---|
| 27. Front grille top | Damaged | Replace |

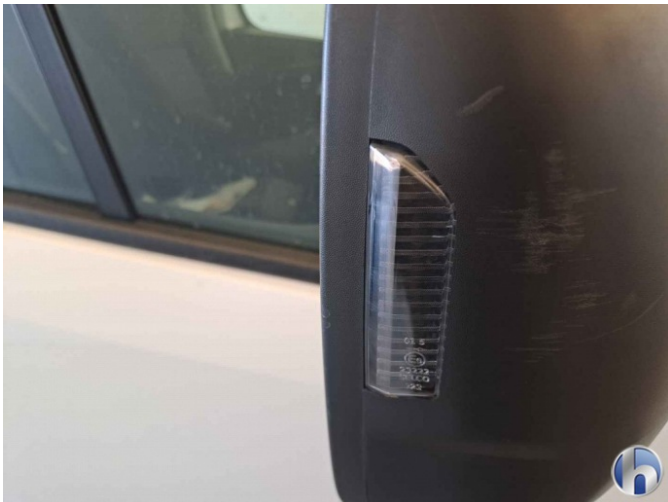
| component | Damage | Rep kind |
|---|---|---|
| 28. Outside mirror - right | Scrape | Replace |

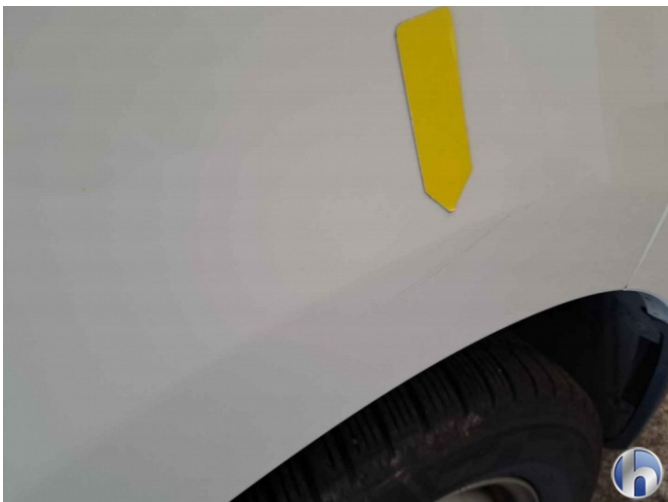
| component | Damage | Rep kind |
|---|---|---|
| 30. Front fender - right | Scratch(es) | Replace |

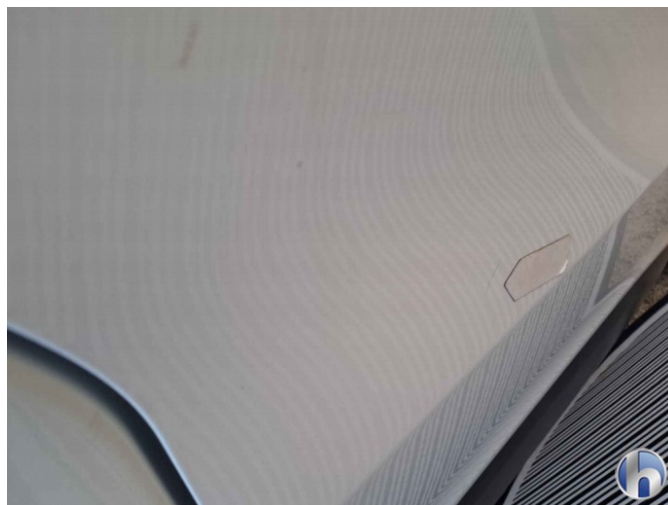
| component | Damage | Rep kind |
|---|---|---|
| 31. Front door - right | Damaged | Refurbish and paint |

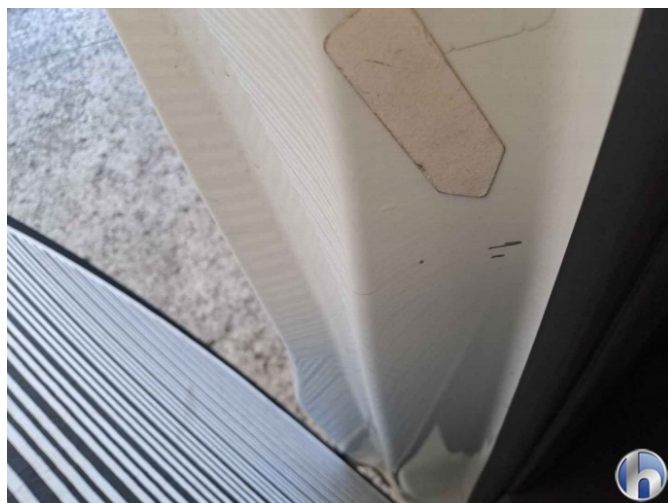
| component | Damage | Rep kind |
|---|---|---|
| 32. Türeinstieg Vorne - Rechts | Damaged | Refurbish and paint |

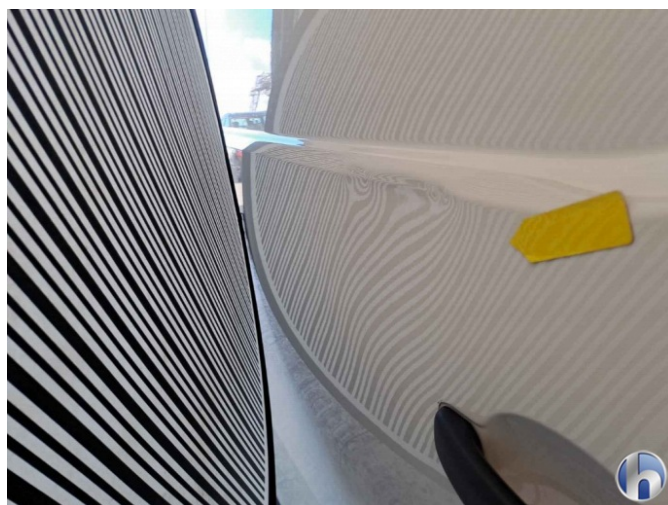
| component | Damage | Rep kind |
|---|---|---|
| 33. Sliding door - right | Damaged | Replace |

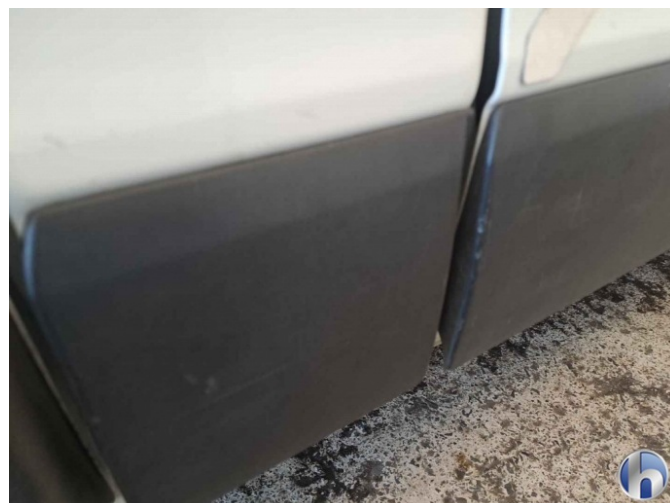
| component | Damage | Rep kind |
|---|---|---|
| 34. Tür Vorne - Rechts Beplankung | Scrape | Replace |

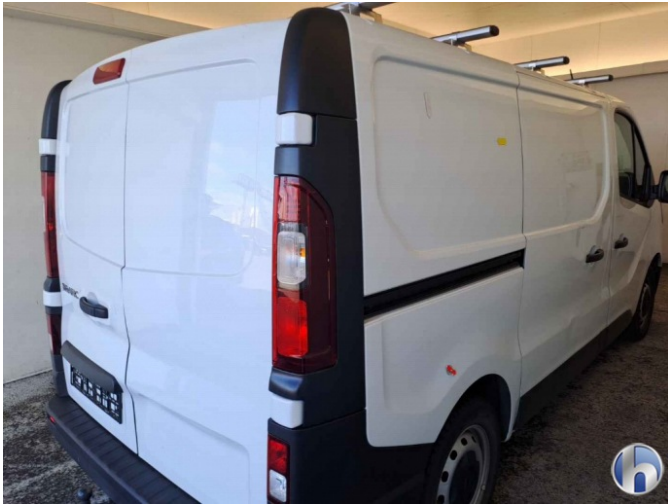
| component | Damage | Rep kind |
|---|---|---|
| 35. Schiebetür - Rechts Beplankung | Scrape | Replace |

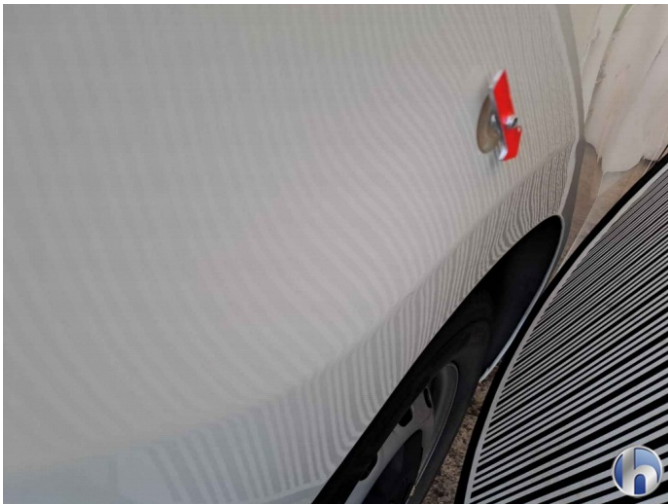
| component | Damage | Rep kind |
|---|---|---|
| 36. Sidewall - Rear - right | Damaged | Refurbish and paint |

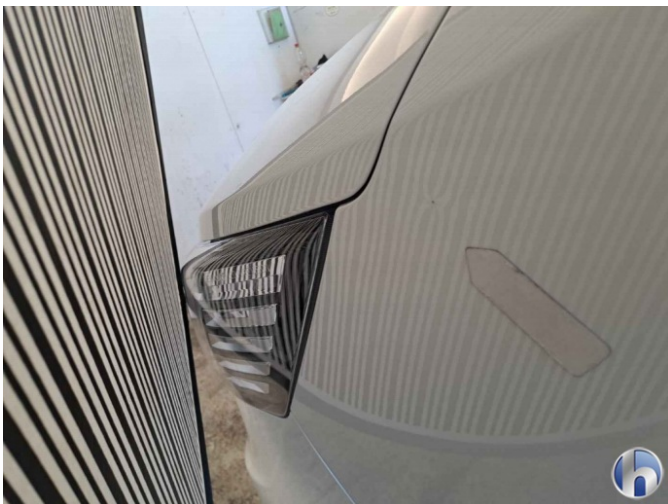
| component | Damage | Rep kind |
|---|---|---|
| 37. Front fender - left | Damaged | Refurbish and paint |

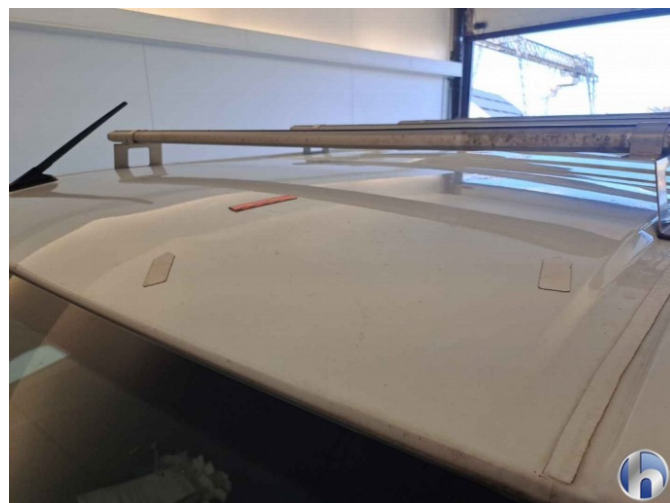
| component | Damage | Rep kind |
|---|---|---|
| 38. Roof frame - right | Damaged | Refurbish and paint |

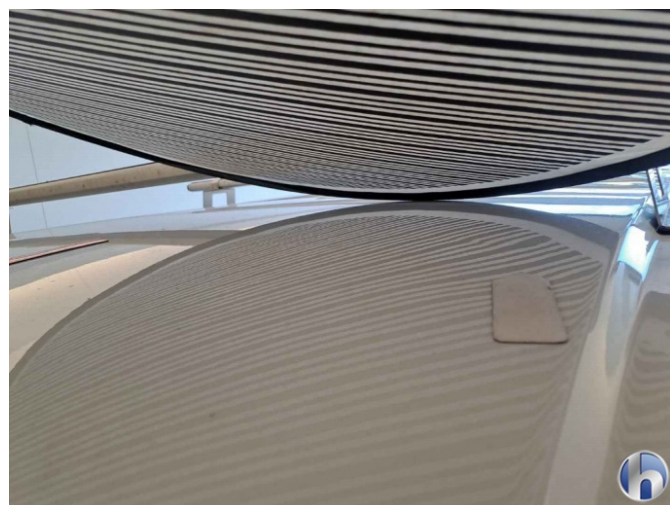
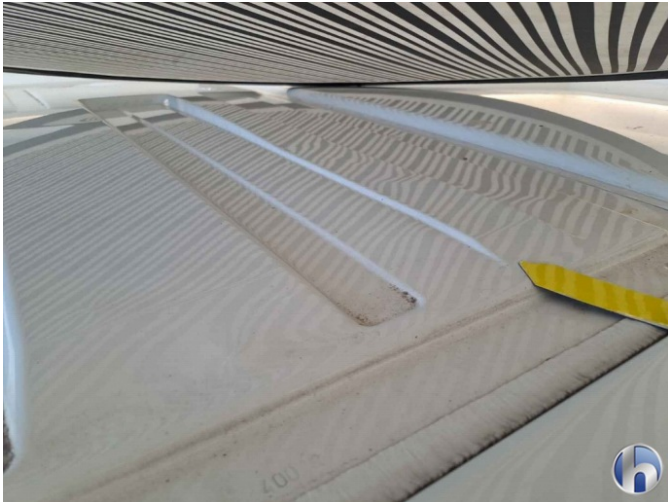
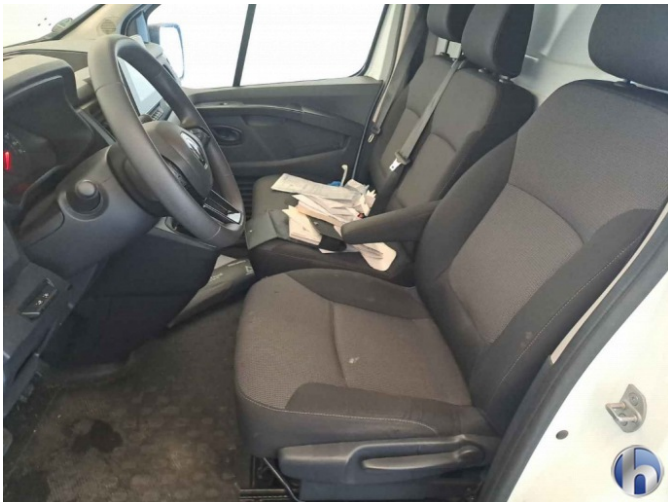
39. roof

| 39. | roof | Damaged | Refurbish and paint |

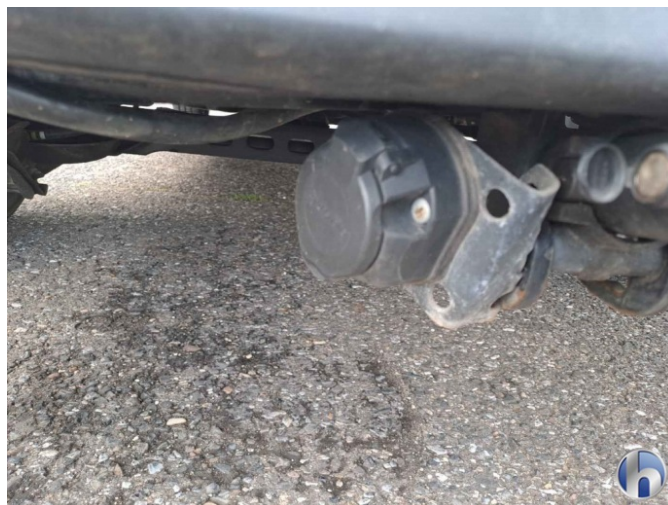
42. Anhängerkupplung

| 42. | Anhängerkupplung | Damaged | Replace |

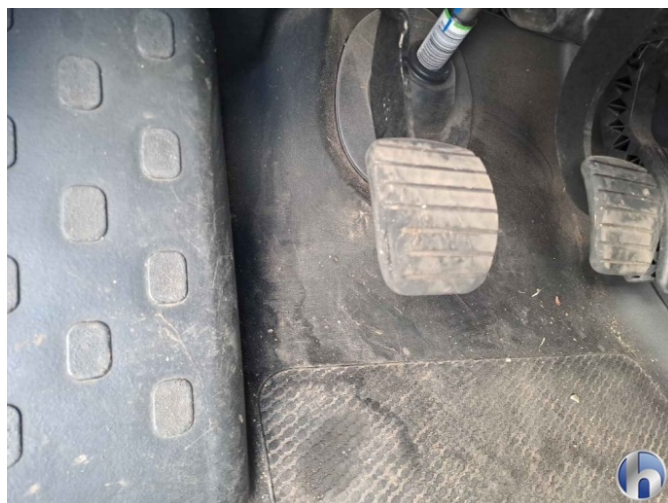
43. Pedalgummis

| 43. | Pedalgummis | Damaged | Replace |
