Expertise

Protocol number: 41767397
Order number / reference: 25177772
Inspection date: 30 Sept 2025

Manufacturer: Renault

Model: Koleos TCe 160 EDC GPF INITIALE PARIS

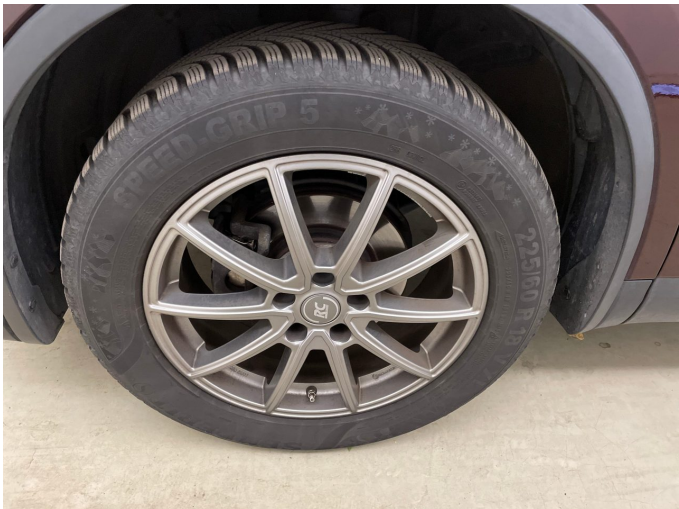
Figure 12: Mounted tyres

#	Tyre size	Type of tyre	Manufacturer	Tread depth
1)	225/60 R18 104V	Winter tyres on Light alloy	Semperit	5mm / 5mm
2)	225/60 R18 104V	Winter tyres on Light alloy	Semperit	7mm / 7mm

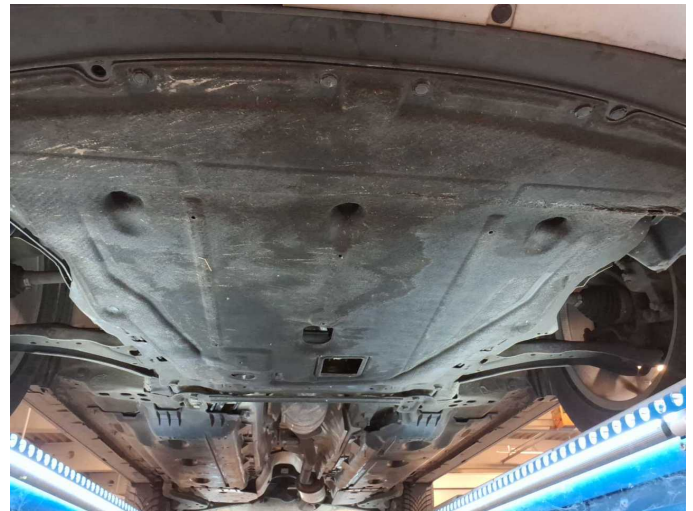
Damage 1: Engine: Engine cowl - lower - Holes - Replace

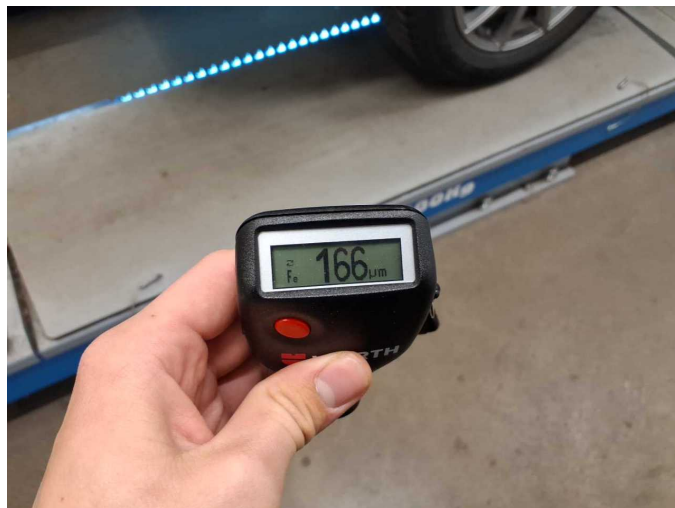
Repainting 6: Side panel - rear right side
