## status report

#### Peugeot 308 Allure

| Vehicle identification number | <b>VF3LBBHZ3GS266997</b> | mileage read: | <b>200013 km</b> |

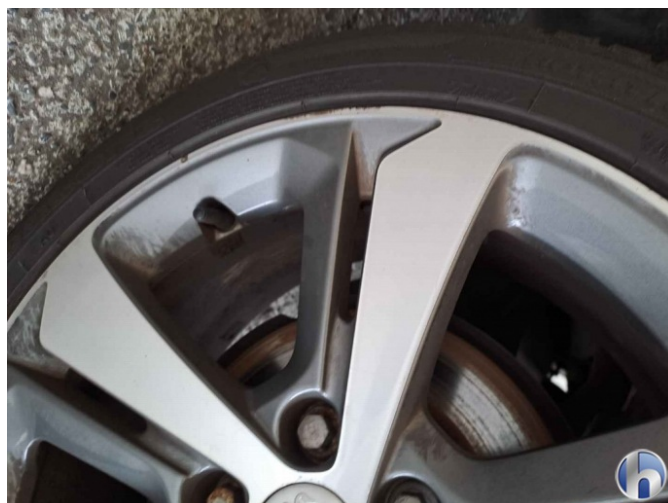
| component | Damage | Rep kind |
|---|---|---|
| 2. Rim rear - left | Scratch(es) | Replace |

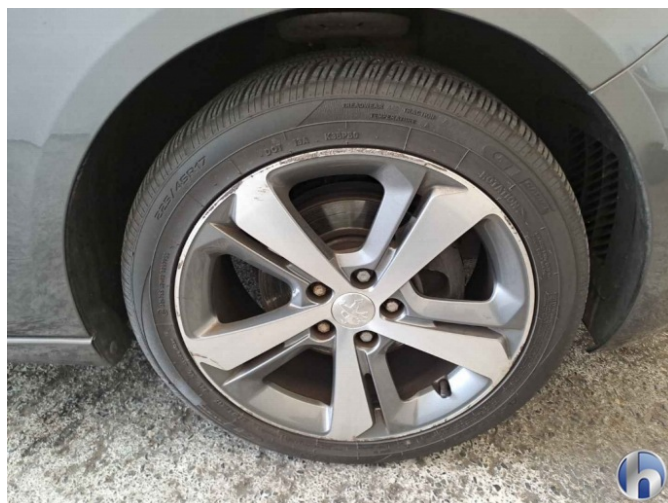
| component | Damage | Rep kind |
|---|---|---|
| 5. tire front - right | Worn | Replace |

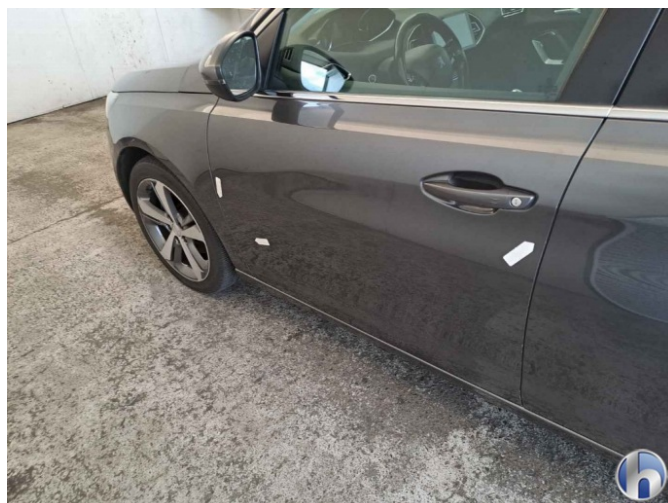
| component | Damage | Rep kind |
|---|---|---|
| 16. Front door - left | Damaged | Refurbish and paint |

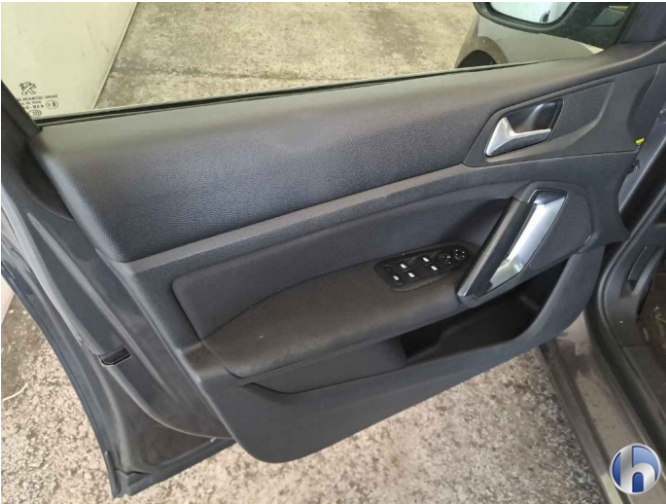
| component | Damage | Rep kind |
|---|---|---|
| 17. Front door trim - left | Damaged | Replace |

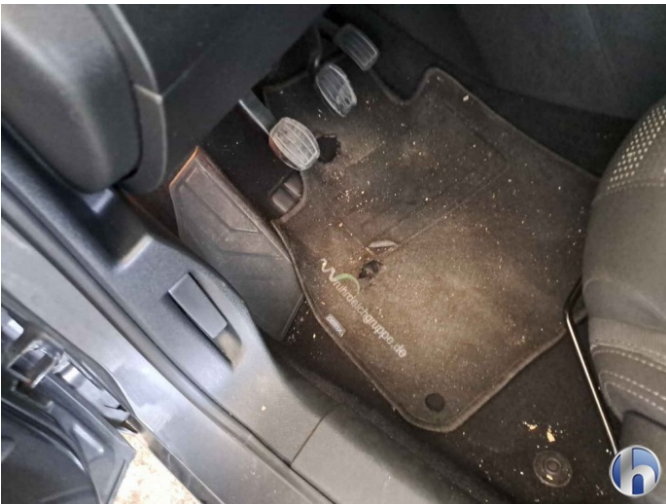
| component | Damage | Rep kind |
|---|---|---|
| 18. | Damaged | Replace |

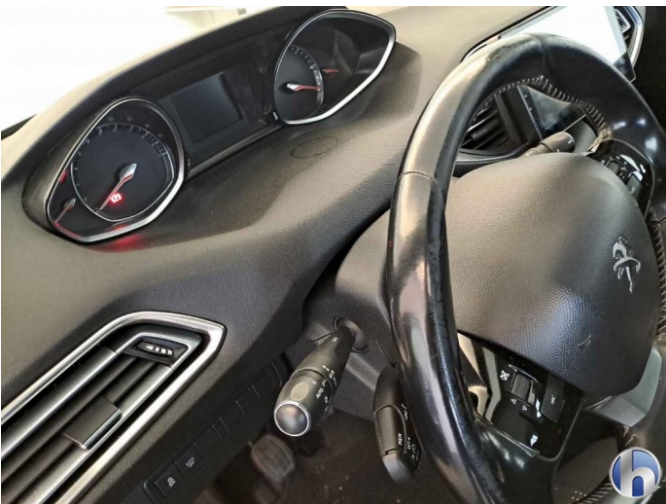
| component | Damage | Rep kind |
|---|---|---|
| 19. Steering wheel (leather) | Scrape | Replace |

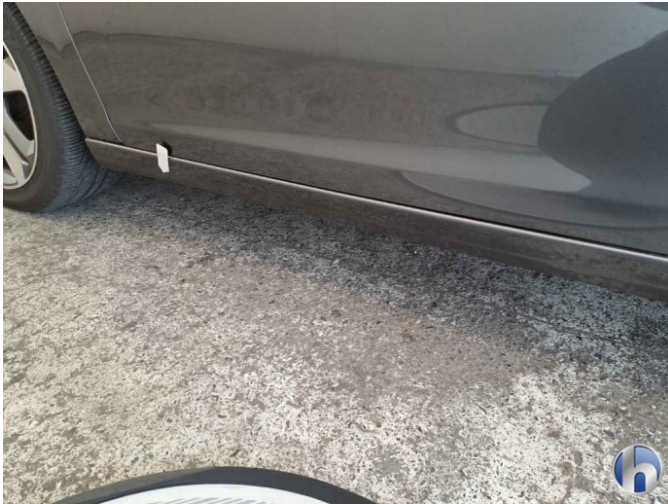
| component | Damage | Rep kind |
|---|---|---|
| 22. side skirt - left | Damaged | Refurbish and paint |

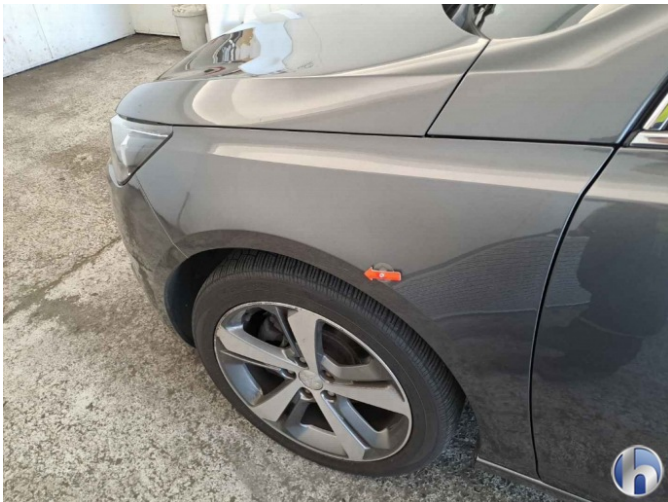
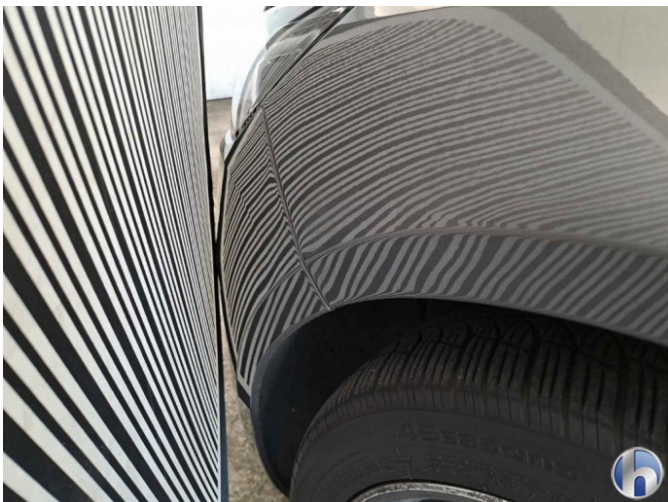
| component | Damage | Rep kind |
|---|---|---|
| 23. Front fender - left | Damaged | Replace |

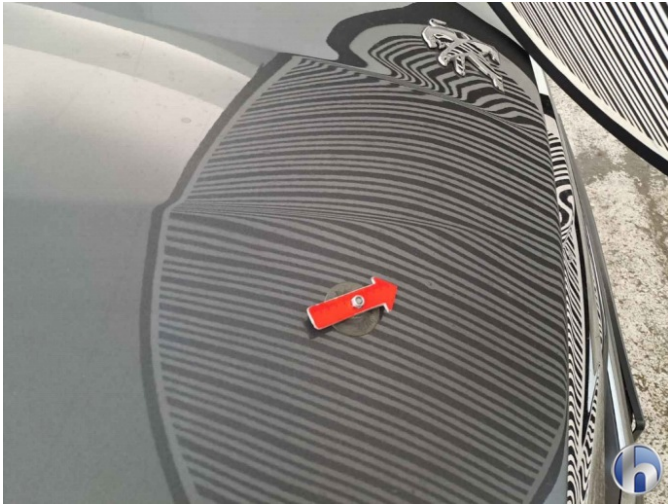
| component | Damage | Rep kind |
|---|---|---|
| 24. hood | Damaged | Refurbish and paint |

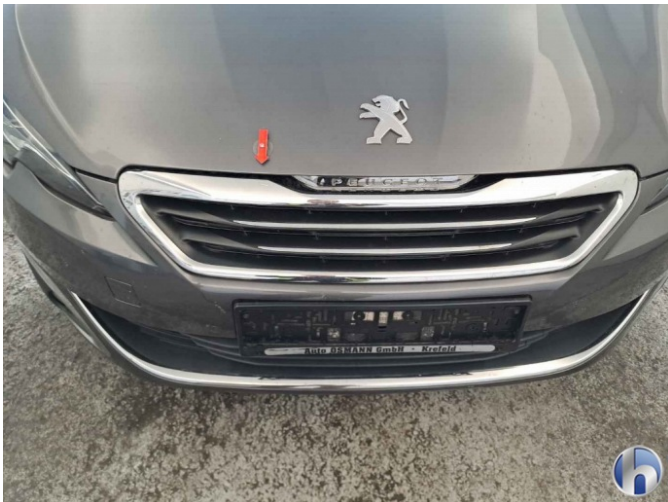
| component | Damage | Rep kind |
|---|---|---|
| 25. Front grille top | Damaged | Replace |

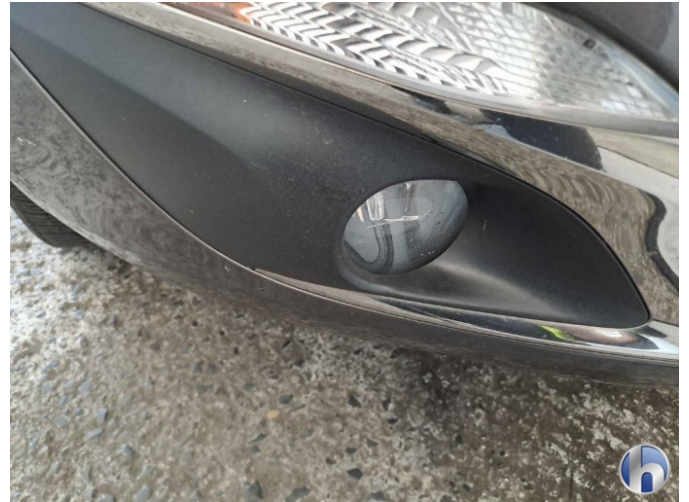
| component | Damage | Rep kind |
|---|---|---|
| 27. | Leaky | Replace |

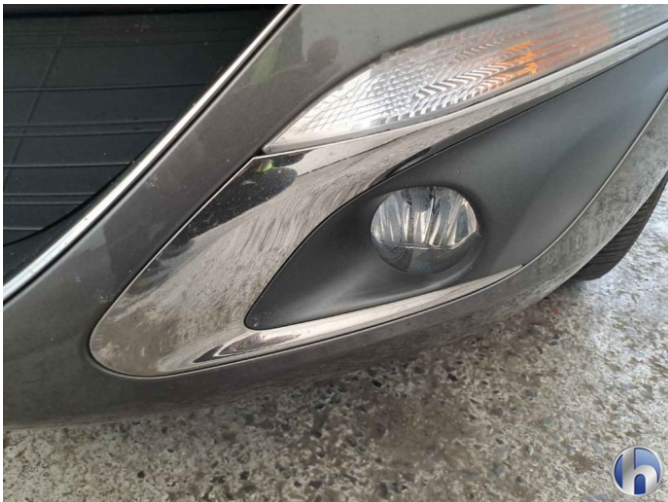
| component | Damage | Rep kind |
|---|---|---|
| 28. | Leaky | Replace |

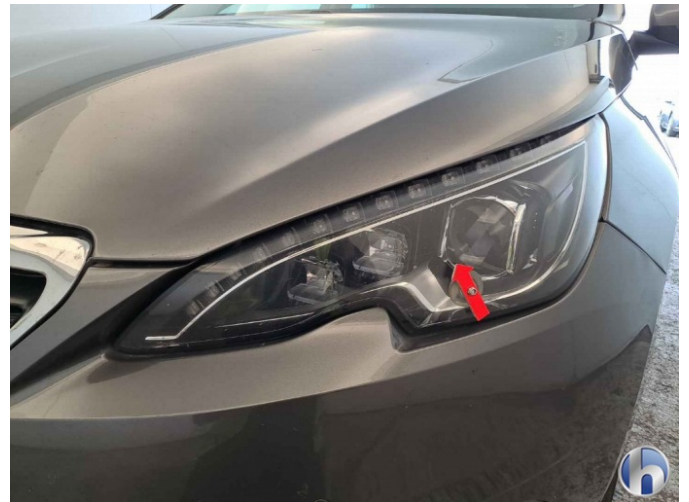
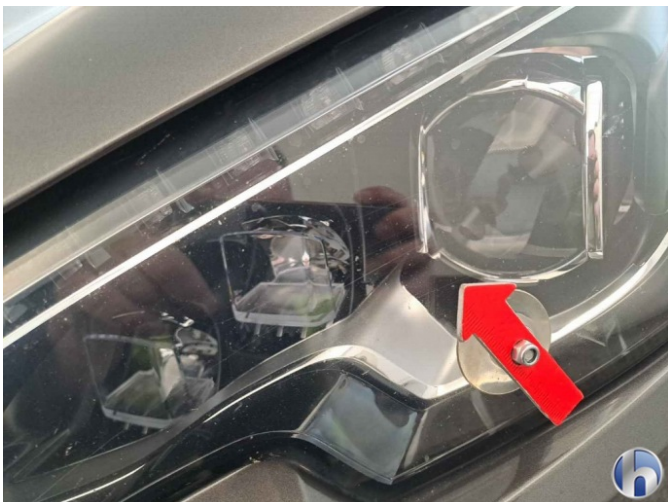
| component | Damage | Rep kind |
|---|---|---|
| 29. | Scratch(es) | Replace |

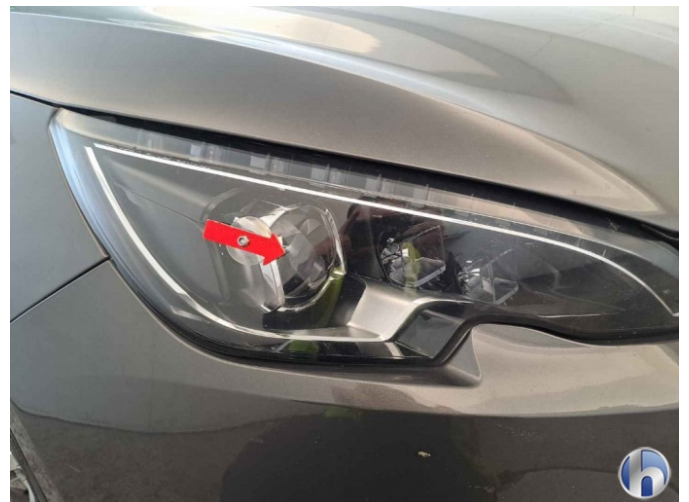
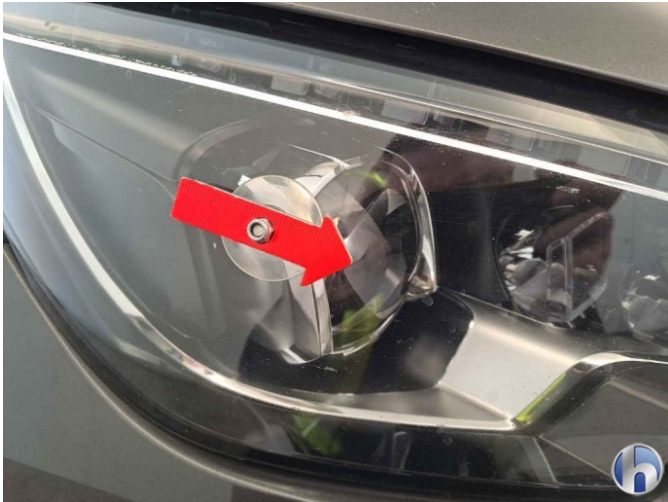
| component | Damage | Rep kind |
|---|---|---|
| 30. | Wear and tear | acceptable |

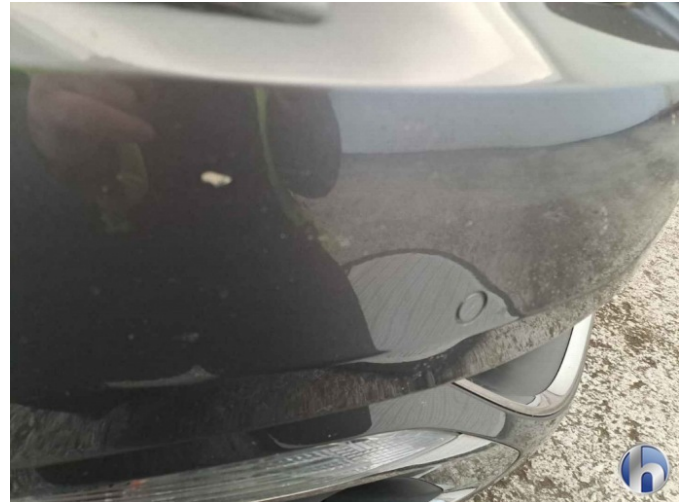
| component | Damage | Rep kind |
|---|---|---|
| 31. exterior body | Damaged | |

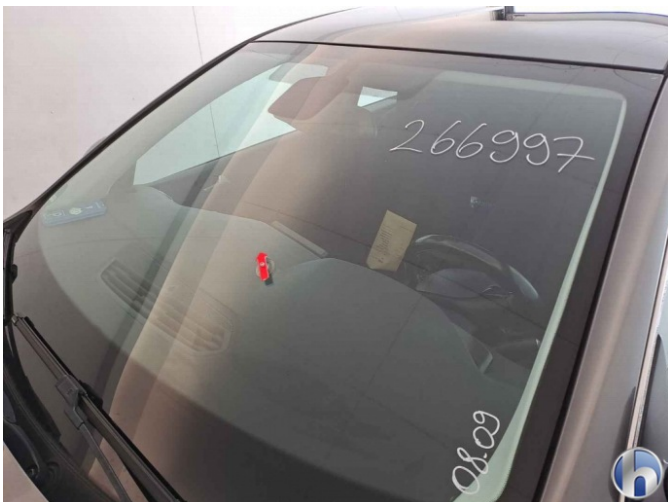
| component | Damage | Rep kind |
|---|---|---|
| 33. Windshield | Damaged | Replace |

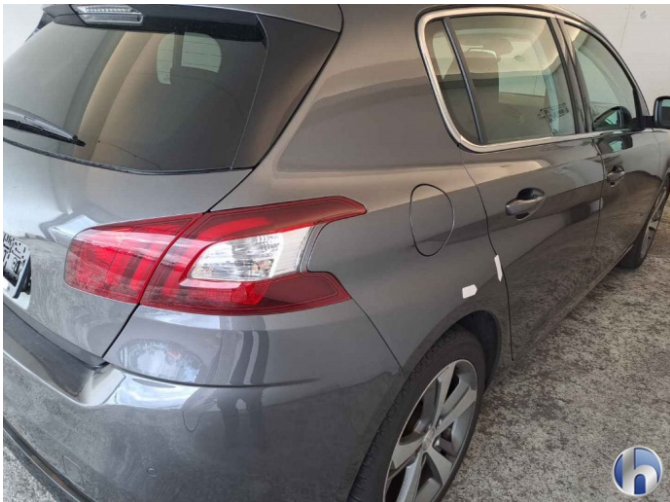
| component | Damage | Rep kind |
|---|---|---|
| 36. Sidewall - Rear - right | Damaged | Refurbish and paint |
