## status report

**customer:** Bank 11, Neuss  
**contract number:** 585175030  
**reference:**

#### Citroën Spacetourer Shine XL

| Vehicle identification number | <b>VF7VEAHHWJZ065628</b> | mileage read: | <b>197281 km</b> |

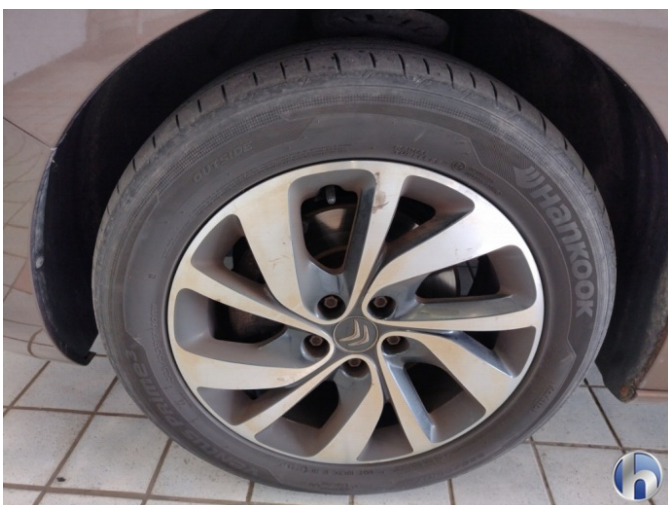
rims

| component | Damage | Rep kind |
|---|---|---|
| 4. Rim front - left | Damaged | Replace |

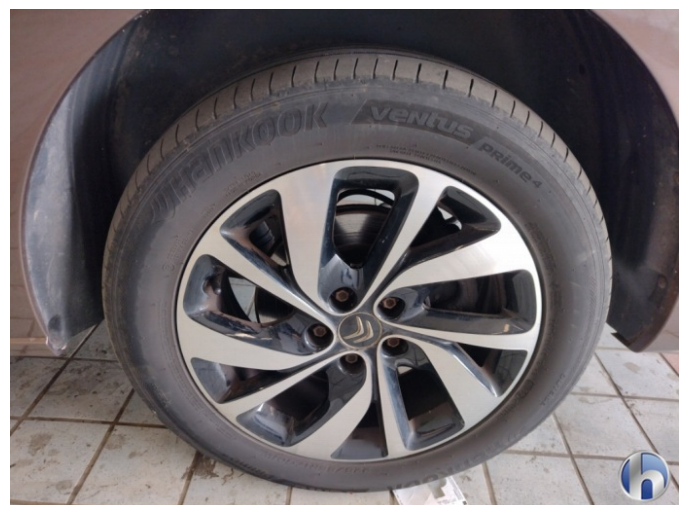
rims

| component | Damage | Rep kind |
|---|---|---|
| 5. Rim front - right | Damaged | Replace |
