Expertise

Protocol number: 39786213
Order No. / Reference: 24714127
Inspection date: 19 May 2025

Manufacturer: Peugeot	Model: 508 SW Hybrid e-EAT8 GT
VIN: VR3F4DGZTLY055701

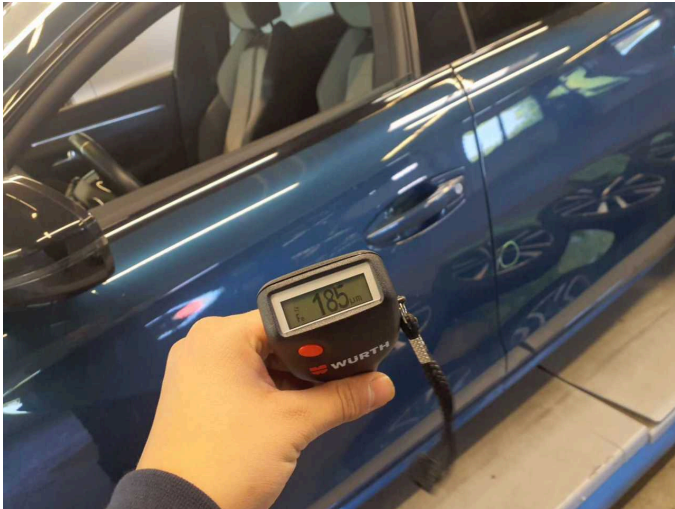
Repainting 1: Roof, Door - rear left side, Door - front left side
