## status report

| <b>report Number:</b> | <b>0000001258969-EN18</b> |

| vehicle data | | | |
|---|---|---|---|
| <b>Peugeot 308 GT</b> | | | |
| Vehicle identification number | <b>VR3FPHNSTPY622977</b> | mileage read: | <b>23001 km</b> |

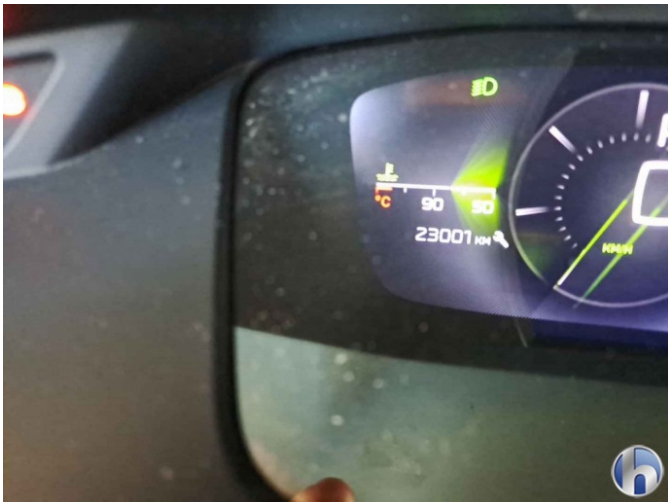
6. warning light

**Error message**

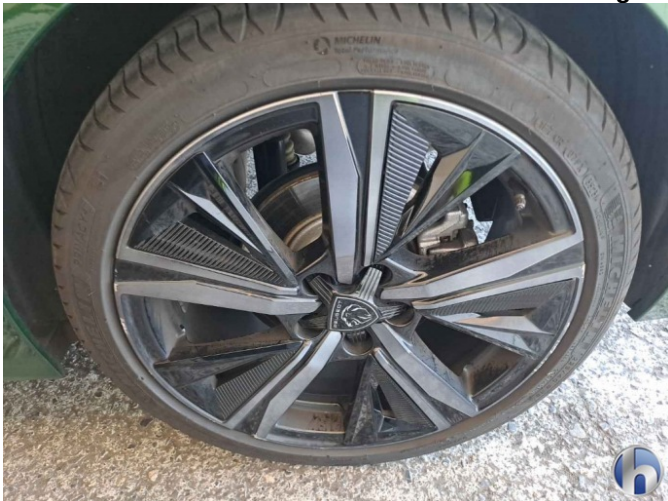
**Scratch(es)**

| component | Damage | Rep kind |
|---|---|---|
| 10. | Scratch(es) | Replace |

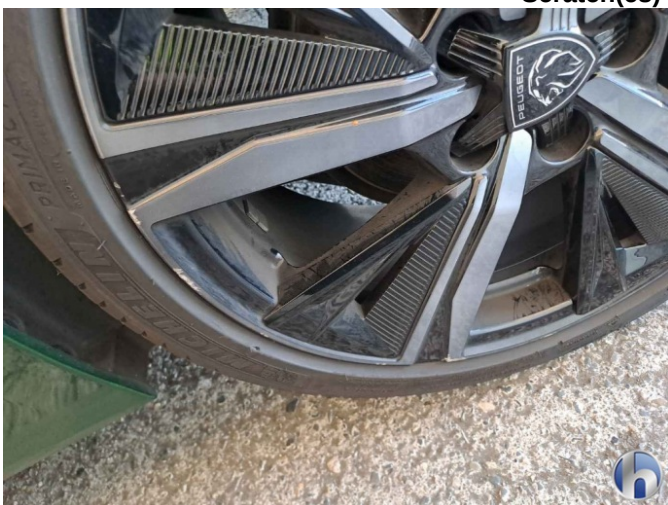
10.

**Scratch(es)**

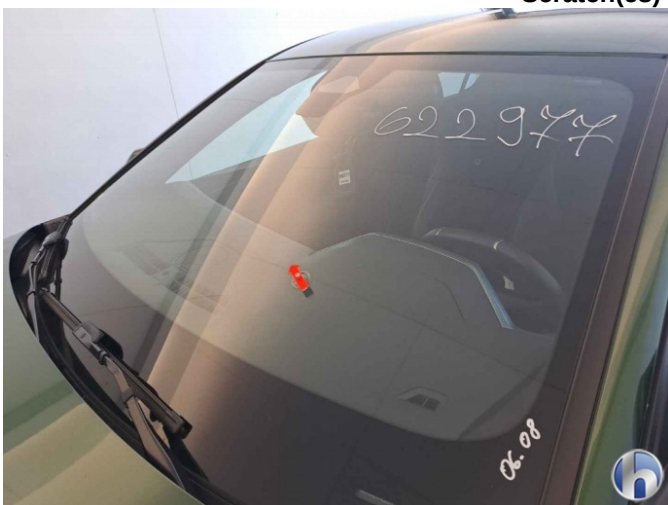
| component | Damage | Rep kind |
|---|---|---|
| 13. Windshield | Chipping from stones in field of view | Replace |

**Chipping from stones in field of view**

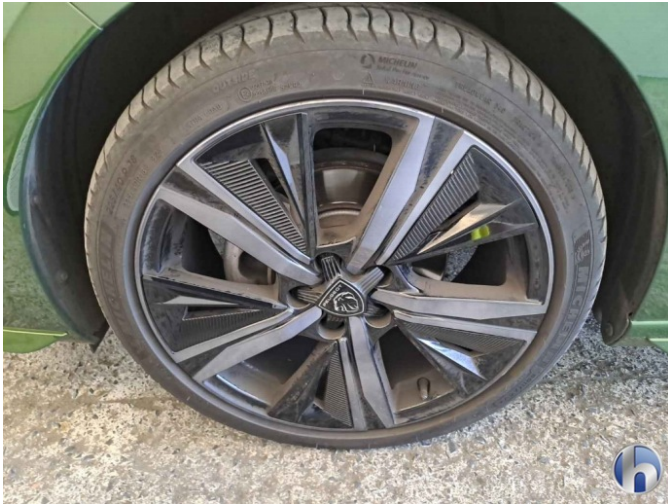
14. Scratch(es)

| component | Damage | Rep kind |
|---|---|---|
| 14. | Scratch(es) | Replace |

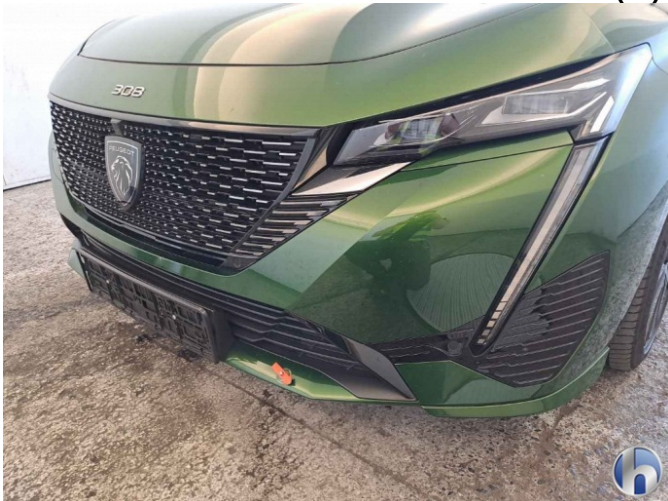
15. Front bumper Scrape

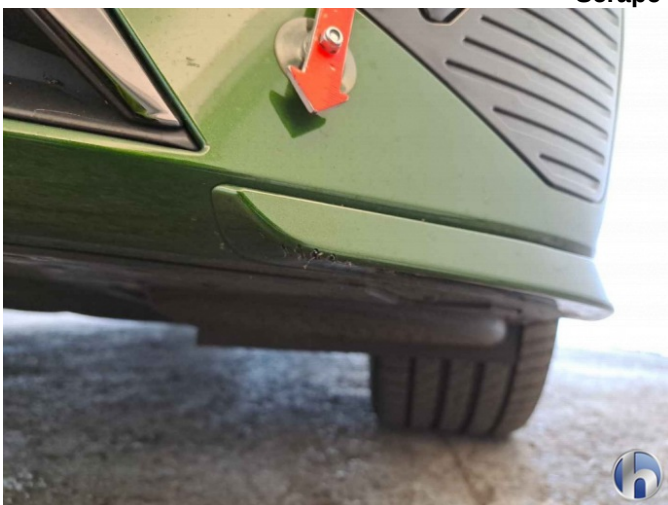
16. spoiler Scrape

| component | Damage | Rep kind |
|---|---|---|
| 16. spoiler | Scrape | Replace |

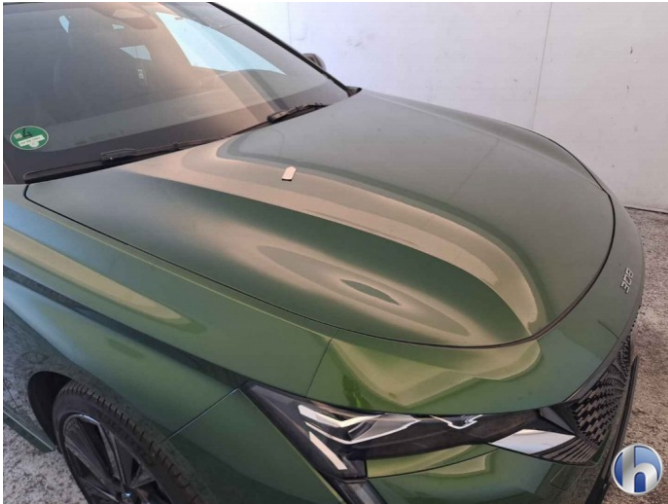
17. hood

**Deformed**

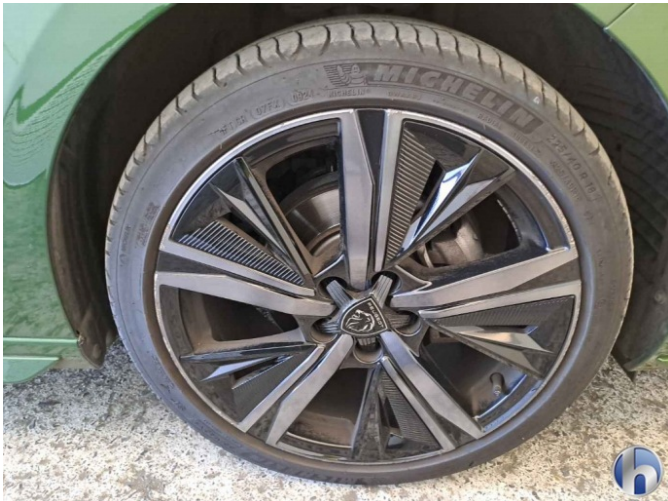
**Scratch(es)**

| component | Damage | Rep kind |
|---|---|---|
| 18. | Scratch(es) | Replace |

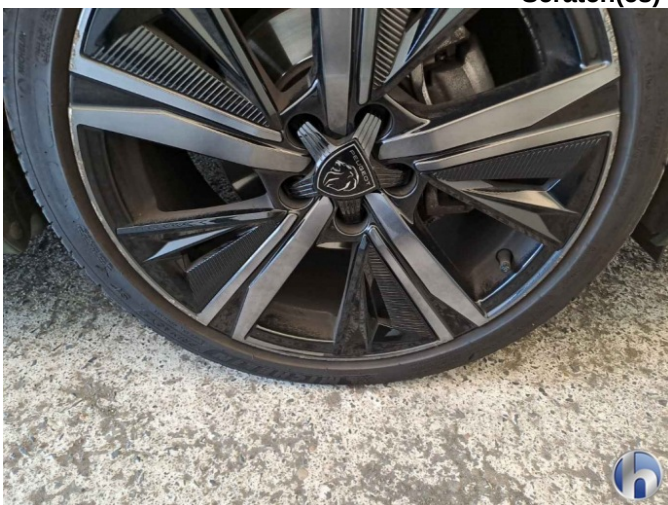
18.

**Scratch(es)**

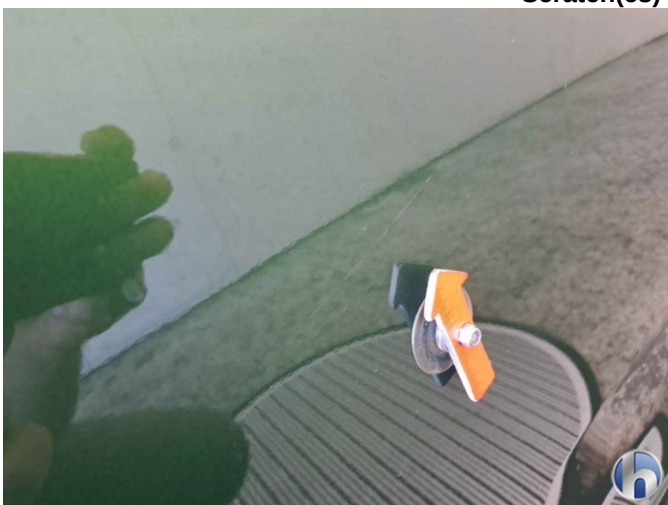
22. Door Rear - right

**Scratch(es)**

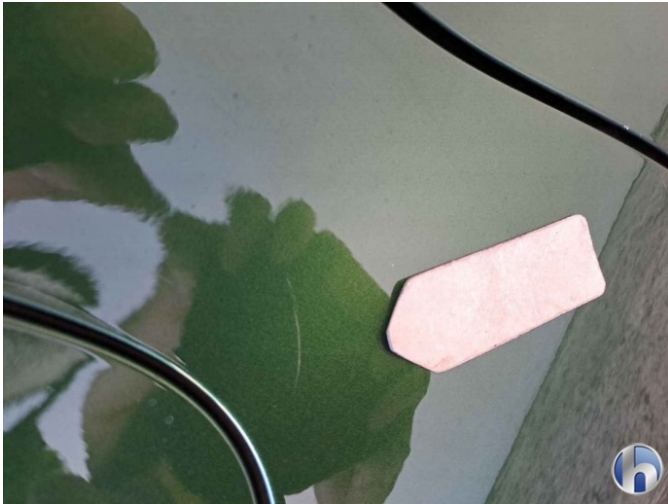
23. Sidewall - Rear - right

**Scratch(es)**

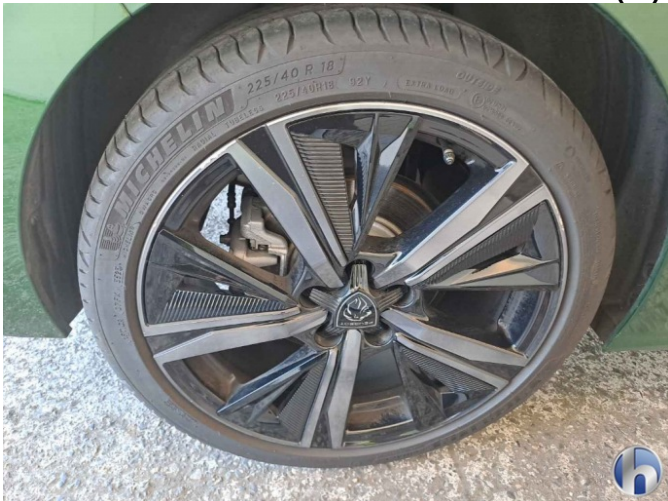
**Scratch(es)**

| component | Damage | Rep kind |
|---|---|---|
| 24. | Scratch(es) | Replace |

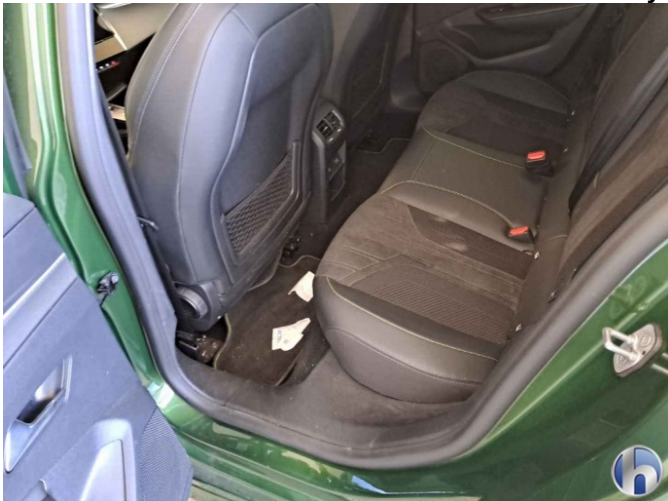
26.

**Dirty**

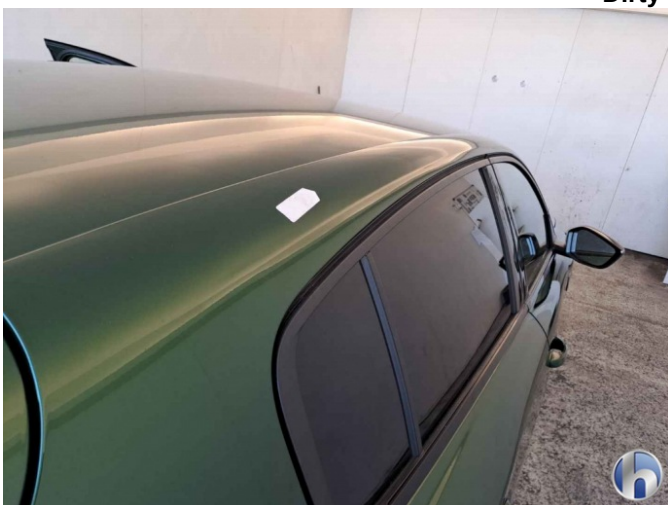
27. Roof frame - right

**Scratch(es)**

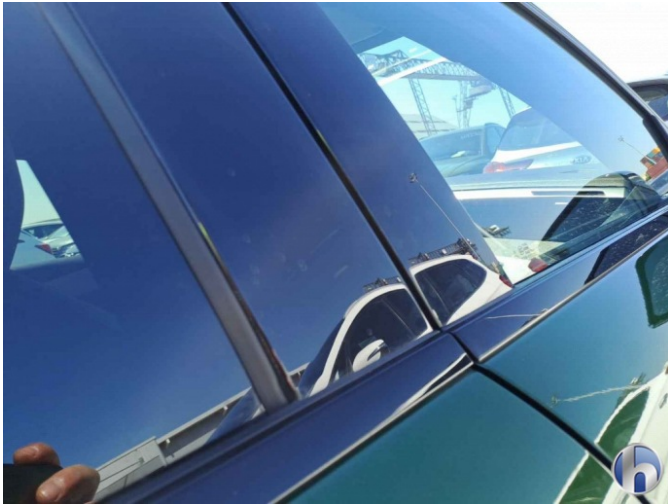
31. exterior body

**Surface scratch(es)**

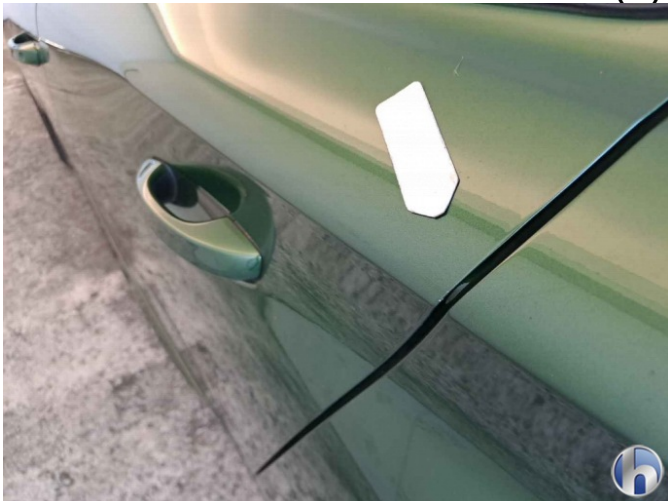
32. Rear door - left

**Scratch(es)**

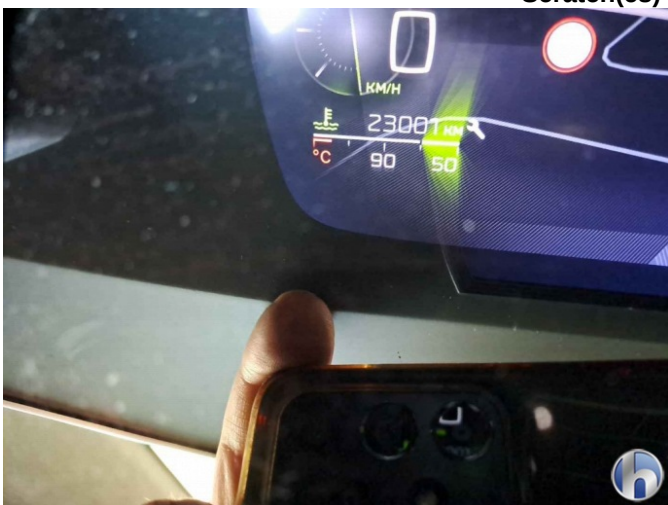
33. warning light

**Error message**

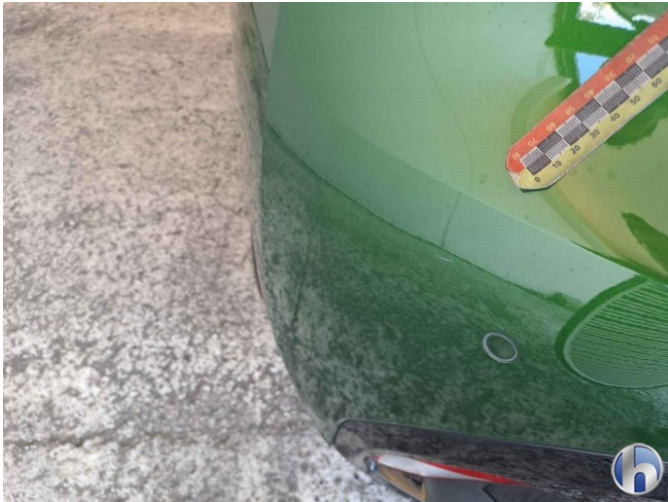
37. Rear bumper

**Scratch(es)**

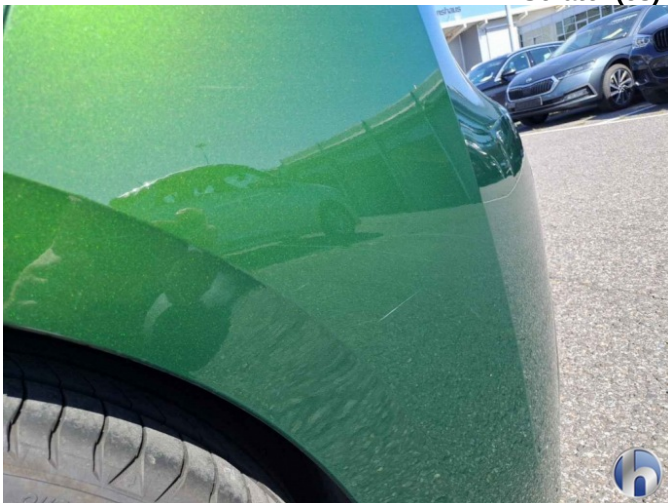
37. Rear bumper

**Scratch(es)**
