## status report

| <b>customer:</b> | <b>BCA Autoauktionen GmbH</b> |

| vehicle data | | | |
|---|---|---|---|
| <b>Opel Movano C Kasten Ka L1H1 3,5t Edition</b> | | | |
| Vehicle identification number | <b>VXEYCBPFA12W06877</b> | mileage read: | <b>40203 km</b> |

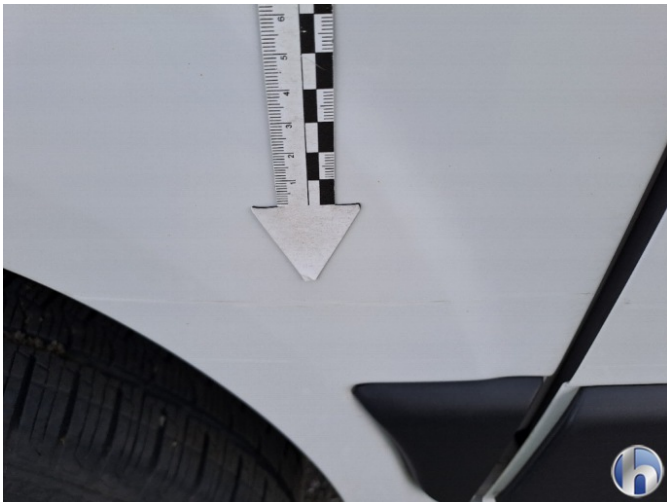
| component | Damage | Rep kind |
|---|---|---|
| 6. Sidewall - Rear - right | Damaged | Refurbish and paint |

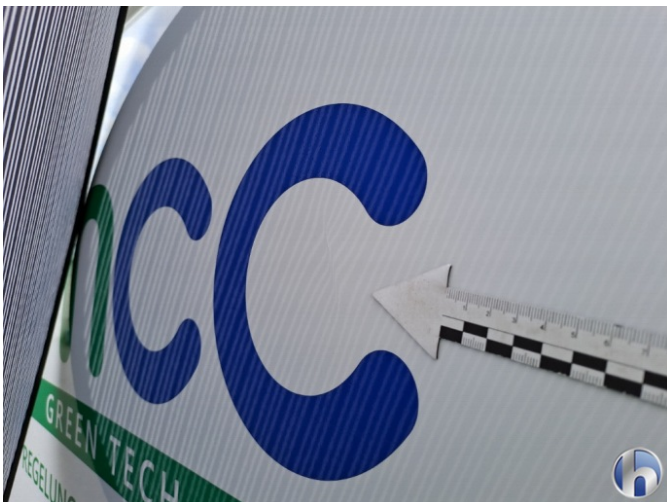
| component | Damage | Rep kind |
|---|---|---|
| 7. Sliding door - right | Damaged | Refurbish and paint |
