Expertise

Protocol number: 41580514  
Order No. / Reference: 25233287  
Inspection date: 16 Sept 2025

Model: Combo Cargo XL 1.5 D EHZ Edition

VIN: W0VEFYHYCMJ854575

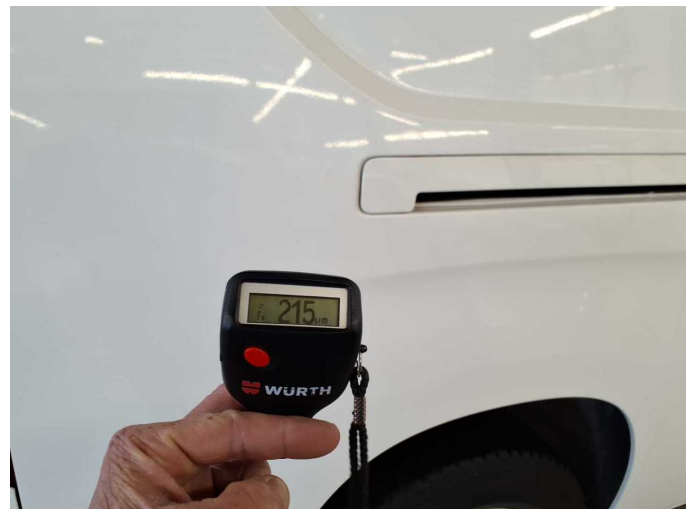
| No. | Component group | Description |
|---|---|---|
| 18 | Side panel - rear right side | Side panel (wellig) - Unprofessionally repaired - Repair and paint |

**Side panel - rear right side:** 215 µm

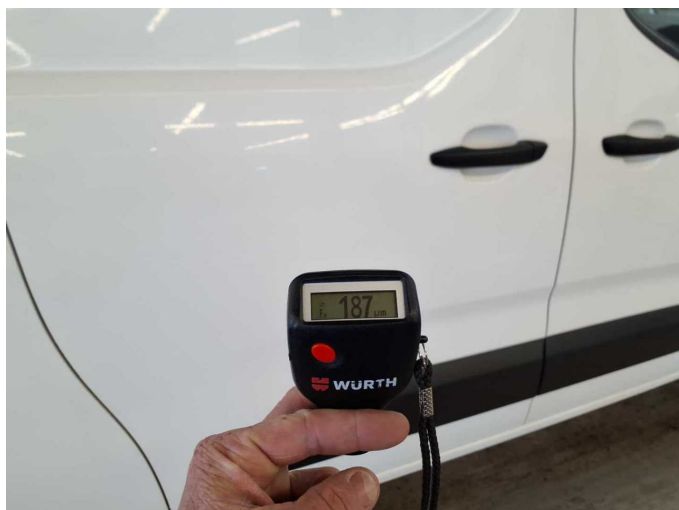
Door - rear right side: 187 µm

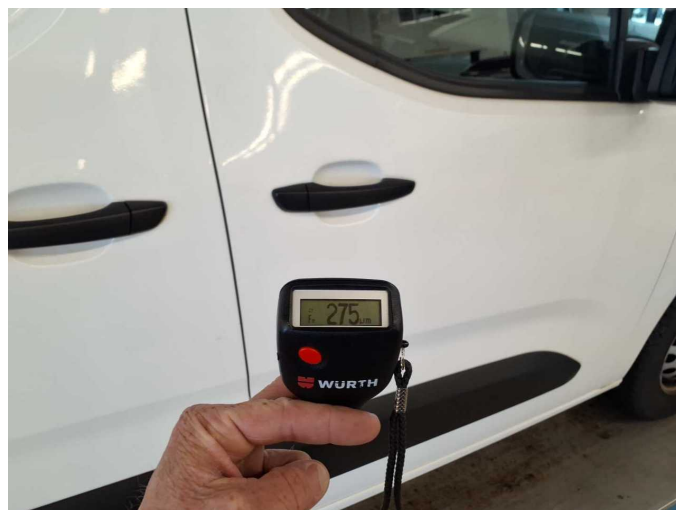
Door - front right side: 275 µm
