Expertise

Protocol number: 41668859  
Order No. / Reference: 25236850  
Inspection date: 17 Sept 2025

| Manufacturer: Opel | Model: Insignia Grand Sport 2.0 Diesel Automatik Business Elegance |

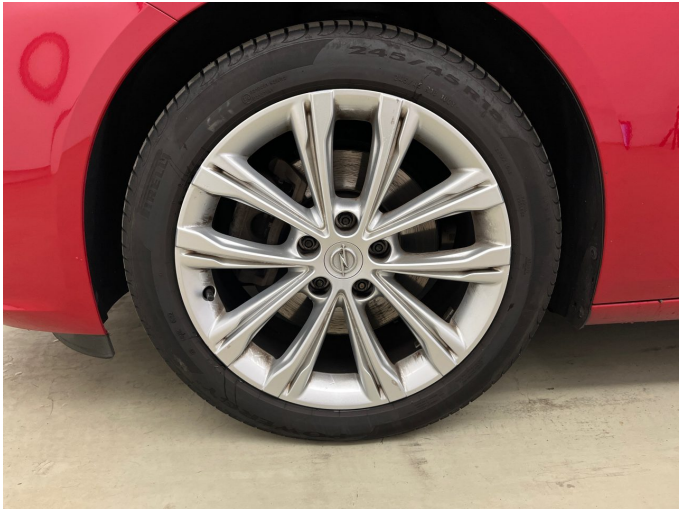
| No. | Component group | Description |
|---|---|---|
| 8 | Wheel / tyres | Tyres - complete set (3 Reifen, nicht fahrbereit) - Porous / cracked - Replace |

Figure 12: Mounted tyres

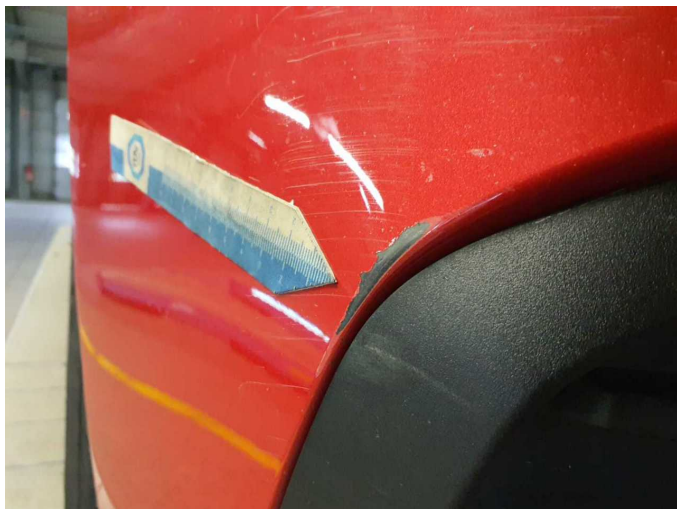
**Accident 1:** Front

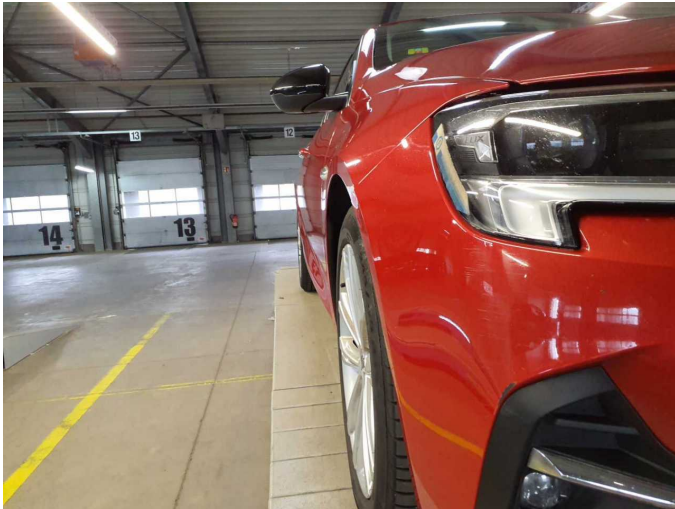
**Accident 1: Front**

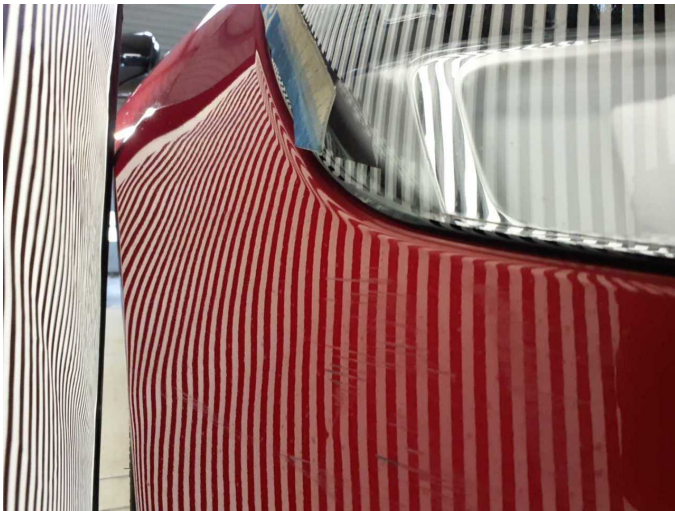
**Accident 1: Front**

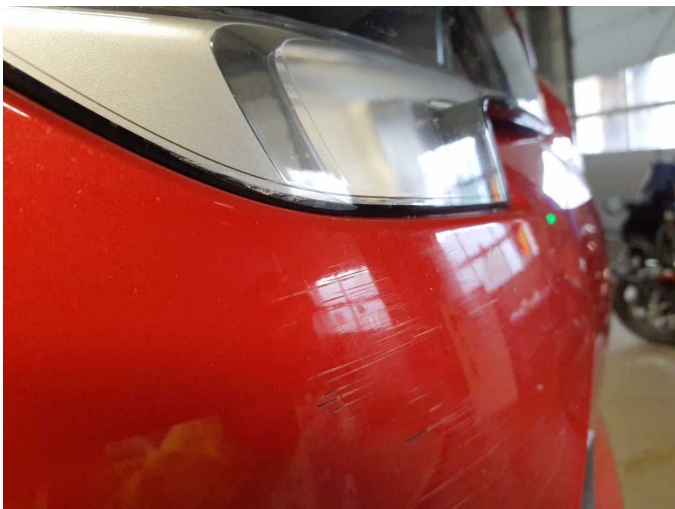
**Accident 1: Front**

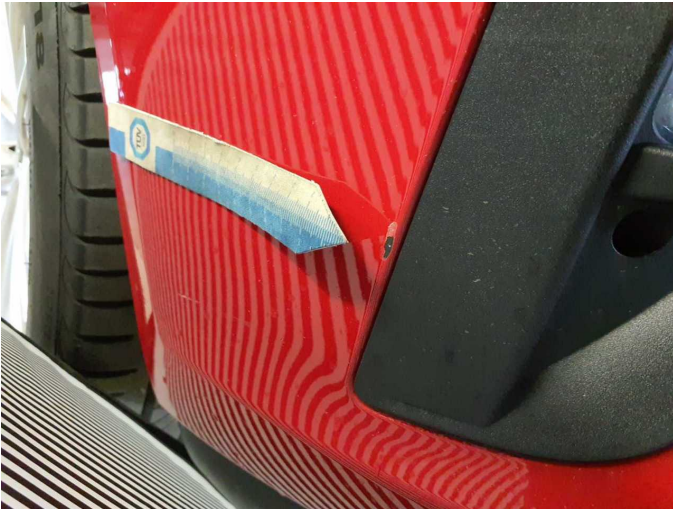
**Accident 1: Front**

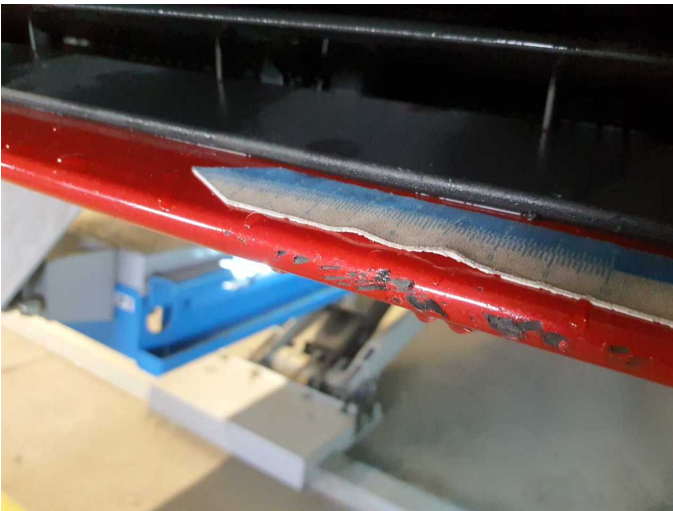
**Accident 1: Front**

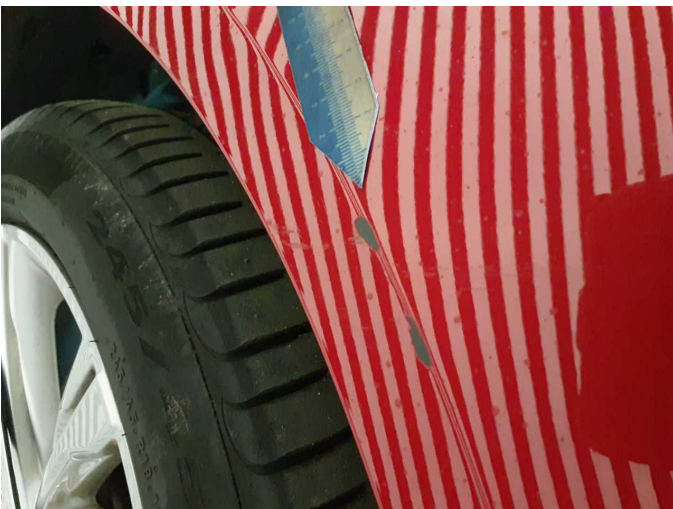
**Accident 1: Front**
