Expertise

Protocol number: 38870551  
Order No. / Reference: 24155659  
Inspection date: 12 Mar 2025

Manufacturer: Mercedes-Benz  
VIN: W1K2052131G052166

Model: C 300 de T 9G-TRONIC

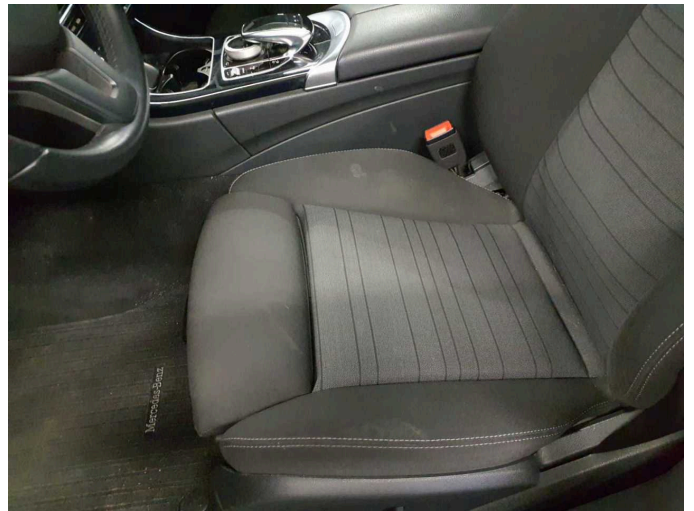
**Damage 1:** Seat - front: Seat cover - left side - Soiled - Clean
