Expertise

Protocol number: 41552822  
Order No. / Reference: 25232583  
Inspection date: 15 Sept 2025

Manufacturer: Mercedes-Benz  
VIN: W1K2054141G101013

Model: C 220 d Cabrio 9G-TRONIC AMG Line

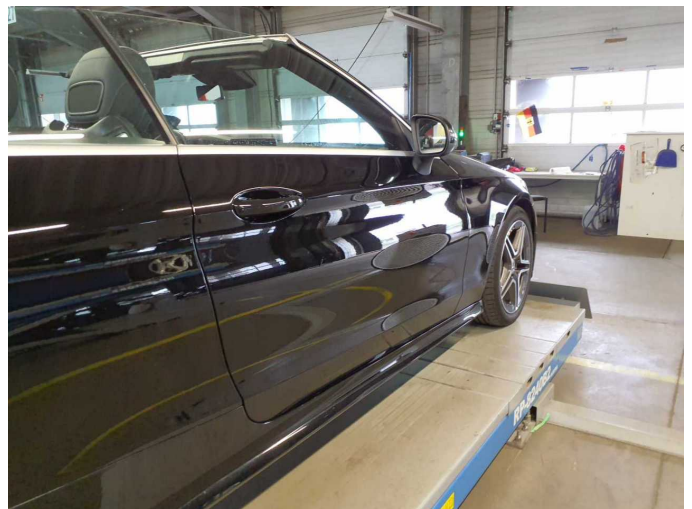
- 1 Side panel - rear right side, Unprofessionally carried out, Invoice of repair done Non-existent
- 2 Door - front right side, Invoice of repair done Non-existent

**Repainting 2:** Door - front right side

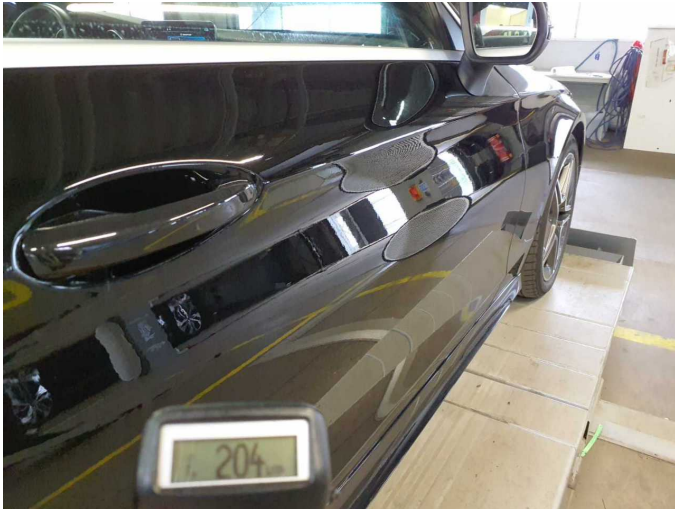
**Repainting 2:** Door - front right side
