## status report

#### Audi A6 Lim. 3.0 TDI quattro

| Vehicle identification number | <b>WAUZZZ4G9JN106716</b> | mileage read: | <b>163011 km</b> |

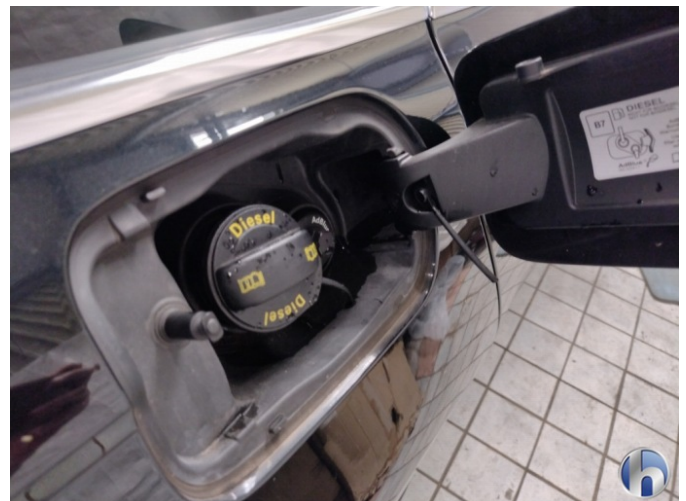
filler cap

| component | Damage | Rep kind |
|---|---|---|
| 26. Tankdeckel Fangband | Damaged | Replace |

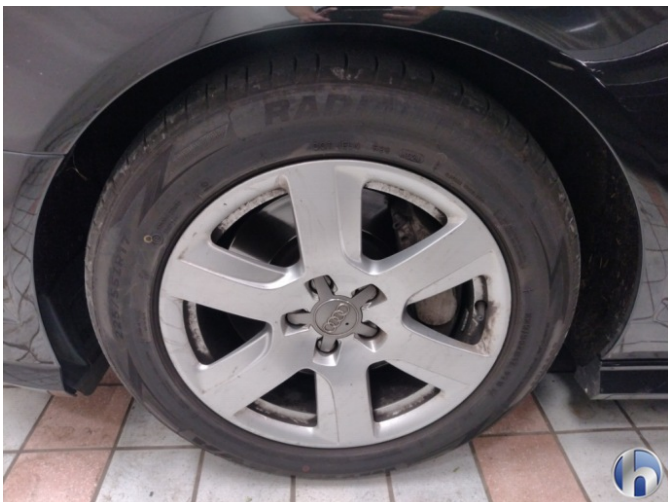
rims

| component | Damage | Rep kind |
|---|---|---|
| 14. Rim rear - left | Scratch(es) | Smart repair |

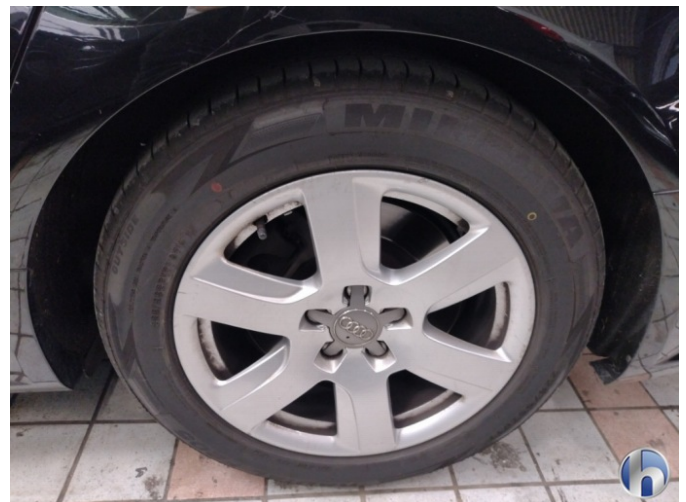
rims

| component | Damage | Rep kind |
|---|---|---|
| 15. Rim rear - right | Scratch(es) | Smart repair |
