## status report

#### Audi S4 Lim. 3.0 TFSI quattro

| Vehicle identification number | <b>WAUZZZ8KXEA027101</b> | mileage read: | <b>73131 km</b> |

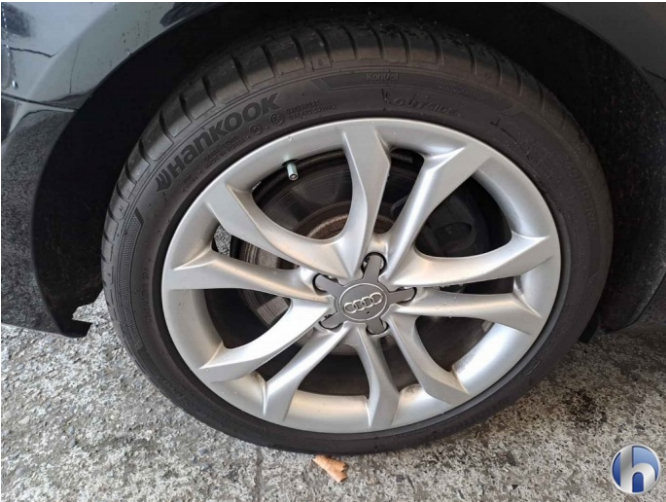
| component | Damage | Rep kind |
|---|---|---|
| 19. Rim rear - right | Scratch(es) | Smart repair |

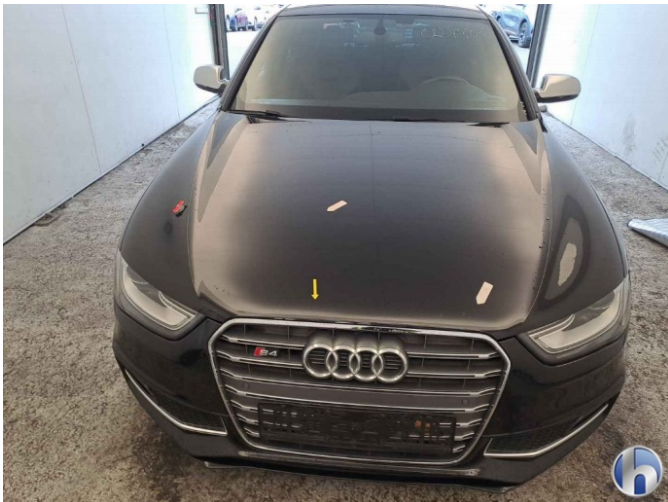
| component | Damage | Rep kind |
|---|---|---|
| 31. hood | Execution defect | Refurbish and paint |

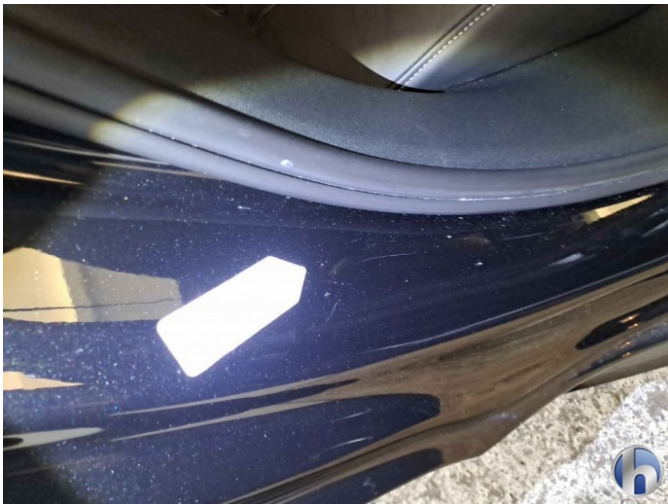
| component | Damage | Rep kind |
|---|---|---|
| 37. Türeinstieg Hinten - Rechts | Damaged | Paint |
