## status report

#### Audi A5 Sportback 2.0 TDI quattro

| Vehicle identification number | <b>WAUZZZ8T7GA028458</b> | mileage read: | <b>110850 km</b> |

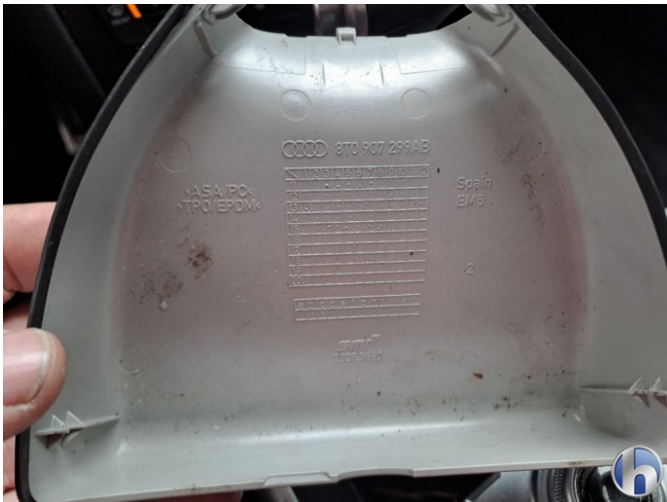
| component | Damage | Rep kind |
|---|---|---|
| 3. Abdeckung Spiegel innen | Breakage | Replace |

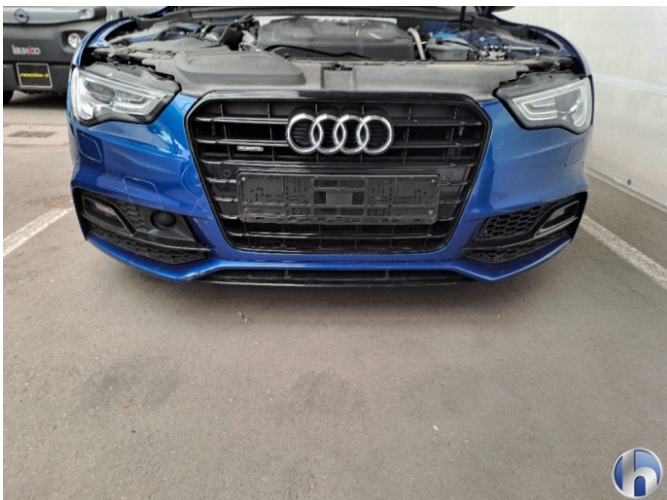
| component | Damage | Rep kind |
|---|---|---|
| 4. Front bumper | Crack | Replace |

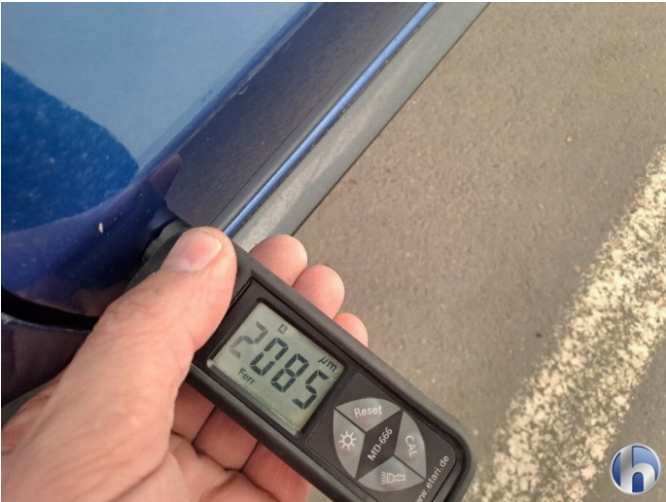
| component | Damage | Rep kind |
|---|---|---|
| 12. Rear door - left | Scratch(es) | Smart repair |

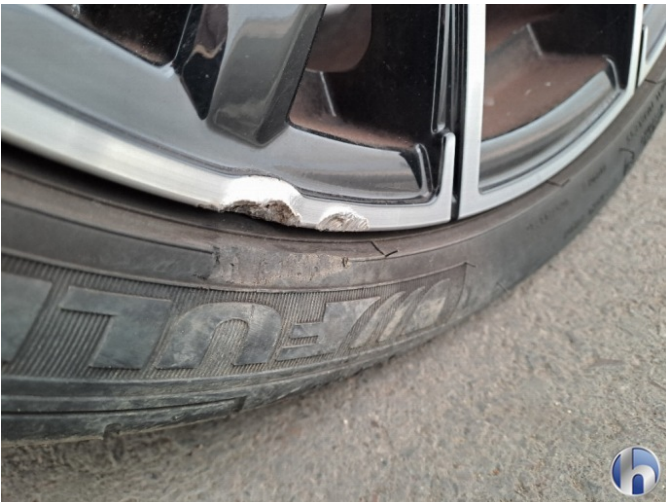
| component | Damage | Rep kind |
|---|---|---|
| 13. Felge vorn links | Scratch(es) | Replace |
